**COMMUNICATION EQUIPMENT MAINTENANCE BULLETIN**

## SECTION II. 'AN' AND ARMY EQUIPMENT

## TYPE AM-215A/U A-F AMPLIFIER

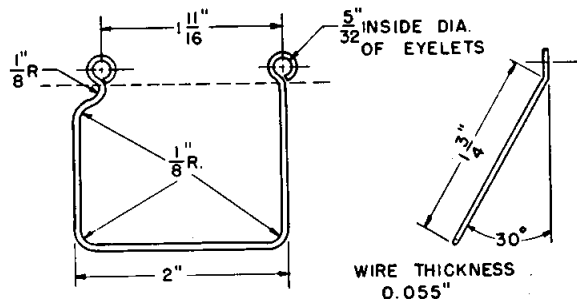
FIGURE 1.—New crystal clamp for model AN/APN-9.

*General.*—Shock and vibration tests at NRL indicate that difficulty may be experienced from the crystal holder coming out of the socket. This change provides added stiffness to the crystal holder spring. Figure 1 shows

*Procedure.*—Fabricate a reinforcing spring as shown in Figure 1. Fasten the spring under the two screws holding the crystal socket supporting bracket and hook it back of the present crystal holder spring to give added stiffness.

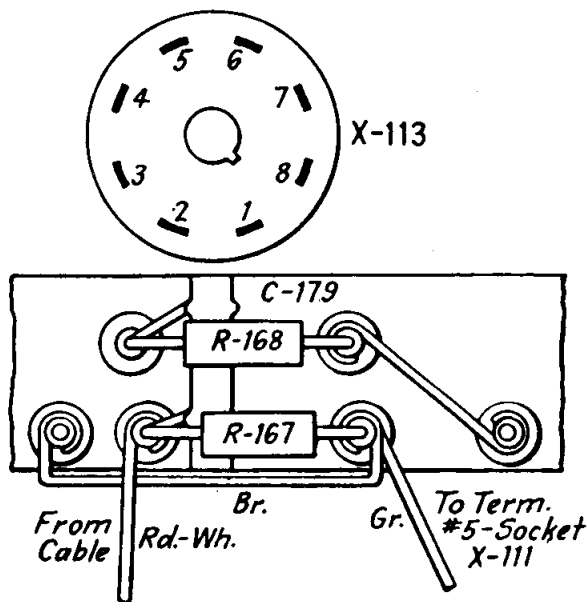
FIGURE 1.—Original arrangement.

Investigation of several failures of capacitor C-179 in AN/ARC-1 equipments has led to the conclusion that the mounting arrangement should be changed as shown in figures 1 and 2 and a capacitor with higher voltage rating substituted.

3 (plate terminal). It is believed, therefore, that the difficulty might be due either to random defective condensers or misplacement in the assembly or both.

1 and may possibly have become misplaced to such an extent that the end nearest to tube socket X-113 was actually in contact with the terminals projecting from the socket. In this case the bakelite insulation on the condenser would soon wear through and result in a contact between the grounded end of C-179 and socket terminal No. 2 (heater terminal 18 volts) or No.

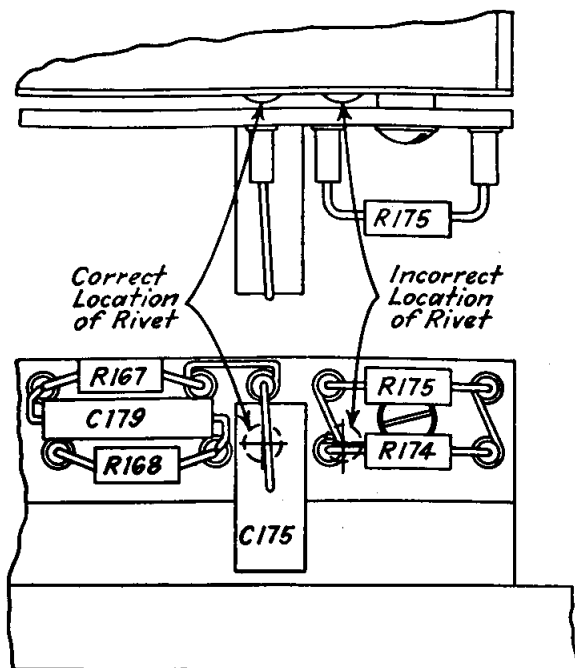
FIGURE 1.—Protection for resistor mounting strip in AN/ARC-1 equipments.

There have been sets shipped to the field, serial numbers unknown, in which the rivets affixing an insulating separator to the chassis are located so as to come dangerously close to live terminals on the resistor strip feeding the modulator audio amplifier tubes V110, V111, V112 and V113. (See Figure 1.) This condi-

tion is present in occasional sets up to current production but will not be found in sets beyond Western Electric 28000 or Westinghouse 7850. To eliminate difficulties which might arise from this source, part BA-40,789 consisting of a  $\frac{1}{32}$  inch thick phenol fiber insulator strip with properly located holes will be furnished to all service activities for general distribution. This strip should be inserted between the existing riveted-on insulator and the resistor strip which is done by removing the three screws mounting the resistor strip, slipping the new
