COMMUNICATION EQUIPMENT MAINTENANCE BULLETIN

SECTION 8. RECEIVING EQUIPMENT

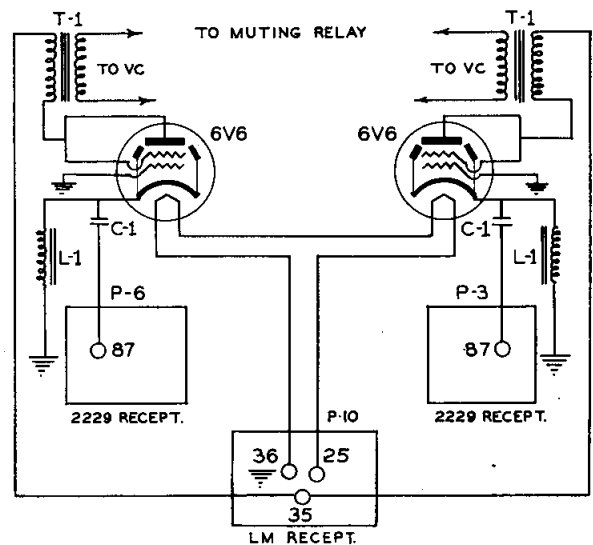
RU receivers and a-c power packs have been received and installed in various Naval Air Activity Control Towers. At the Naval Air Training Bases, Corpus Christi, Tex., it was found necessary to modify the a-c power pack in order to bring each receiver output up to loud speaker volume. The modification was made as illustrated in Figure 1.

FIGURE 1.—Modification of power pack of model RU receiving equipment.

— CHANGE R-10 IN GF-RU-LM POWER SUPPLY TO A 5000Ω 10 WATT RESISTOR

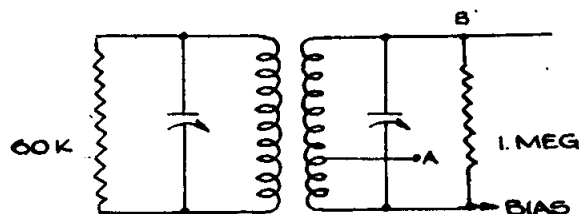
REVISED I.F. 1 & 2

FIGURE 2.—Revised first and second i-f stages.

was increased by decreasing the distance between the primary and secondary coils from $1\frac{1}{2}$ " to $\frac{7}{16}$ ". It was necessary to apply heat to the porcelain coil form to accomplish the movement of the primary coil.

(3) A 1/2-watt resistor of 60,000 ohms was connected in parallel with the primary circuit of each i-f stage, as shown in Figures 2 and 3.

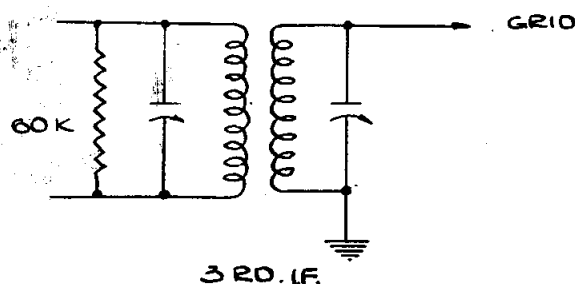
3RD. I.F.

FIGURE 3.—Revised third i-f stage.

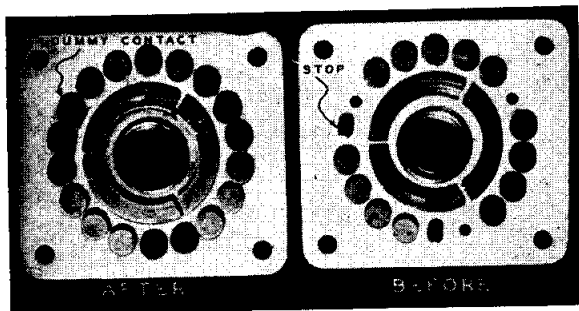
FIGURE 1.—RBB/RBC receivers band switch stators—before and after modification.

Purpose.—To prevent the band switch rotor contacts from twisting.

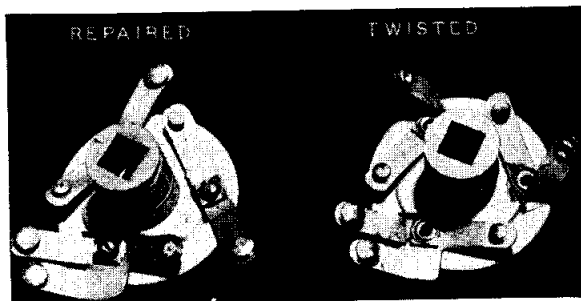
FIGURE 2.—RBB/RBC receivers band switch rotors—twisted and repaired.

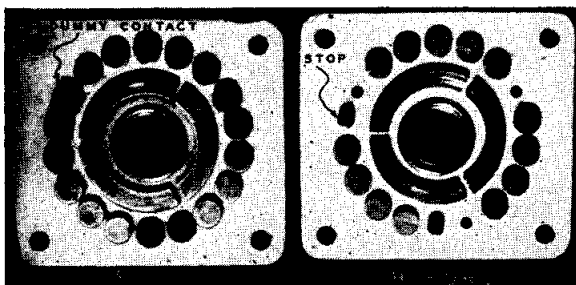
FIGURE 1.—RBB/RBC receiver band switch stator—before and after modification.

Procedure.—Equipments should be modified as shown in the accompanying photographs, Figures 1 and 2. The modification, which was

suggested by C. E. Swiger, RT 1/c of the U. S. S. *Cascade* (AD-16), consists of removing the stop pins and filling the holes on the band switch with plugs made of bakelite or

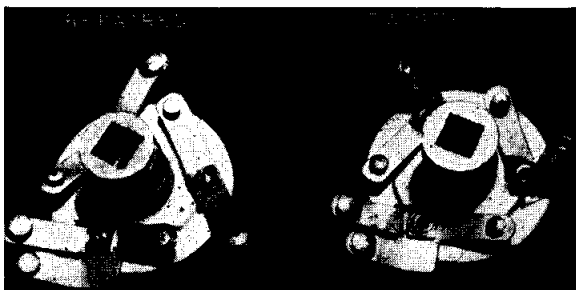
FIGURE 2.—RBB/RBC receiver band switch rotor—twisted and repaired.

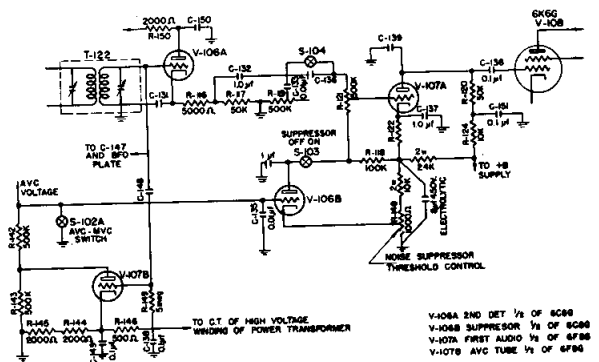
FIGURE 1.—Modification of model RBH-1 to provide carrier-controlled noise suppression action.

The wiring in the receiver is rearranged in accordance with figure 1, utilizing components already in the receiver as required. Resistor R-148 functions as a noise suppression thresh-

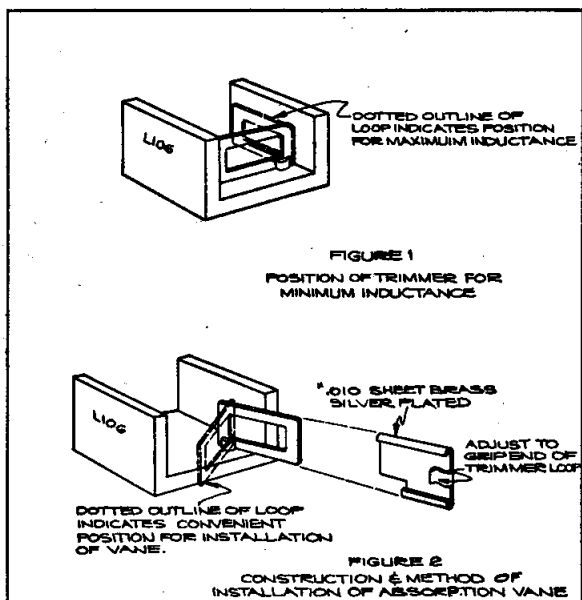
FIGURE 1.—Modification of mixer inductance trimmer to reduce value of the inductance.

2. Remove shield plates from the last multiplier mixer compartment. Determine by inspection the setting of the mixer inductance. If this trimmer is at minimum inductance setting (see fig. 1 of accompanying sketch) or within 30° of minimum (inside the inductance) it will be necessary to install the absorption vane on the trimmer as shown in figure 2 of the accompanying sketch. If the trimmer setting is 30° or more from the minimum position, the absorption vane is not necessary.
