Section 10
AIRCRAFT NAVIGATION EQUIPMENT
Y Series

COMMUNICATION EQUIPMENT MAINTENANCE BULLETIN

SECTION 10. AIRCRAFT NAVIGATION EQUIPMENT

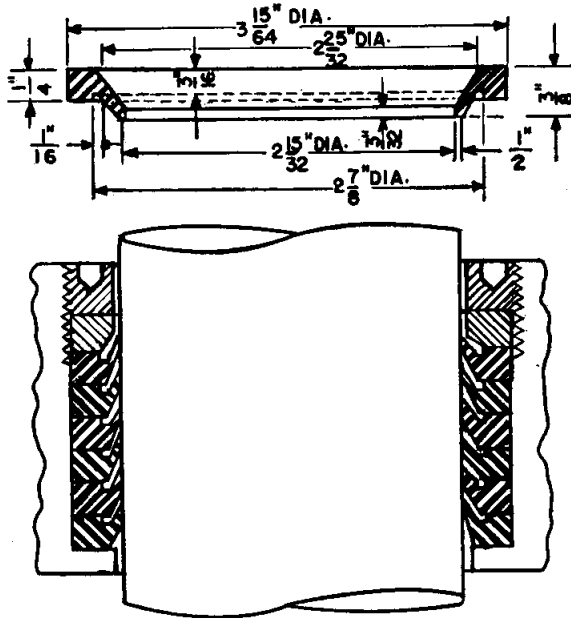
FIGURE 1.—Reconditioning YE antenna and drive mechanism.

(11) A new type of packing used in the drive unit water seal consists of six specially constructed rings molded from synthetic rubber.

The packing gland box is filled with graphite grease. To install these new type rings, it is necessary to cut off the three extensions on the aluminum gland nut, and to cut a bevel on the inner circumference of the fiber ring to allow clearance for the top packing ring. (See Fig. 1.)
