THE EFFECT OF LINE VOLTAGE VARIATIONS ON THE MODEL DAB DIRECTION-FINDING EQUIPMENTS

DISCRIMINATING FILTERS AND NEW COMMUTATORS FOR MODEL DAB DIRECTION-FINDING EQUIPMENTS

MODIFICATION OF THE MODEL DAE DIRECTION-FINDING EQUIPMENTS

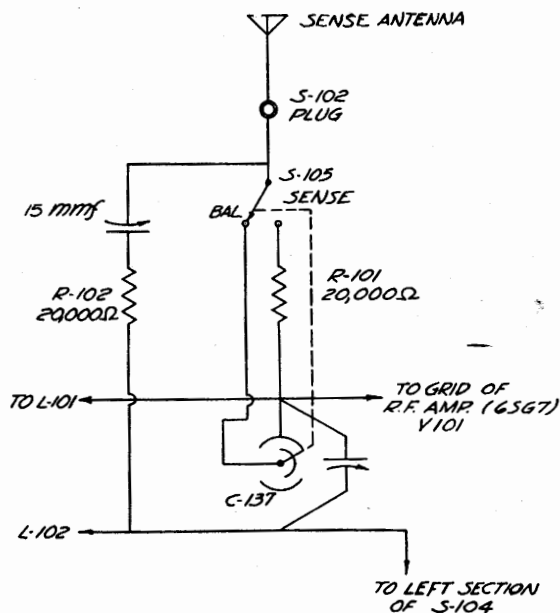
FIGURE 1.—Schematic of circuit.

The faulty operation of the model DAE direction-finding equipment has been traced to the S-105 capacitor switch. It was noticed that stray in-phase voltage components were being introduced through the sense balance circuit and causing an unbalance to the loop circuit.

This fault has been corrected by installing a 15-micromicrofarad variable capacitor and a 20,000-ohm $\frac{1}{2}$ -watt resistor between the antenna and the tuning capacitor forming a balanced bridge circuit (see Figure 1). The stray in-phase component produced by the capacitance between the antenna and the sense resistor R-101 through

switch S-105 is opposed by the potential introduced by the 15-mmfd. variable capacitor and the 20,000-ohm resistor, causing these potentials to cancel. This in turn balances the loop circuit. It should be noticed in Figure 1 that R-102 must be of the same value as R-101 in order for the circuit to balance.

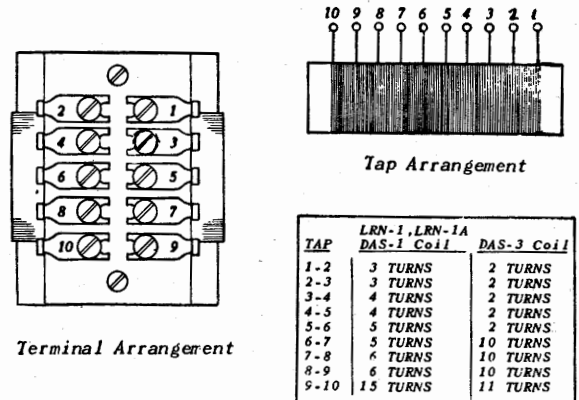
FIGURE 1.—Terminal and top arrangement of loading coil.

(1) Improper adjustment of the loading coil. In many instances the entire number of coil turns is used (from tap 1 to tap 10), and no attempt has been made to adjust the number of turns (by selecting appropriate taps) for maximum signal strength. The loading coil should be connected so that it is in series with the antenna lead-in and the center conductor of the coaxial cable. The active number of turns is the number between the two taps to which the two flexible leads (one from the antenna, one from the coaxial cable center conductor) connect. The tap arrangement is somewhat peculiar, as shown in Figure 1, and should be carefully noted.

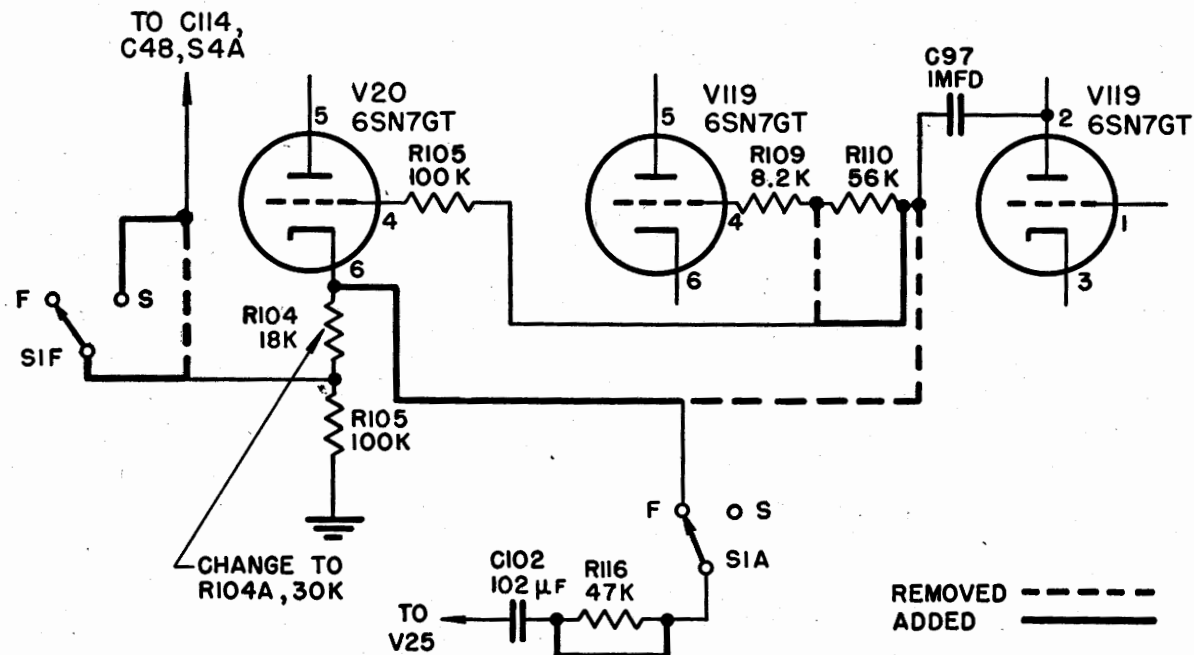
Figure 1.—Schematic for field change no. 4 for LRN-1A.

The fundamental difficulty with the original design when used with tubes having excessive grid leakage is that the intensifier voltage which would normally be maintained below cut-off except during the operation of the pedestal generator, leaks up into the conducting range before the fast sweep is triggered and thereby creates the bright spots at the beginning of the traces. The problem, then, is to drive the intensifier down so far during the off period that even with leakages up to 50 microamperes it won't be able to drift up past cut-off before the next positive kick from the pedestal generator.

Referring to the accompanying diagram (Figure 1), the five steps necessary to accomplish this modification are as follows:

- (1) Disconnect the wire at the junction of R110 and C97 that runs from the pedestal generator V-19 to switch S1A, and connect it to pin 6 of V-20, the cathode follower.
- (2) Disconnect the wire at the junction of R109 and R110 which runs through R105 to pin 4 of V-20, and connect it to the junction of R110 and C97.

- (3) Short circuit R116.
- (4) Replace R104 with a 30K 1/2-watt resistor, R104A.
- (5) From the junction of R103 and R104A connect to an unused section of S1 (the slow-fast sweep switch) in such a way that the circuit will be closed back to C114 in the slow sweep position and open during the fast sweeps.
