**AN/FRC-37 Filament Power Supply — Wiring Error
Hint**

AN/FRD-10A(V) Manual DF Position Receivers—Alternate Procedure for Minimum Discernible Input Signal Check

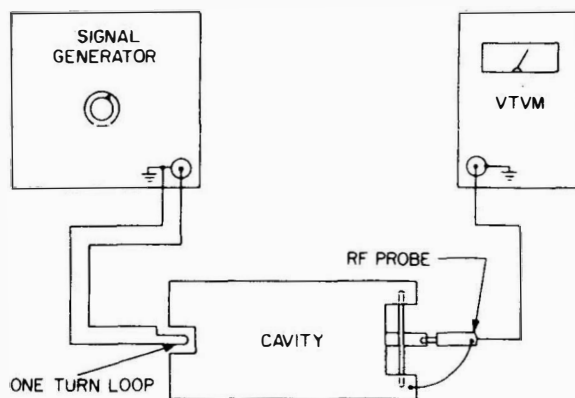
Figure 1. Method of Tuning Cavities

Maintenance personnel at some stations have experienced difficulty in obtaining the rated power output (200w) from the AN/FRN-12A transmitter. In most cases where the output is low, the plate current tends to be unstable and neutralization is incomplete and erratic. Investigation of these conditions has disclosed that most of these symptoms are caused by high RF resistance between the elements of the Beehive cavities Z-0401 and Z-0402. Another factor contributing to unbalance in the circuit is improper tuning of the variable cavity Z-0401. It is imperative that the two cavities be electrically identical, otherwise the power tubes, V-1004 and V-1005, will not deliver equal power.

- a. Remove the AM-323/FRN-12 chassis from the transmitter and place on work bench.
- b. Carefully remove Beehive Cavities Z-0401 and Z-0402 from the amplifier chassis.
- c. Disassemble each cavity, clean the cavity elements thoroughly, and burnish all mating surfaces with fine abrasive paper, such as crocus cloth.
- d. Before reinstalling the cavities on the amplifier chassis, perform the following (see figure 1):

(1) Loosely couple the output of a VHF signal generator, such as an AN-URM-26, through a one turn coil to the fixed tuned cavity Z-0402.

(2) Connect the RF Probe of a VTVM (HP-410A or equal) across the other end (high impedance end) of the cavity.

(3) Tune the signal generator to cavity resonance as indicated on the VTVM. This frequency will be in the neighborhood of 140 mcs.

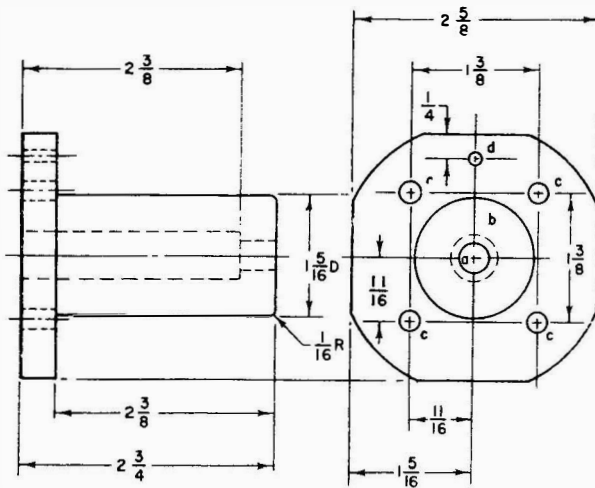
The High Voltage Standoff Insulator P-106A in the AN/FRT-24 is subject to breakage when the RF Assembly is rolled in and out of the cabinet. If repeated failure of P-106A cannot be corrected by properly aligning it with its banana plug, the difficulty may be corrected by replacing this ceramic insulator with a more rugged one made of teflon.

Instructions for fabrication of this teflon insulator are given in figure 1.

MATERIAL: TEFLON ROD, 3 INCH DIA

- HOLE SIZES:
- a. 3/8" DRILL, 1 HOLE
 - b. 1/2" DRILL, 1 HOLE
 - c. 3/16" DRILL, 4 HOLES
 - d. NO. 25 (0.1495) DRILL, 1 HOLE

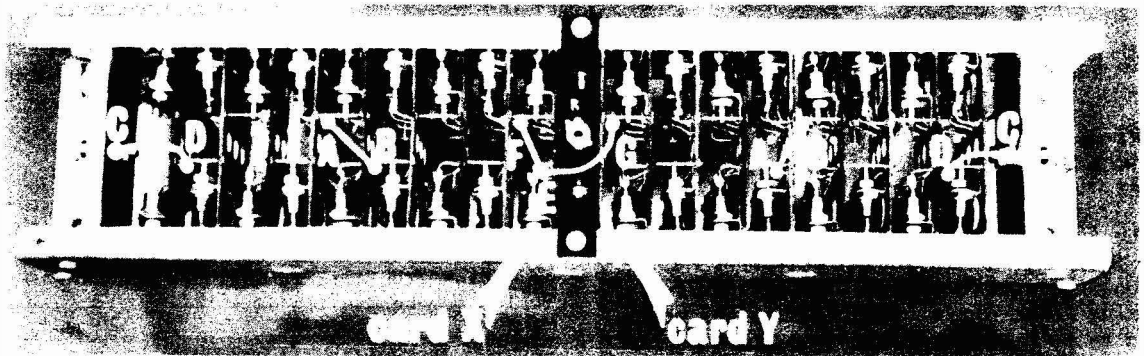
Figure 2. Method of Bridging Faulty Cards.

c. Temporary repair to stack. -Where measurements, both front and back, indicate an open card in a stack (condition usually caused by faulty rivet as previously noted), emergency repair may be effected by bridging the faulty card with No. 16AWG solid copper, 600V insulated wire, in accordance with the following procedure:

(8) Reinstall repaired stack observing same polarity as noted in step (1) above. Up to twenty per cent of the cards of any stack may be shunted in the above manner without reducing the effectiveness of the stack.

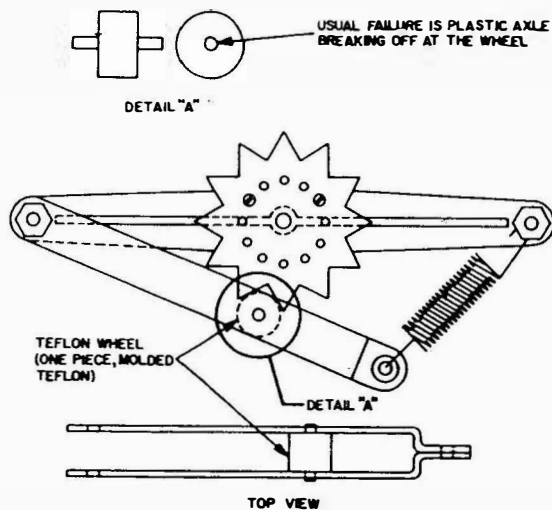
Figure 1. Switch S-202 Index Assembly.

The indexing mechanism on the rear of IPA Band Switch S-202 in the AN/FRT-39/40 has a teflon wheel which engages a star gear for indexing. The shaft of this wheel has been found to be a high failure rate item and the wheel is not stocked as a discrete part, the entire band switch must be replaced upon failure of the teflon wheel.

A method of repair of this item is outlined as follows. Refer to figure 1 for details. Steps to be followed in repair are:

1. Remove spring and arm assembly and separate the teflon wheel from the arm by spreading the fork.
 2. Drill a 0.125" hole through the center of the teflon wheel.
 3. Cut a piece of 0.125 dia. brass rod to slightly more than the width of the fork.
 4. Insert the wheel into the fork and press the brass rod through holes in fork and wheel.
 5. Peen both ends of the brass rod to hold it in position.
 6. Reassemble spring and arm assembly.
- This method of repair can be adopted to other switch assemblies which are constructed in a similar manner. (792)

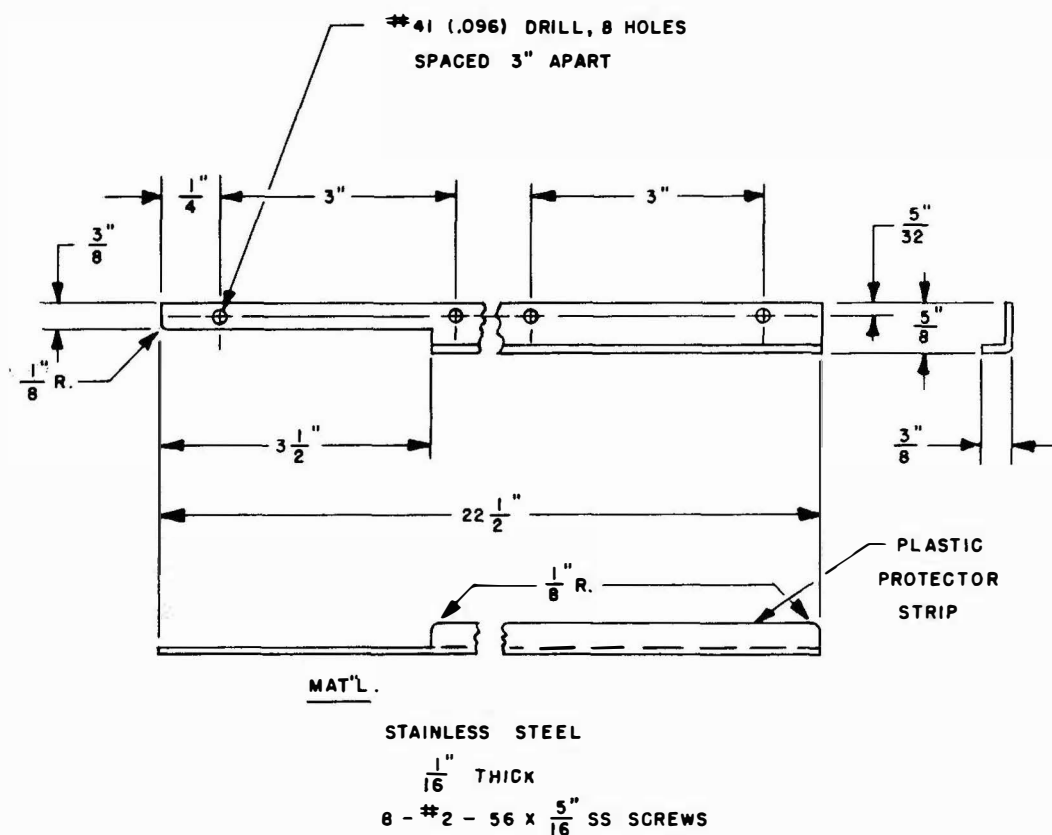
Figure 1. Door Support Tape Storage Bin

Some activities have reported the use of wire rope or metal chain to support the bin access door. Although the adequacy of such

fixes is not known, the use of the angle bar support shown in figure 1, appears to offer a worthwhile solution to the storage bin access door problem. The stainless steel angle bar can readily replace the existing hinge cover strap on the tape storage bin door and is recommended for implementation where the basic problem exists. The plastic piece, shown in figure 1, should be attached along the top edge of the angle bar to act as a stop and prevent scratching the storage bin access door when open and resting on the stop. (799)

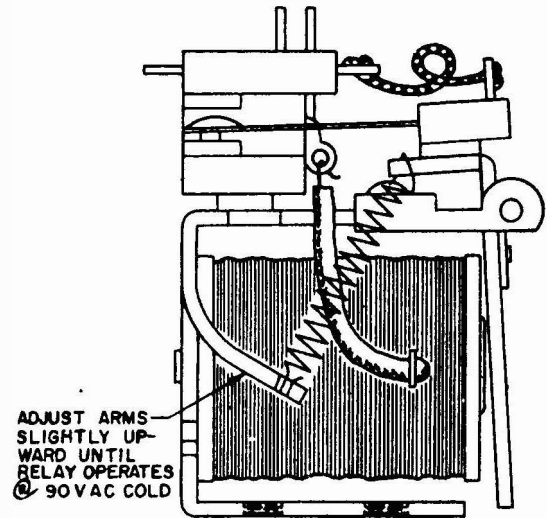
Figure 1. Relay K-105, Armature Return Spring Arm Adjustment

to obtain relay closure at 90-volts line voltage. If the spring tension is decreased too much, then the relay contacts are sure to open under mechanical shock and shut down Radio Set AN/GRC-27.

Radio-Set Controls, Serial 1 through 115, will be field changed to use the new, properly adjusted relay. Stock maintenance relays of the old type will be replaced with the new type.
