**AN/UCC-1(V)-Telegraph Terminal Diversity Pairs**

**AN/UCC-1(V) Series Telegraph Terminal Utilization-Information Concerning**

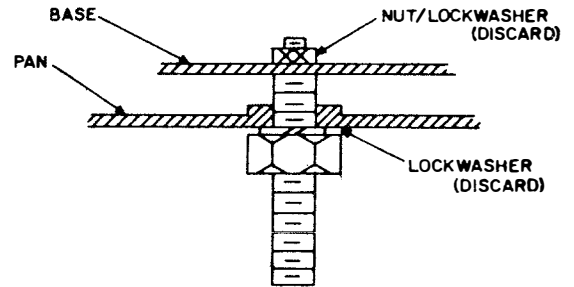
Figure 1. 305051 Shipping Stud

Several reports have been received of activities improperly installing the AN/UGC-20, AN/UGC-25 series teletypewriters. NAVSHIPS 0967-059-9010, Section 573-100-202, provides installation information. The 305051 shipping stud, which secures the equipment to the plywood pallet for shipping, disables the internal shock mounts of the equipment, figure 1.

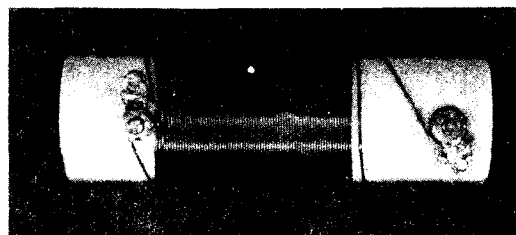
Figure 1. Coil 2L8.

Coil 2L8 has two terminal posts mounted on the coil form. One terminal is located 3/16 inch from the end of the coil form and the other terminal is located 3/8 inch from the opposite end of the coil form (refer to figure 1). The coil form flush mounts to the top of the chassis of the AM/2061/URT and is identified by the circuit symbol number printed on the chassis adjacent to the coil form. High level d-c and rf voltages are present on these two terminals. If the terminal that is 3/16 inch from the end of the coil form is mounted adjacent to the chassis, there is the probability that the voltages present will arc to chassis ground.

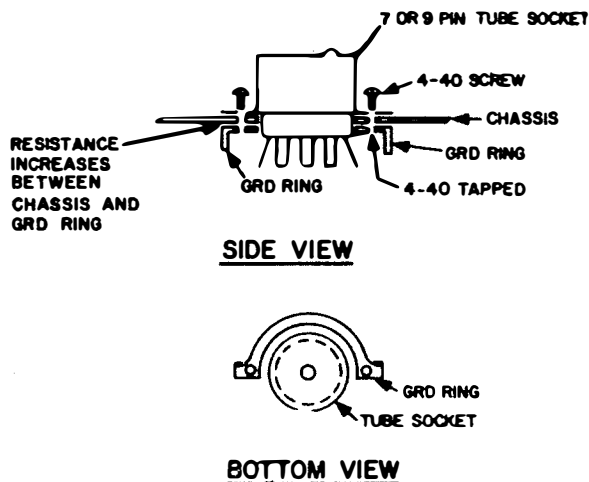
Figure 1.

This article describes the possibility of unusual problems that can be encountered and caused by faulty ground connections. The types of equipment in which ground problems are most likely to be encountered are those whose chassis have been anodized and which employ the half-ring ground tube socket mountings (see figure 1).
