AN/URT-2, -3, -4 OVERHEATING

AN/URT-2, -3 AND -4 INSPECTION OF BRUSHES

AN/URT-2, -3 AND -4 AN/SRT-14, -15 AND -16 CORROSION OF CABLE CONNECTORS AND RECEPTACLES

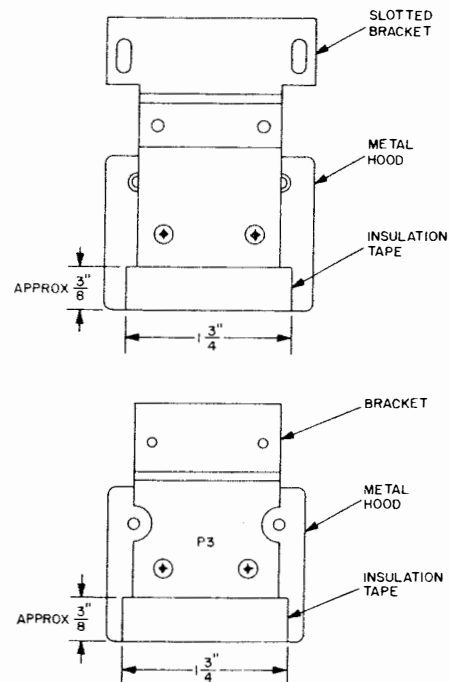
A number of failures have occurred in the 66-pin connector plug 1A2P3 located in the case assembly for the radio frequency amplifier AM-3924(P)/URT. Connector 1A2P3 failure occurs when the insulation between the connector pins that carries the 440 VAC input power and the connector metal hood cover breaks down. To reduce arcing and probable failure of the connector, a strip of high voltage insulation tape is applied to the inside of both halves of the metal hood on connector 1A2P3.

Figure 1. Method of Applying Insulation Tape to Metal Hood.

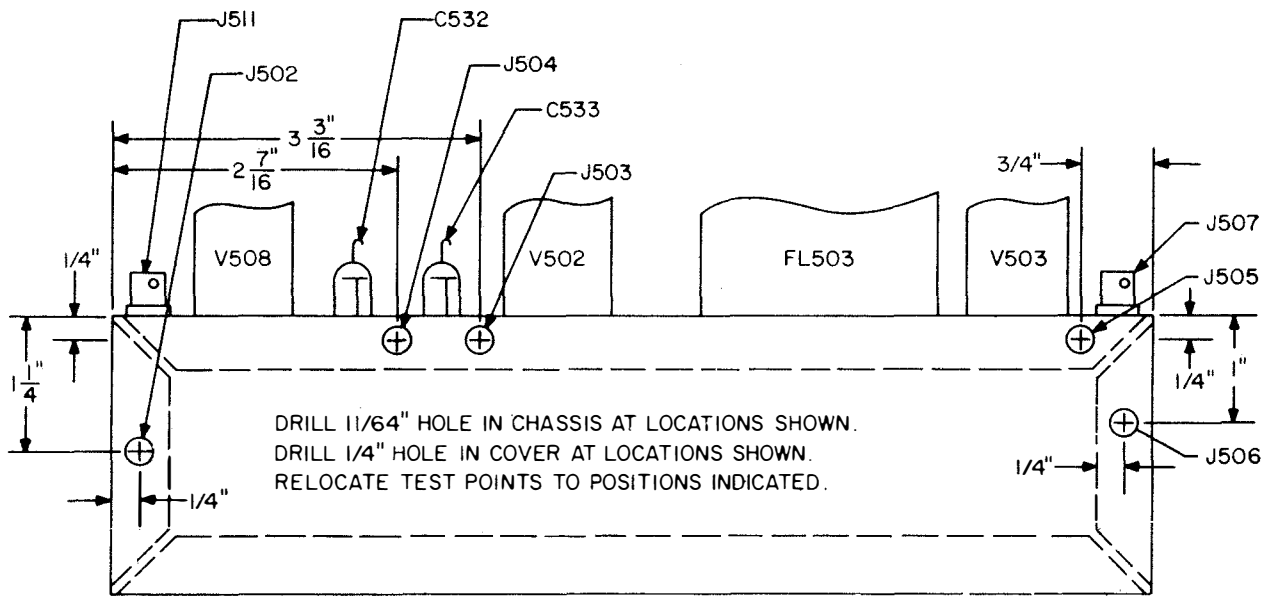
Figure 1. Top View of Injection IF Amplifier as Installed in CV-920/WRR-2 converter.
 Relocated test points J502 through J506.

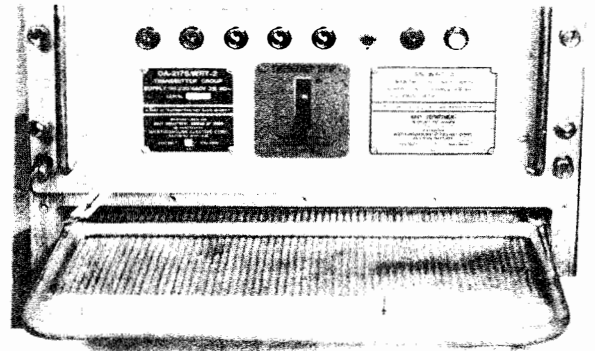
The purpose of this article is to inform the maintenance personnel of the correct method for installing the air filter in the AN/WRT-1 and AN/WRT-2 series transmitters. Figure 1 illustrates the correct positioning of the air filter and guide bar before being inserted into the cabinet. The filter should be positioned in the cabinet with the direction of the air flow downward. The guide bar should be inserted below the angle as shown by the arrow marked "A" in figure 1. clean the air filter weekly. (EIB 727)

Figure 1. Correct Position of Air Filter and Guide Bar before Insertion in Cabinet.

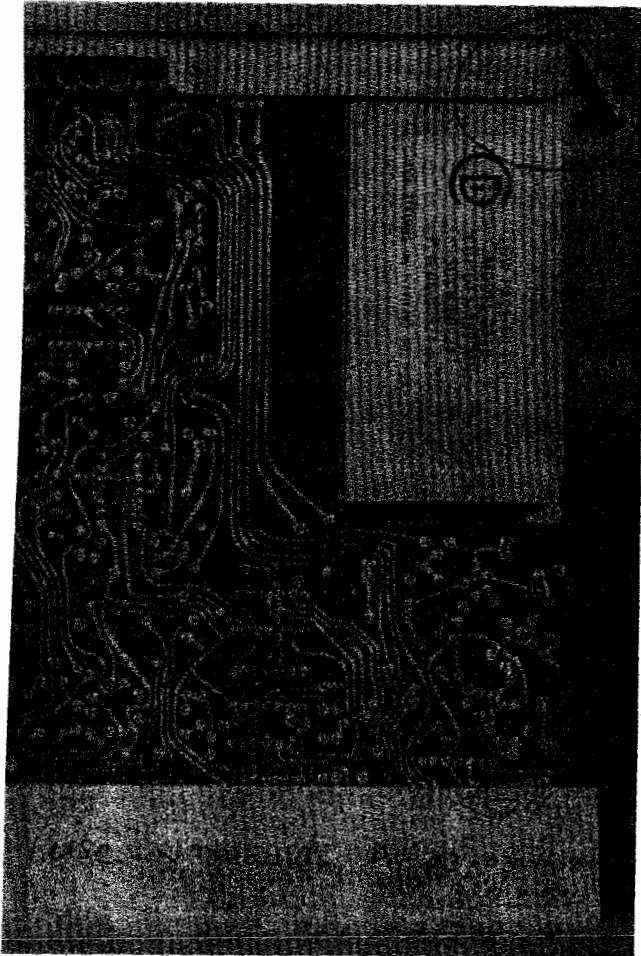
This article describes mechanical damage which has been found on "whiskey three" Power Supply and Transmitter MODULES received at the repair depot. Mounting ears are bent down at crazy angles for no apparent reason (see Figure 1). Packing containers show no signs of mishandling and packaging methods appear to be sufficient to protect the MODULES in transit. Most damage can be corrected with minimum cost, but, some damage is so severe that the entire case must be replaced. Severe damage has a

Figure 1. AN/WSC-3 Module PN 03-03246-001.
