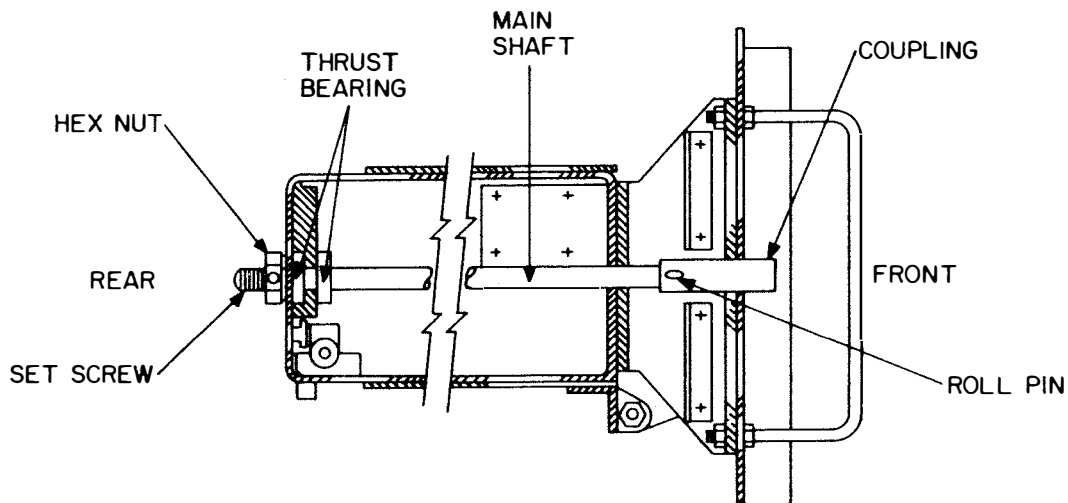
Figure 1. Access to Center Drive Shaft.

In the event of roll pin failure, the coupling will unscrew from main shaft. A large flat blade screwdriver can then be used to unmate and remove logic chassis for repair.

2. Remove entire shaft by loosening set screw in hex nut on rear of shaft, remove hex nut and pull shaft from chassis figure 1).

6. Reassemble and replace shaft in logic chassis reversing foregoing steps 2 and 4.

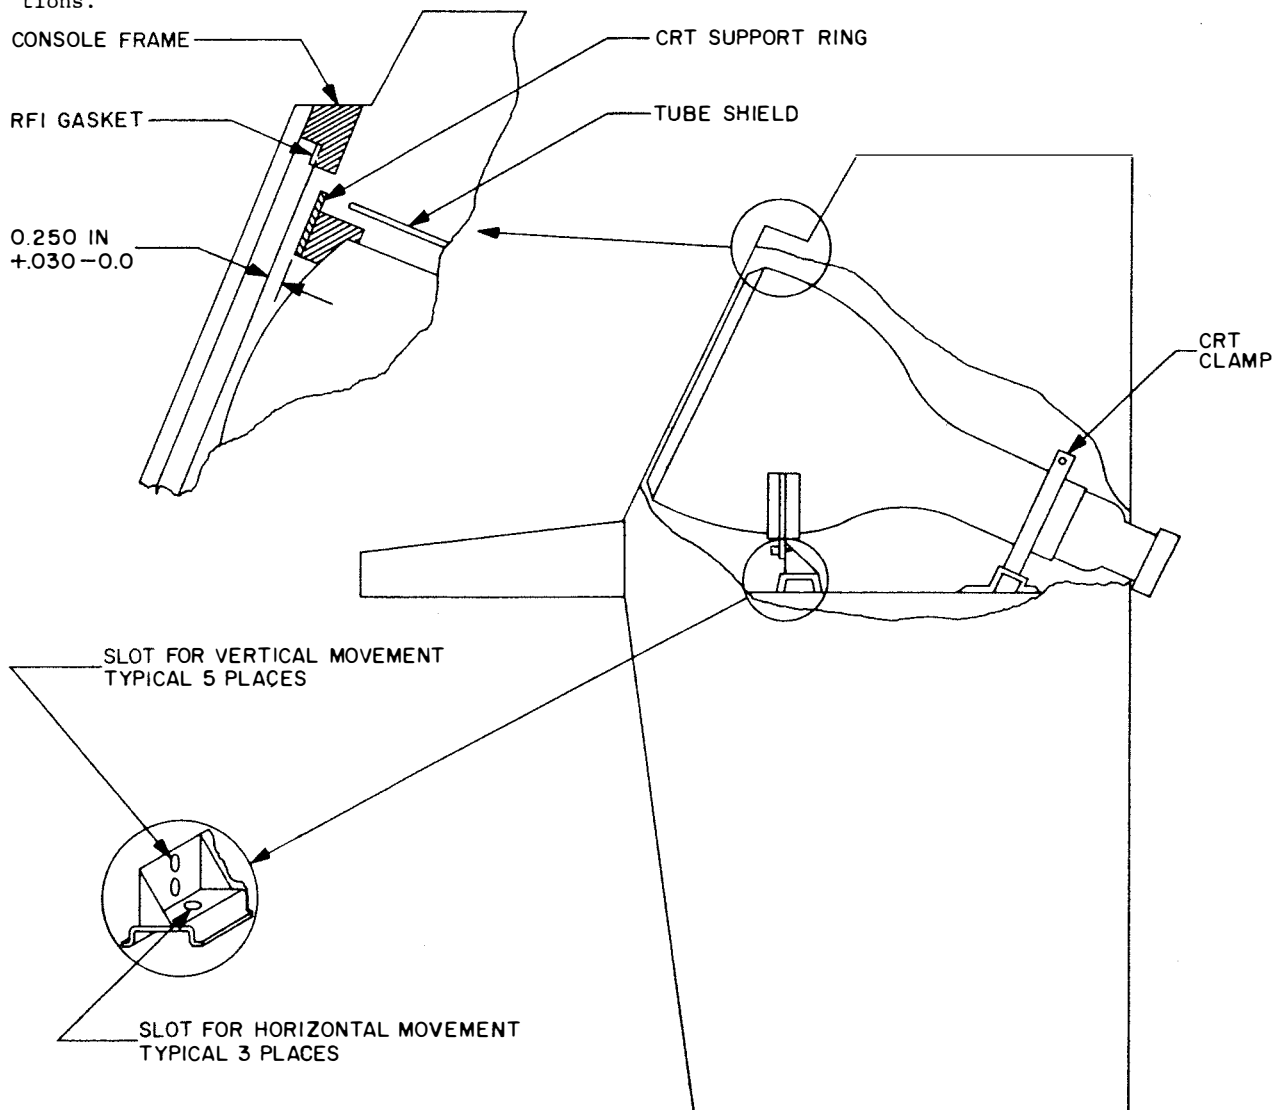
Figure 1. PPI Console

Do not slide the CRT assembly back further than the minimum dimension indicated or the PT-490A plotter optics will be degraded due to increased parallax.

5. Raise the PPI console lid and loosen the nut on the CRT clamp around the neck of the CRT shield at the rear of the PPI console as indicated in figure 1.

6. Loosen the three screws in the front CRT support bracket which have the slots for horizontal movement (Refer to detail in figure 1). There is one screw on the left side, one on the right and one in the middle of the CRT support bracket.

8. The dimension indicated in step 7 must be checked at the top of the CRT and on each side. If the CRT needs to be moved vertically, loosen the five screws in the front CRT support bracket which have the slots for vertical movement as indicated in detail in figure 1.

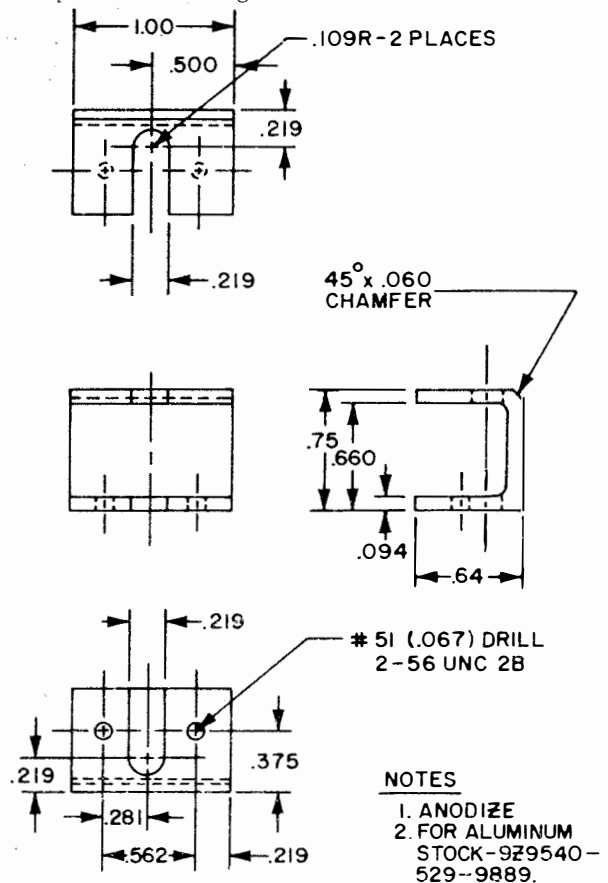
Figure 1. Fabrication of Switch Mounting Bracket

Many holders of 0A-7979(V)1/UYA-4(V) through 0A-7979(V)9/UYA-4(V) data display consoles have reported the inability to obtain the switch mounting brackets, Hughes Aircraft Company (HAC) P/N 1576467, required for initial installation of the new, more reliable switch now provided under FSN 9N5930-890-9713 for replacement of switches A4S1 through A4S18.

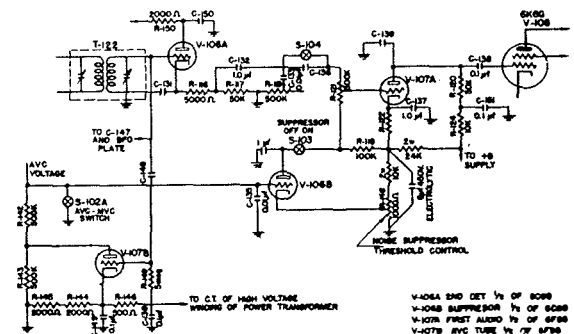
FIGURE 1.--Modification of model RBH-1 to provide carrier-controlled noise suppression action

The wiring in the receiver is rearranged in accordance with figure 1, utilizing components already in the receiver as required. Resistor R-148 functions as a noise suppression threshold control or an adjustment which determines the strength of the incoming carrier necessary to unlock the audio system. Switch S-103 is used to remove the noise suppression feature if desired. The circuit is adjusted by setting the suppressor threshold control so that atmospheric disturbances are just barely eliminated with the r-f gain full on and no carrier being received. The suppressor circuit is highly sensitive and only a very weak signal is required to trigger it. Sensitivity of the receiver may be reduced by the r-f gain control although too much reduction in gain will decrease or eliminate the avc voltage and as a consequence the suppressor circuits will not unlock the audio system.

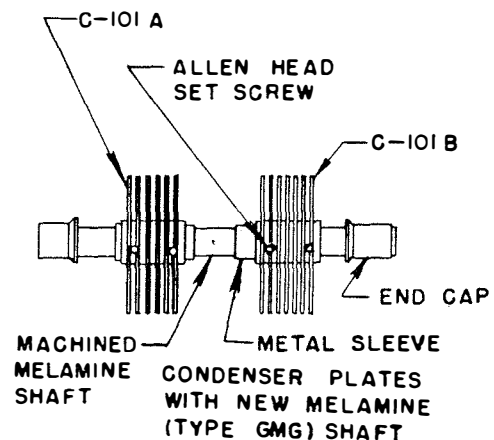
FIGURE 4. Showing New Shaft Installed.

The basic suggestion consists of replacing broken ceramic tuning capacitor shafts with shafts fabricated from GMG glass fiber (Melamine) rod.
