RL-216/UG Tape Winder--Possible Shock Hazard

SERVICE NOTES

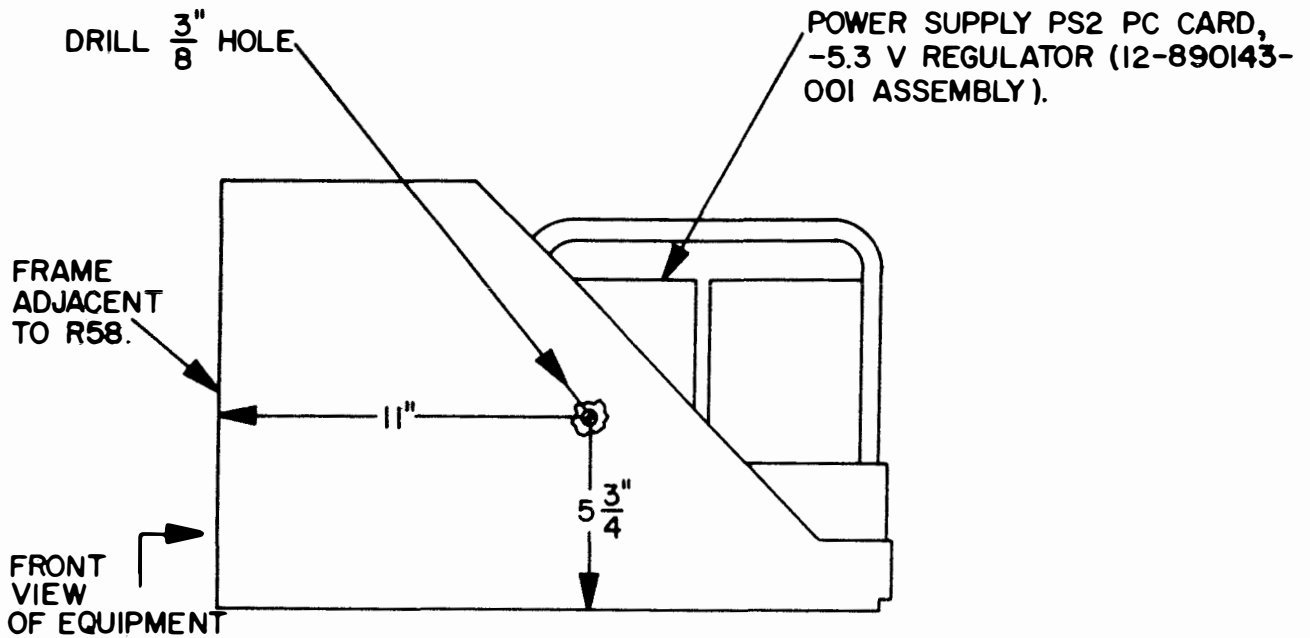
RIGHT SIDE VIEW OF CONTROL LOGIC ASSEMBLY

Voltage adjustments to the Printer Interpreter Power Supply, items 16 and 42, Figure 4-49, NAVSHIPS 0967-324-0060, requires the use of an offset screwdriver which creates a hazard of short circuiting and damage to personnel and equipment. To eliminate the hazard and to facilitate making future adjustments to the -5.3 and -6.0 volt DC power supplies, 3/8-inch holes must be drilled through the equipment frames adjacent to R-53 (-5.3 V regulator) and R-20 (-6 V regulator) to permit adjustment with normal tools.

The foregoing alteration should be performed during the next maintenance period on the RO-314/G punch equipment. Use standard hand tools and assure power to the equipment is turned off and that adequate protective covering is placed over surrounding circuit boards and chassis. It is suggested that assemblies 12-890143-001 and 190-3591-6 be removed prior to drilling to prevent possible damage to these printed circuit cards. (See figure 1 for details.)

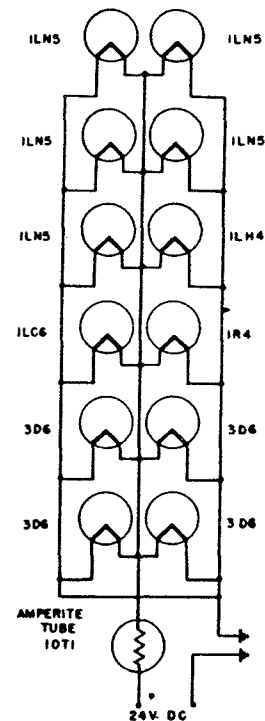
FIGURE 1. Receiver filament circuit.

When removing receiving tubes from the SCR-610 be sure that the power is off. The filaments of the receiving tubes are all hooked in parallel, in series with an Amperite tube 10T1, as shown in figure 1. If more than three tubes are out of the circuit when the power is applied, the rest of the tubes will almost certainly be damaged. Without the proper number of tubes, there is not enough current to give the correct voltage drop across the Amperite tube, leaving too much voltage across the receiving tube filaments.

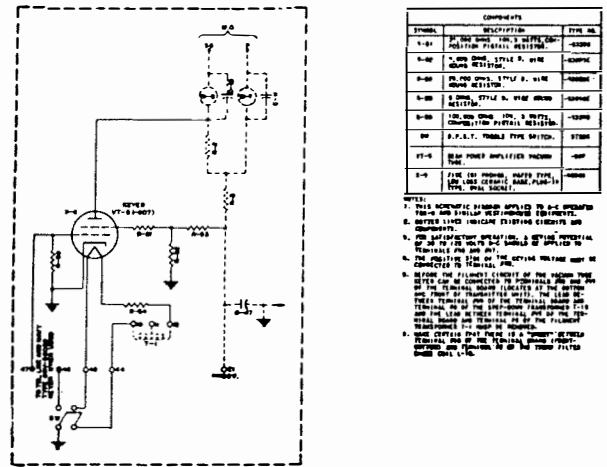
FIGURE 10. Vacuum tube keyer schematic diagram.

When the keyer tube heater circuit is excited (First the keyer switch "SW" should be thrown in the "Vacuum Keying" position and then the "Test Key" S-10 of the transmitter should be thrown in the "lock" position. It should be noted that when vacuum tube keying is employed, the "Keying Relay" K-1 and the "Compensating Relay" K-2 must be locked in (continuously energized) by either throwing the "Test Key" S-10 in the "lock" position or by some other convenient outside means), the plate of the keyer tube draws current through the master oscillator screen dropping resistor R-2; this reduces the master oscillator screen grid voltage to a low value and the master oscillator

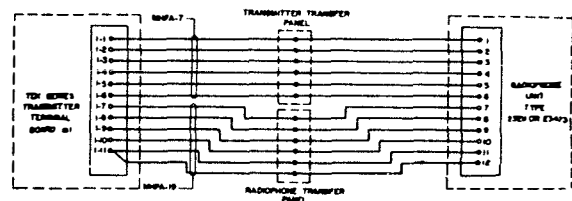
FIGURE 1. Wiring necessary for interconnection of model TCK series transmitters with standard radiophone unit

TCK series transmitting equipment has recently been added to the radio allowance of certain Naval vessels. It is noted, however, that the instruction books for current models of this equipment do not indicate clearly the wiring necessary to incorporate the installation of the present "6-wire" system. This information will be included in the instruction books furnished with subsequent models. Meanwhile the wiring shown in figure 1 should be followed for current installations.
