**SERVICE NOTES**  
**RADAR**

**DEPARTMENT OF THE NAVY**  
**BUREAU OF SHIPS**

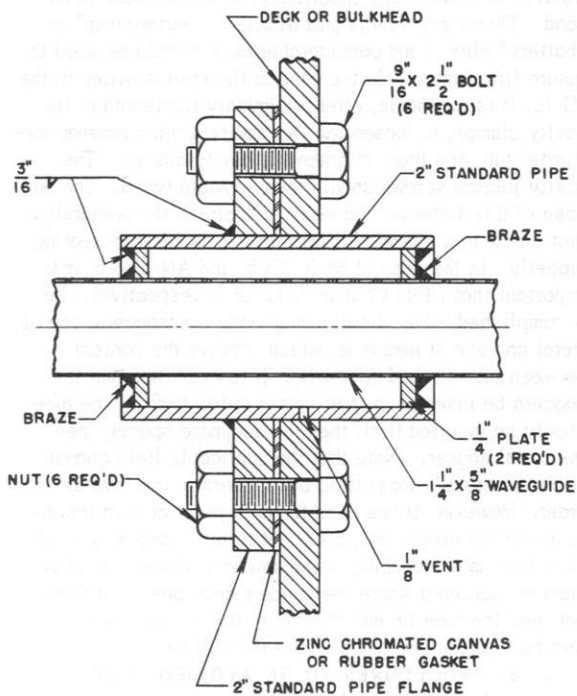
FIGURE 1.—Method of passing waveguide through bulkhead or deck.

A method for passing waveguides through bulkheads and decks has been suggested. This method will facilitate removal and reinstallation of waveguides for inspection and repairs. A frequent source of trouble in waveguide transmission lines is the collection of condensation in the horizontal sections. The adoption of this suggestion will reduce the amount of time necessary to correct this condition. In addition, it will reduce the amount of blistering of the paint inside waveguide walls which occurs during the brazing process.

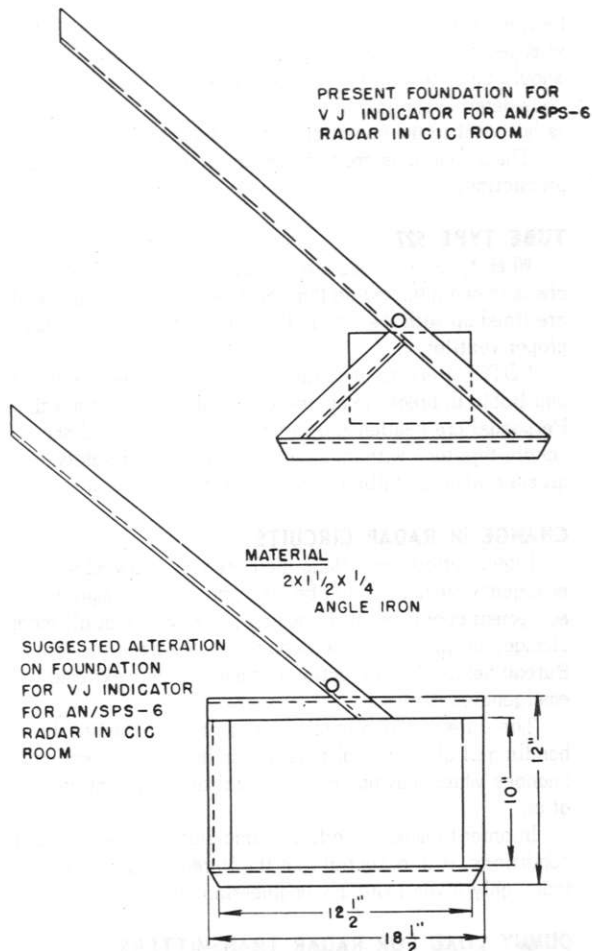
There have been several reports of radar indicators being installed on foundations in a manner that does not permit servicing access plates to be removed unless the indicator is removed from the foundation.

A method for altering the indicator foundation of the VJ equipment to permit removal of the access plates for servicing the unit without removing the complete unit has been suggested. The sketch illustrates the method as applied to a specific case.

The suggested foundation alteration, or a similar method, is recommended for activities which encounter this condition. Installation activities are cautioned to adhere closely to current installation practices when initial installations are made since this sort of thing should be avoided rather than cured.

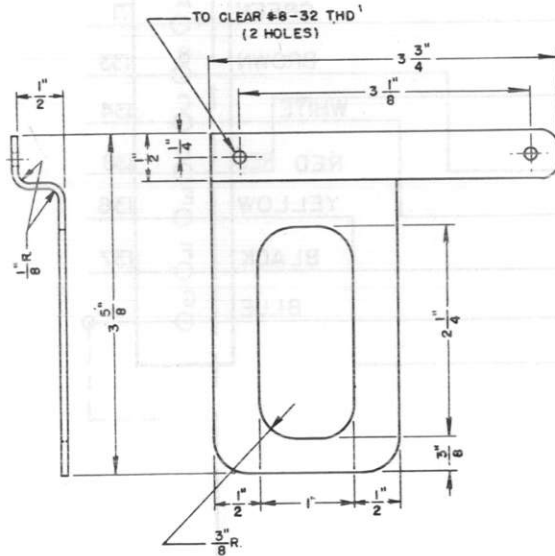
It is possible to brush against the power switch on the AN/SPA-4A (Radar repeater), throwing power off unintentionally. This suggested that guards be fabricated, in accordance with figure 1, and installed to protect the exposed switches.

Figure 1 - SWITCH GUARD: Make from stock aluminum 4 1/8 in x 3 3/4 in x 1/16 in. Remove 2 Allen screws on left side of repeater switch panel and secure guard with 2 longer screws.

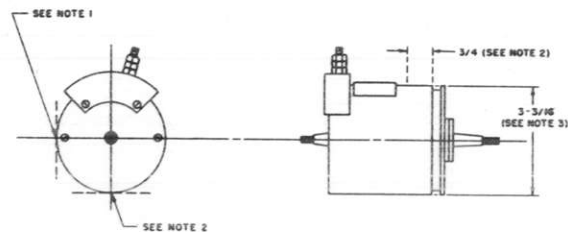
Scan motors for Radar Set AN/SPN-8 should be examined for conformance to figure 1 when withdrawn from stock. Milling may be performed by installing activity if necessary for proper fit.

1. PRODUCTION RUN TYPE D-15-12 IS OVERSIZE, BEING 3.250 INCH DIAMETER OVERALL. A FLAT OF 0.050 INCH SHOULD BE MILLED LENGTH OF BODY AT THIS POINT.
2. MILL FLAT OF 0.050 INCH FOR A LENGTH OF 3/4 INCH AT THIS POINT.
3. IF TOLERANCE HAS BEEN MAINTAINED DISREGARD NOTES 1 AND 2.
4. ROTATION - COUNTER CLOCKWISE WHEN VIEWED FROM TERMINAL BOARD END.

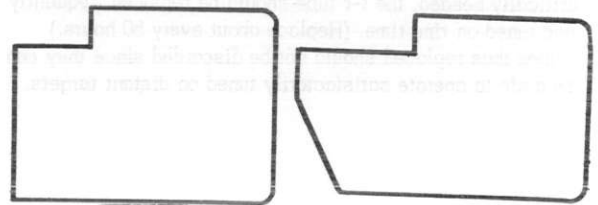
AN/SPS-6B  
WIND VANEAN/SPS-6C  
WIND VANE

Repair Facilities are cautioned NOT to interchange antenna assemblies of the AN/SPS-6B with those of the AN/SPS-6C. A number of AN/SPS-6C antennas have arrived at repair facilities, and such interchange of units might very well happen due to their similarity in appearance. However, an AN/SPS-6B antenna, even with Field Change 21-AN/SPS-6B installed, will not rotate on an AN/SPS-6C. Modifications provided by Field Change 21-AN/SPS-6B have been taken into consideration in the design of the AN/SPS-6C antenna assembly. To distinguish between units, observe the difference in the wind vane structure shown in

The AN/SPS-6C antenna assembly will work on the AN/SPS-6B pedestal. It should be noted that AN/SPS-6B-type antennas are also used with the SR-3 and SR-6 equipments.

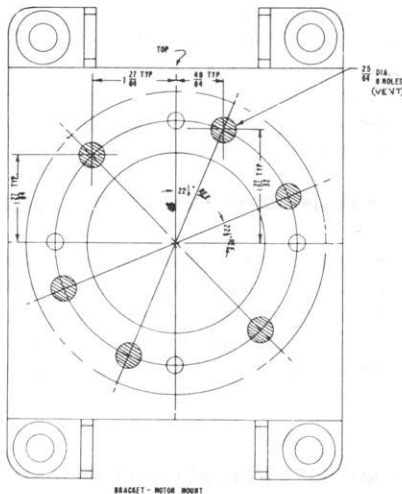
Figure 1

Modification procedures for AN/SPS-10, B801 motor mounting vent holes: (Refer to Technical Manual for Radar Set AN/SPS-10-NAVSHIPS 91921A), figure 7-1111, pages 7-87 and 7-88; Figure 7-130, pages 7-155 and 7-156, and in B801 removal and replacement instructions of paragraph 5(a), page 7-86.

In accordance with the plan layout shown in figure 1 correct the end bell and motor mounting bracket drawing to show the 25/64" diameter ventilation holes. Although the motor holes may be matched to the brackets to ascertain the drilling location, the plan shown in figure 1 may be used.

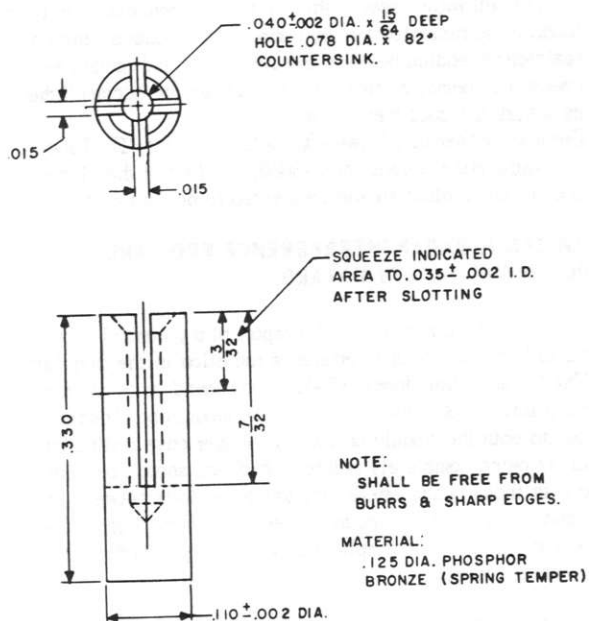
Figure 1

The AN/SPS-10 receiver local oscillator tube, as furnished with original equipment, has a small brass cylindrical extension which slips over the end of the coaxial probe that extends downward from the bottom of the tube base. Since this extension is not furnished with tubes drawn from stock, it is necessary to remove the extension from the original tube and install it on successive tubes used as replacements. Without the extension, the receiver local oscillator will be unstable in operation and difficult to tune.

The accompanying figure 1 is for use in case the extension has been lost or discarded with the old tube.
