ANTENNA DEHYDRATORS FOR SC SERIES

MODEL SC/SK SERIES TROUBLESHOOTING NOTES

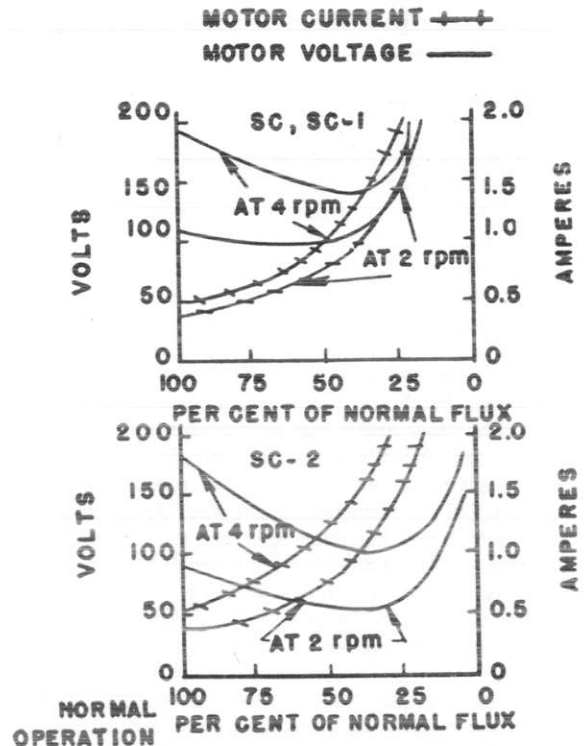
FIGURE 1.—Effect on pedestal drive motors of loss of magnetism.

- a. Remove the brushes.
- b. Remove the commutator end shield, turn it 90° counterclockwise as viewed from the commutator end, and reassemble. If brush leads are short, turn the end shield 90° clockwise and apply opposite polarity in step (d).
- c. Replace the brushes and block the rotor.
- d. Apply between 250 and 300 volts d.c. with positive polarity on the A_1 lead and negative on the A_2 lead. Current required will be about 8 amperes for motor 5BBY-47AB3 and about 20 amperes for 5BBY47AB6, so that a fairly stiff source of power should be used. Leave the S_2 lead disconnected.¹

g. Remove the brushes, change the end shield back to its original position and replace brushes.

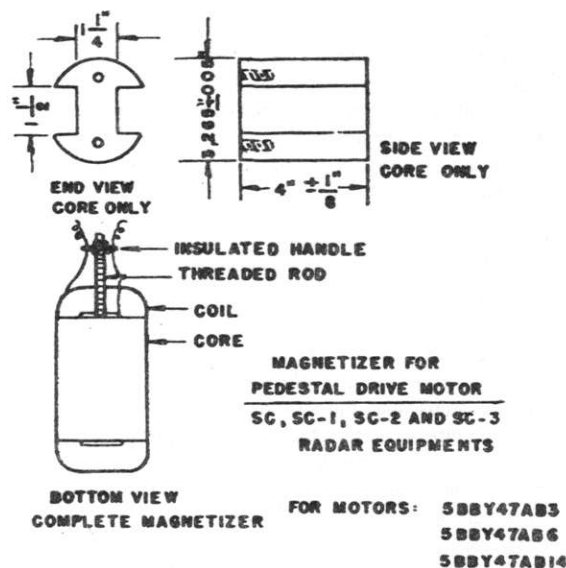
FIGURE 2.—Magnetizer for pedestal drive motor.

For more than two or three cases of damagnetized motors, it is more convenient to have a magnetizer constructed. The core for such a magnetizer can be made of almost any soft iron or steel. Cast iron or stainless steel should not be used since they saturate at low flux densities. Dimensions of the core are shown in figure 2.

should be selected to produce at least 5,000 and preferably 10,000 ampere turns. No. 19 wire should be approximately correct for 110-volt use if the coil is layer wound. No. 10 wire will be correct for approximately 20 volts. A sample magnetizer random wound with No. 18 double cotton wire worked very well on 40 volts.

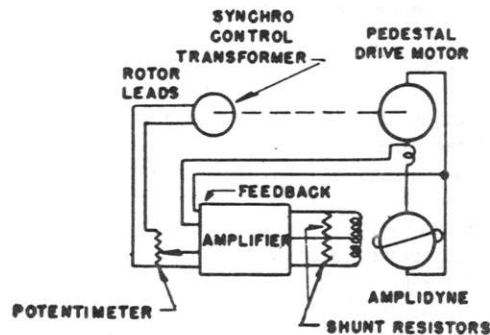
FIGURE 3.—Reducing sensitivity of amplidyne position control.

Sensitivity can be decreased by shifting the amplidyne brushes in the direction of rotation. An angular shift of 5° may cause as much as a 2-to-1 change in amplification. **In an Emergency:** The SC-2 amplidyne will perform properly in an SC or SC-1 system if the control amplifier is modified to correspond to the SC-2 amplifier, Navy Type CG-50ABN. This change entails adding a 270-ohm 2-watt resistor in the cathode circuit of each 6L6 vacuum tube, and replacing the 51,000 ohm 1-watt resistor in the feedback circuit with a 1,000 ohm 1 watt resistor.

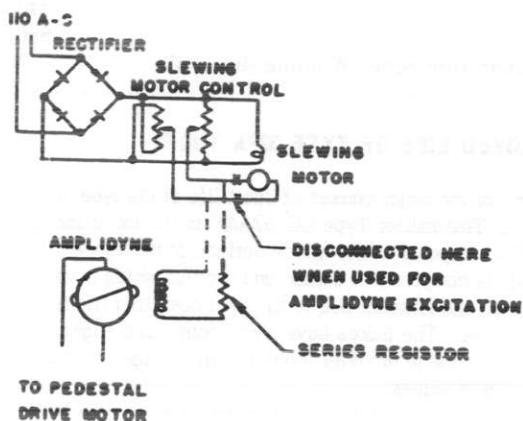
FIGURE 4.—Temporary speed control.

If the indication of the antenna's position is independent of the control system, as it is on the SC series of equipments, accuracy of bearing indication will not be impaired by use of a speed control. Disconnect the amplifier completely and connect a source of d-c to the amplidyne fields by means of a potentiometer. Six-to-fifteen volts from a few dry cells should be sufficient. A d-c slewing motor armature is supplied with voltage by exactly the type of control desired for exciting the amplidyne fields. (See fig. 4). A wire wound resistor in region of 2,000 ohms placed in series with the amplidyne field will help to

spread out the potentiometer control. With this type of control, it may be difficult to keep the antenna from creeping.

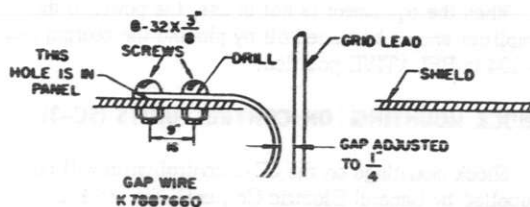
FIGURE 1.

Internal arcing of type 327A tubes causes abnormal voltages to be built up in the pulsing circuit. Sparkovers in switch S-308 discharge the pulsing capacitors C-303 and C-304 through grid ammeter M-303. In order to prevent possible damage to this meter a protective gap has been installed for the grid feed lead where it passes through the horizontal shield into the oscillator compartment. This change was made in production at the same point as given above for filament socket protective gaps.

Installation of the gap is shown in the sketch of figure 1.

A quantity of these gap wires K-7887660 and mounting screws will be supplied to the installation men. One hole for the mounting screw is already in the shield. The second hole should be drilled in a line between this hole and the grid lead wire and nine-sixteenths inch from it. The gap should be adjusted to one-fourth inch.

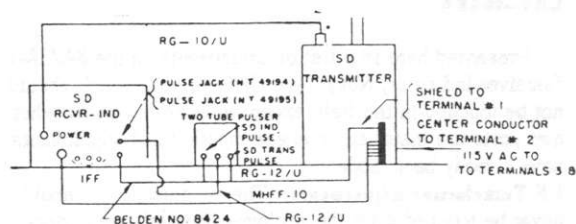
The power-pulse cable (RCA drawing No. M-422723) between the SD transmitter and receiver-indicator is no longer available. In the event that this power supply cable assembly fails, the following method of repair can be used.

FIGURE 1.—Connections when 2-tube pulser is used with SD.

Two cables are used instead of one. Coaxial cable RG-12/U and power cable MCO5-10 are connected as shown in figures 1 and 2. A pulse jack (Navy type 49194) is added to the receiver and a pulse plug (Navy type 49195) is used on the coax. The present power plug and jack can be reused.

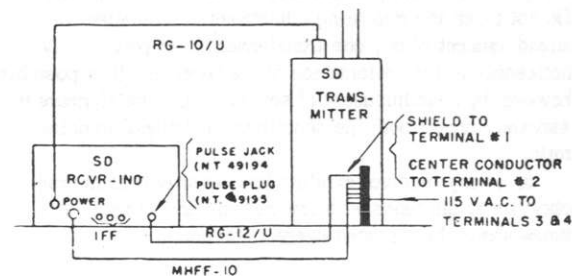
FIGURE 2.—Connections when SD is used without pulser.

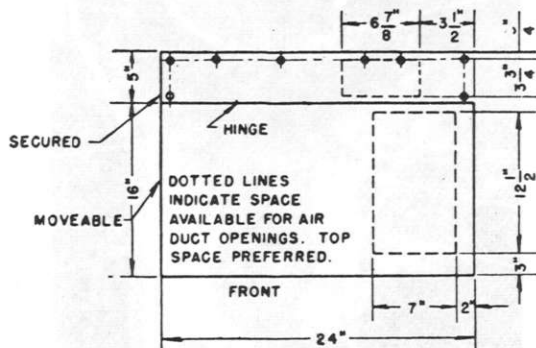
FIGURE 1.—Top view of SF/SF-1 indicator cover.

Shelf Obstruction: The shelf that supports the unit should be of the frame type. However, a few equipments were installed on a solid plate shelf. Holes should be drilled through the solid shelf to allow the air to rise rapidly through the unit. Holes also should be drilled through shelves mounted immediately above the equipment installation.

If the ambient temperature still remains above 50° C. after making the above improvements, a Navy Standard exhaust duct should be added to the top cover of the unit. The top cover view below shows the space available where a drip-proof hole or an air duct can be run to the ship's exhaust system.
