INCORRECT METHOD OF RANGING

METHOD TO REDUCE FAILURES OF THE RF SIGNAL MONITOR FOR SG-1 SERIES

LOSS OF ECHOES IN SG-6 RADAR ANTENNA GEARS

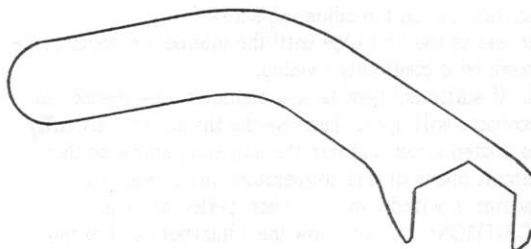
FIGURE 1.—Special wrench for TR box.

Because a standard wrench or pliers will not fit locking nuts on SG-1 TR boxes a special wrench (fig. 1) is being provided, and quantities are being shipped to all yards. One of these wrenches should be furnished each SGA or SG-1 up to equipment 717 which was the first to include it in equipment spares.

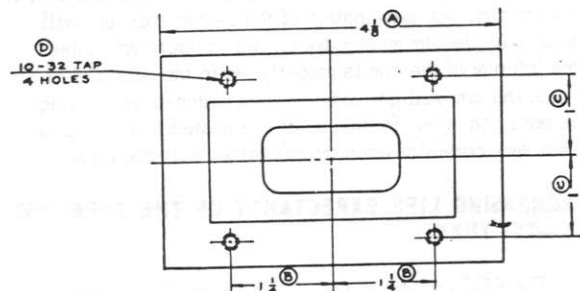
FIGURE 1.—Proper mounting holes.

It has been found that two types of construction have been used in the manufacture of 1B54 tubes supplied to the fleet in SG-3 and SX radar equipments. The original 1B54 had a shell made of brass; however, this was later changed to steel when it was found that the brass shell tubes failed due to temperature cycling. The two types may be identified by using a magnet since only the later steel shells will be attracted by the magnet.

It has also been found that the life of the 1B54's can also be increased by using only 4 of the original 10 mounting holes. The proper holes are shown on the accompanying illustration.

It is recommended that any brass shell 1B54's now on hand be removed from active stock and reserved for emergency use only.

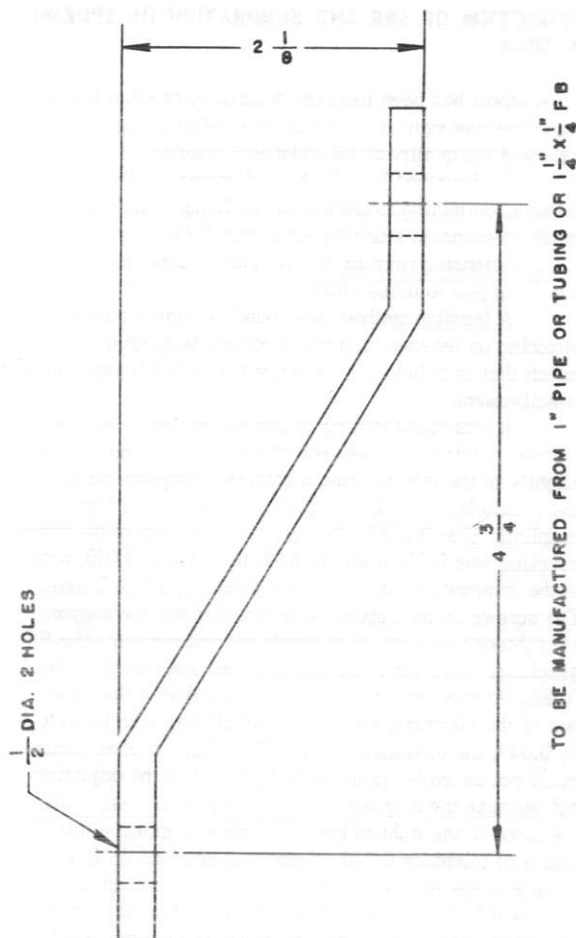
A suggestion proposing a new locking device for securing SG series or SO series radar antenna for repair on active vessels or preservation on reserve fleet vessels has been submitted. Formerly, angle iron with flanges welded on each end was used. This type of bracket was expensive to construct as it required the services of two crafts to manufacture.

The suggested bracket may be manufactured (see sketch) from either 1-inch or 1 1/2-inch pipe or 1 1/4-inch strap iron. Preventing rotation of the reflector while work is in process or the equipment is in "mothballs" the bracket may be unbolted, turned over, and the antenna rotated with the locking device still attached, precluding the possibility of loss of the locking device while checking out the radar. The illustration shows the proposed locking device in place.

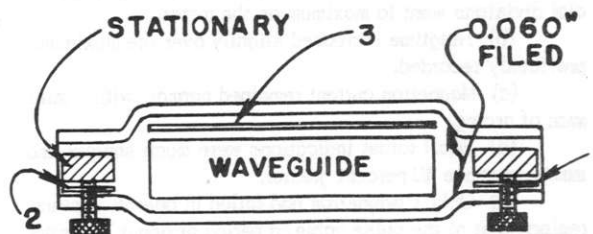
FIGURE 1.

It was found that RF plumbing support D was bent inboard, forcing the lower end of the RF plumbing to move slightly to the left inducing a cantered mismatch along the X axis between the maggie flange and choke flange coupling. (See fig. 2.) The spacing at the top of the flange coupling was 0.070 while at the bottom it was 0.040, within the tolerance of spacing but uneven along this Z axis. The screws on the support were removed and the support straightened as much as possible without removing the RF plumbing. This done, the spacing was now even but about 0.080. At this time it was also noticed that at the other end of the plumbing, the flange was off center to the left by 0.047, the tolerance being 0.020. The receiver chassis could not be moved to the right by means of the adjusting nut because the magnetron and transmitter chassis could not come to the right to keep the choke coupling within limits of tolerance 0.100. Supporting brackets A, B and C were loosened, then support "A" (fig. 1) at positions 1, 2, and 3 shimmed with 0.050 metal stock to bring the waveguide over to the left approximately the error involved,

0.047. This gave a good match along the X and Y axis. Then it was noticed there was still a mismatch along the Z axis at this point. The spacing was 0.090 at the top and 0.030 at the bottom. The only way to correct this without fouling up the RF plumbing was to remove bracket A again and file 0.060 (0.090"-0.030") from the forward corners of the supporting bracket, as shown in the diagram, to bring the wave guide forward 0.060, the error involved. This done, the spacing to 0.030" was evened up by alignment of the lower supporting bracket at C. After tightening down all bolts everything was in alignment within the tolerances. No extra twists or bends were induced in the waveguide run by the corrections. Before alignment the SWR was 1.5:1; it is now 1.2:1. The ring time is over 2,000 yards and significantly the signal to noise ratio has improved.

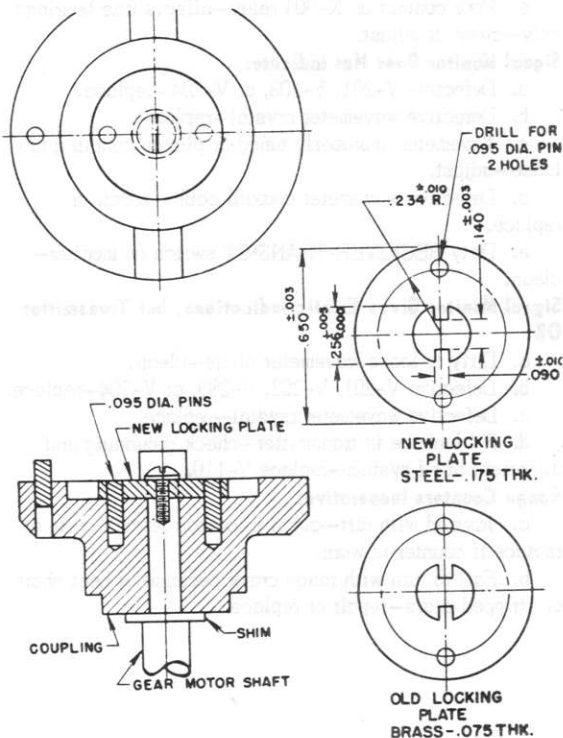
A suggestion has resulted in the approval of an improved coupling (between synchro unit and gear box

in the antenna) for replacing couplings which have failed. The original coupling is taken apart and the locking plate removed and replaced by a new locking plate. (See figure 1). The coupling is reassembled and connected in position between the synchro and the gear box. The antenna is then given a complete lubrication in accordance with the lubrication chart (to prevent excessive torque from shearing the synchro-to-gear-box coupling) and returned to normal operation.

The new locking plate is made of untempered steel instead of brass and is 0.175-inch instead of 0.078-inch in thickness. It is silver soldered to the coupling instead of being attached by a small screw.

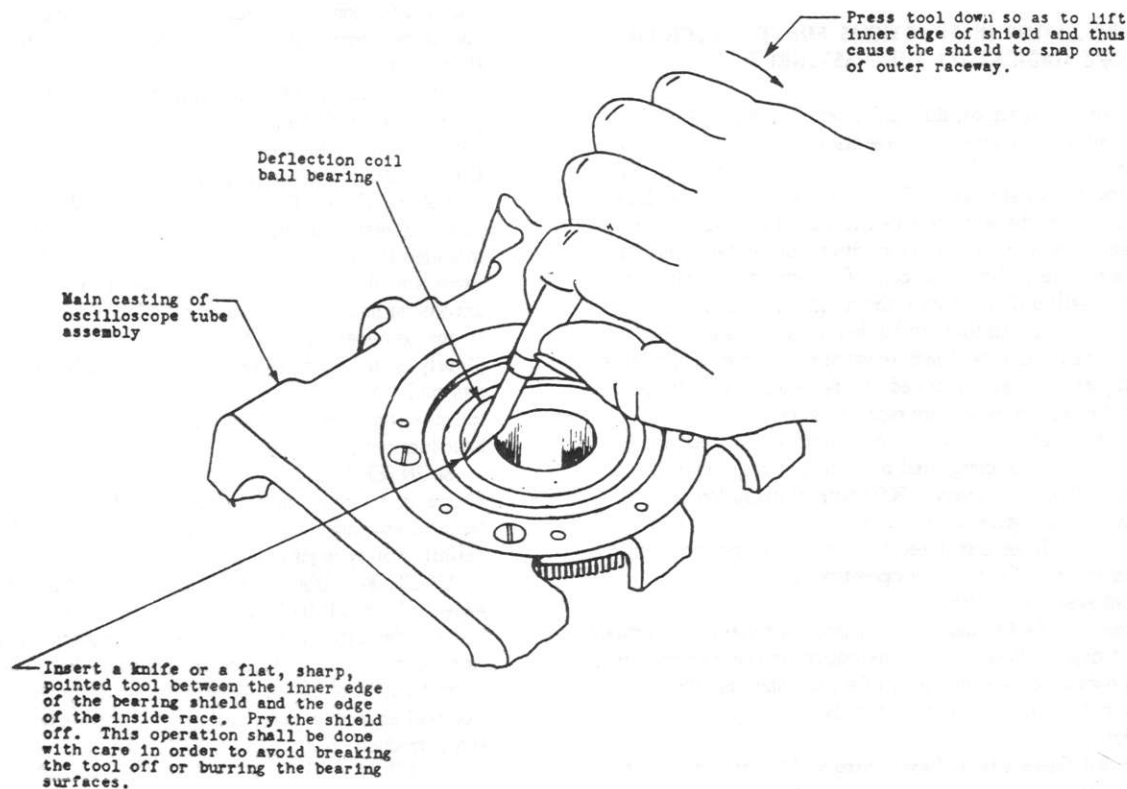
FIGURE 1.—Method of removing shield from deflection coil ball bearing.

c. Examine bearing carefully while rotating it first in one direction and then in the opposite direction. If bearing is free and smooth in operation and there is no evidence of caked grease adhering to the balls and races it may be assumed that the bearing is in good condition. Bearings in good operating condition merely require packing with OS1350 (Beacon M-285) grease. After packing, rotate bearing several times and remove excess grease.
