SYNCHRO ALIGNMENT OF ROTATING WAVEGUIDE SECTION

AZIMUTH GEAR TRAIN FAILURE IN SX ANTENNA ASSEMBLY

LOCAL OSCILLATOR TUNING RODS

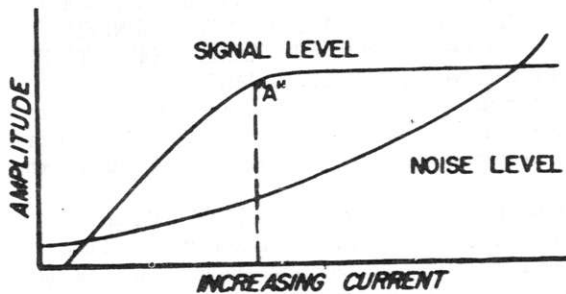
FIGURE 2.

From figure 2 it is obvious that maximum signal-to-noise ratio will occur at point A. The crystal current corresponding to this point depends upon the individual crystal. For Sylvania JAN 1N21B's, it is usually in the vicinity of 0.2 ma. One way of finding this point, if signals are available, is as follows:

- a. Increase the local oscillator coupling to the crystal from a minimum, keeping the amount of grass on the synchroscope at constant amplitude with the IF gain control.
- b. The point that gives maximum signal is the correct operating point. If no variation can be found, and signal and noise increase at the same rate, the crystal is not operating correctly and should be changed.

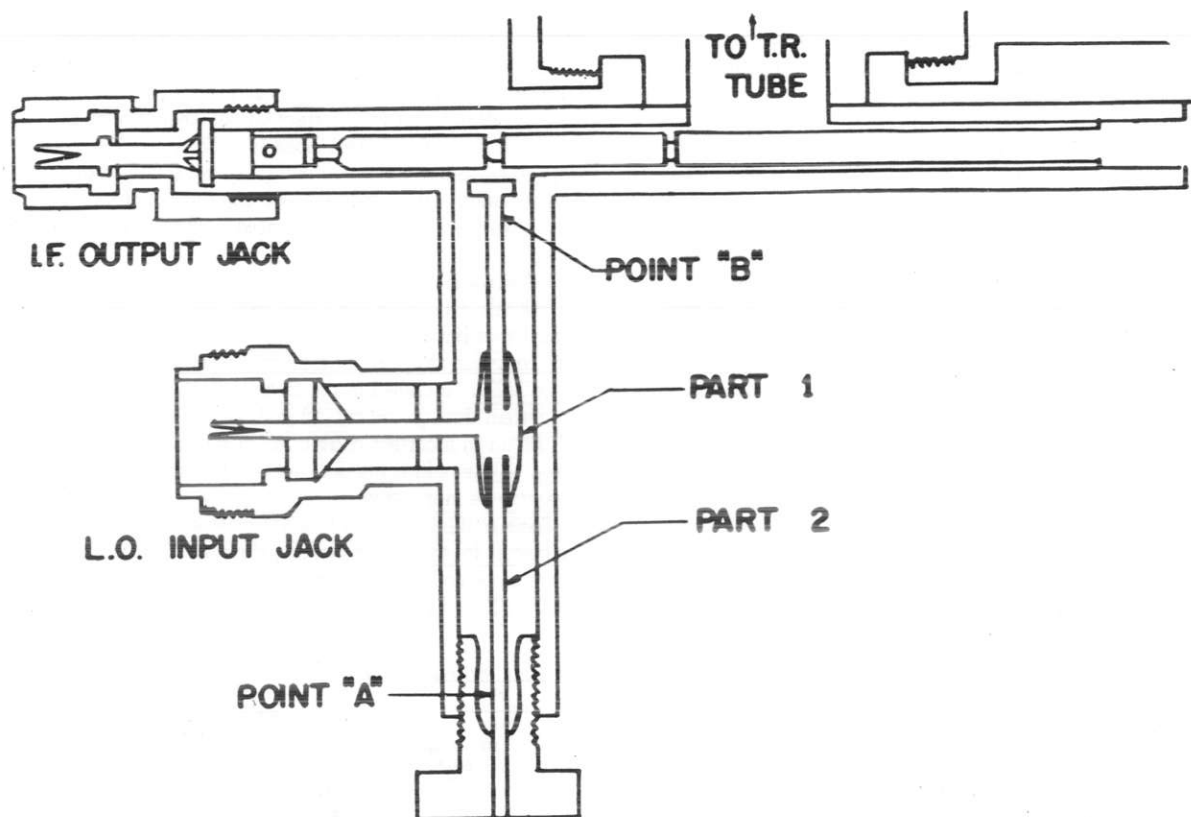
FIGURE 3.—LO coupling adjustment.

reason for this is that the sleeve and rod assembly inside the mixer make poor contact. The sleeve couples the local oscillator signal to the rod, which in turn couples it capacitively to the mixer. A cutaway view of the mixer is shown in figure 3. The sleeve (pt. 1) is cut on each end into four sections which should make good spring contact on the rod. When these contacts become loose it is not possible to adjust them to insure good contact with the insure good contact with the rod without unsoldering the rod. A better way is to file a notch in the rod (pt. 2) at each end (points A and B). Sliding the coupling sleeve up to notch A, each of the four fingers on the end may be squeezed into the notch individually. A similar process carried out at the other end of the rod tightens the sleeve at both ends and the mixer is again in serviceable condition. However, if the LO coupling probe is badly bent due to being jammed against the crystal coupling probe, it is advisable to unsolder the knurled knob from the coupling probe rod and straighten the rod, being careful not to nick or mar the surface of the rod. Then bend the contact fingers in slightly on the sliding tee connector so that it makes firm contact on the rod, reassemble the LO coupling probe, and resolder the knob to the rod. Most of the troubles with the mixer assemblies are caused by jamming the LO coupling probe into the crystal probe in attempting to raise the crystal current. To prevent the LO probe from jamming when screwed in all the way, install a washer between the locknut and outer knurled portion of the knob. This washer should be about one-thirty-second-inch thick in most mixers and have a three-eighths-inch hole with an outer diameter of one-half inch. By removing the crystal you can see whether or not the washer is the correct thickness to prevent the LO coupling probe from jamming when it is screwed in all the way.

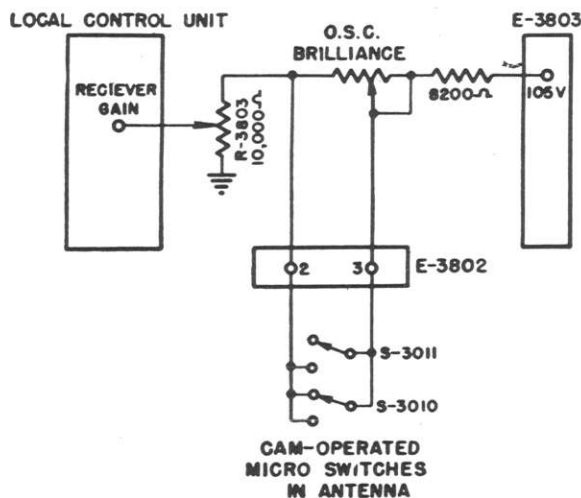
FIGURE 4.

Some confusion seems to exist as to exactly what is the circuit for the ship's heading flasher. This circuit is shown incorrectly in the instruction book and on the cable running diagrams. A corrected diagram is shown in figure 4.

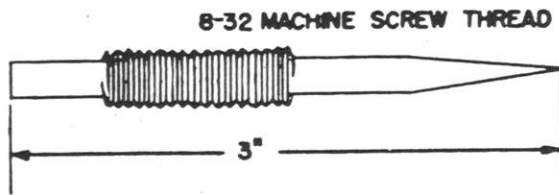
FIGURE 5.

If it does become necessary to disassemble the amplidyne, do not remove the brass disk on the motor end of the unit. This disk is approximately 2 inches in diameter and about 3/8-inch thick. Several holes of varying depth are drilled into the circumference. This is the balance collar. Once removed, it is necessary to ship the amplidyne to a navy yard or other repair facility for rebalancing in a dynamic balancer. The exploded views in Section VII of the instruction book of the various "Motor-Dynamo Amplifiers" are very helpful for reference when disassembling and reassembling the amplidynes. Reassembling the amplidyne can be made much simpler if a tool such as the one shown in figure 5 is constructed.

This tool will aid in holding the grease retainer ring in place during assembly until one or two of the bolts in the end bell holding this ring are started from outside the end bell. The tool may then be removed and replaced with a bolt.

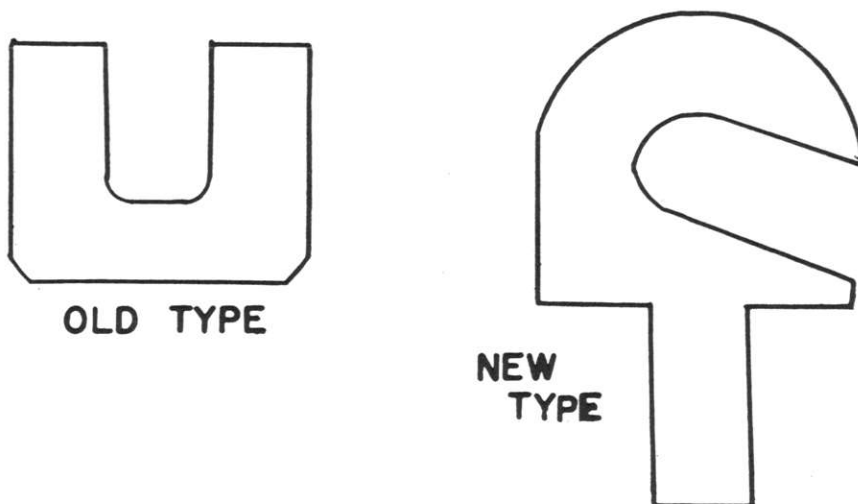
FIGURE 9.

On at least two occasions considerable trouble has been experienced with the azimuth gear train. The lower section of the gear train includes a casting that must be positioned accurately. The space between the bottom plate and the side casting is adjusted with shims. These shims are shaped as shown below.

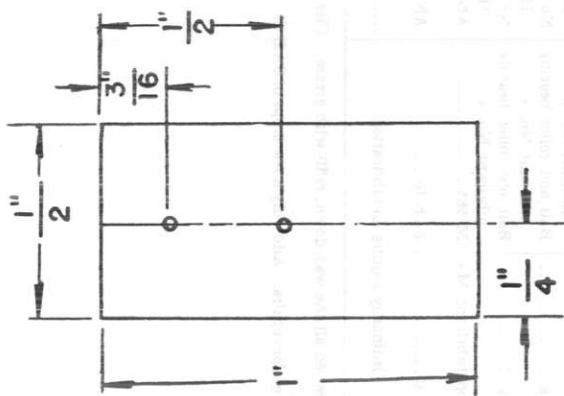
Many condenser lenses (1) 101 of the VG Series of equipments have cracked because of excessive heat. This is not a fault of the lens but is caused by the mounting of lens.

The lens is held in place by metal clamps which project slightly over the edge of the lens. Since metal is a better conductor of heat than glass, the clamps conduct the heat to the portions of the lens they touch. This causes an uneven distribution of heat about the surface of the lens and internal stresses are set up which will eventually cause the lens to crack. Also, as the lens heat up, it expands. It bears against these metal clamps, which tend to keep the lens from expanding in the places held by these clamps; again, stresses are set up tending to crack the lens.

FIGURE 1.—Dimensions of pad. Made of $\frac{1}{32}$ -inch asbestos stock. Holes are $\frac{5}{32}$ -inch in diameter.

A proposed cure is to place asbestos pads between the clamps and the lens. These pads will compress a slight amount as the lens expands and will also serve to insulate the lens from the clamps giving a more even heat distribution about the surface of the lens.
