TK-188/UG Teletypewriter Tool Kit

LINE CURRENT REQUIREMENTS

TELETYPEWRITER MAINTENANCE

CAREFUL MAINTENANCE REQUIRED FOR HIGHER SPEEDS IN TELETYPEWRITERS

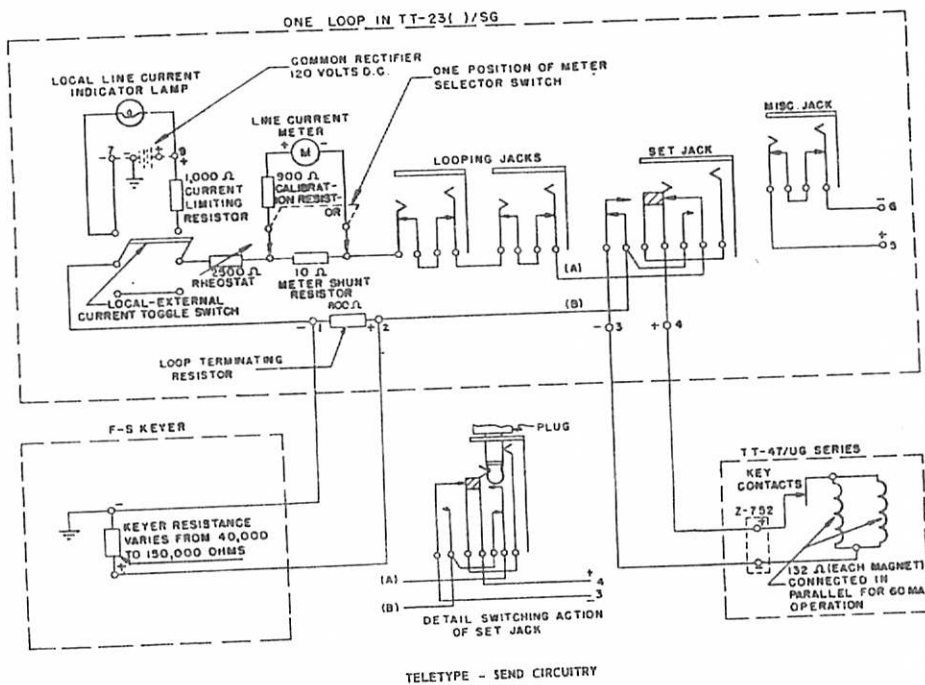
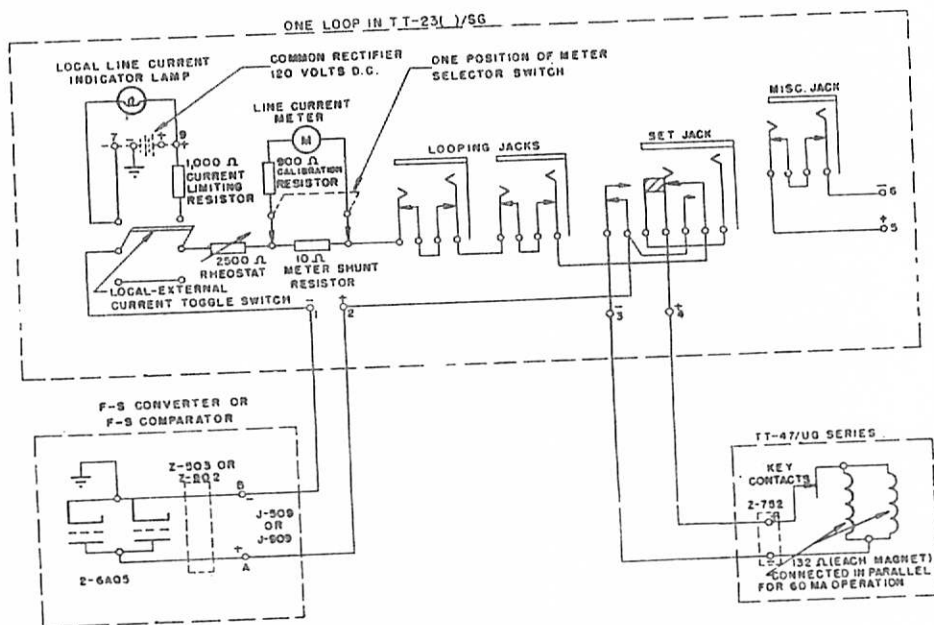
Figure 1. Teletype - Receive Circuitry

Typical circuitry of a send loop in TT-23()/SG, terminated by a teletypewriter across terminals 3 and 4, and a f-s keyer and terminating resistor across terminals 1 and 2, is shown in send circuitry portion of accompanying illustration. The 1000 ohm limiting resistor in the positive leg of each loop should never be strapped out of the circuit because it serves to protect the panel meter and teletypewriter selector magnets in the event of a cable or equipment ground.

The polarity of the voltage applied to the teletypewriter input terminals at the filter (Z-752) should be in accordance with that shown so that effective use is always made of the filter across key contacts in the teletypewriter. Contrary to other published information, the polarity shown on the miscellaneous jacks in the accompanying illustration is correct, and should be observed.

The internal loop circuitry in certain TT-23/SG, TT-23A/SG, TT-23B/SG, TT-23C/SG, TT-23D/SG, and TT-23E/SG panels has been found to be contrary to that shown in the illustration. Exceptions to the illustrated circuitry will not only restrict use of the panel but could introduce sufficient difficulties to cause unsatisfactory performance.

Typical loop circuitry terminated in a teletypewriter and f-s converter is shown in receive circuitry portion of illustration, figure 1.

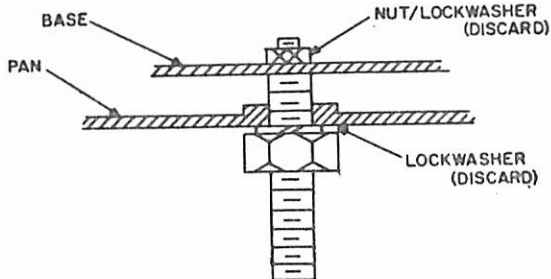
Figure 1. 305051 Shipping Stud

Several reports have been received of activities improperly installing the AN/UGC-20, AN/UGC-25 series teletypewriters. NAVSHIPS 0967-059-9010, Section 573-100-202, provides installation information. The 305051 shipping stud, which secures the equipment to the plywood pallet for shipping, disables the internal shock mounts of the equipment, figure 1.
