SEPTEMBER 1946

BUSHIPS

Electron

NavShips 900,100

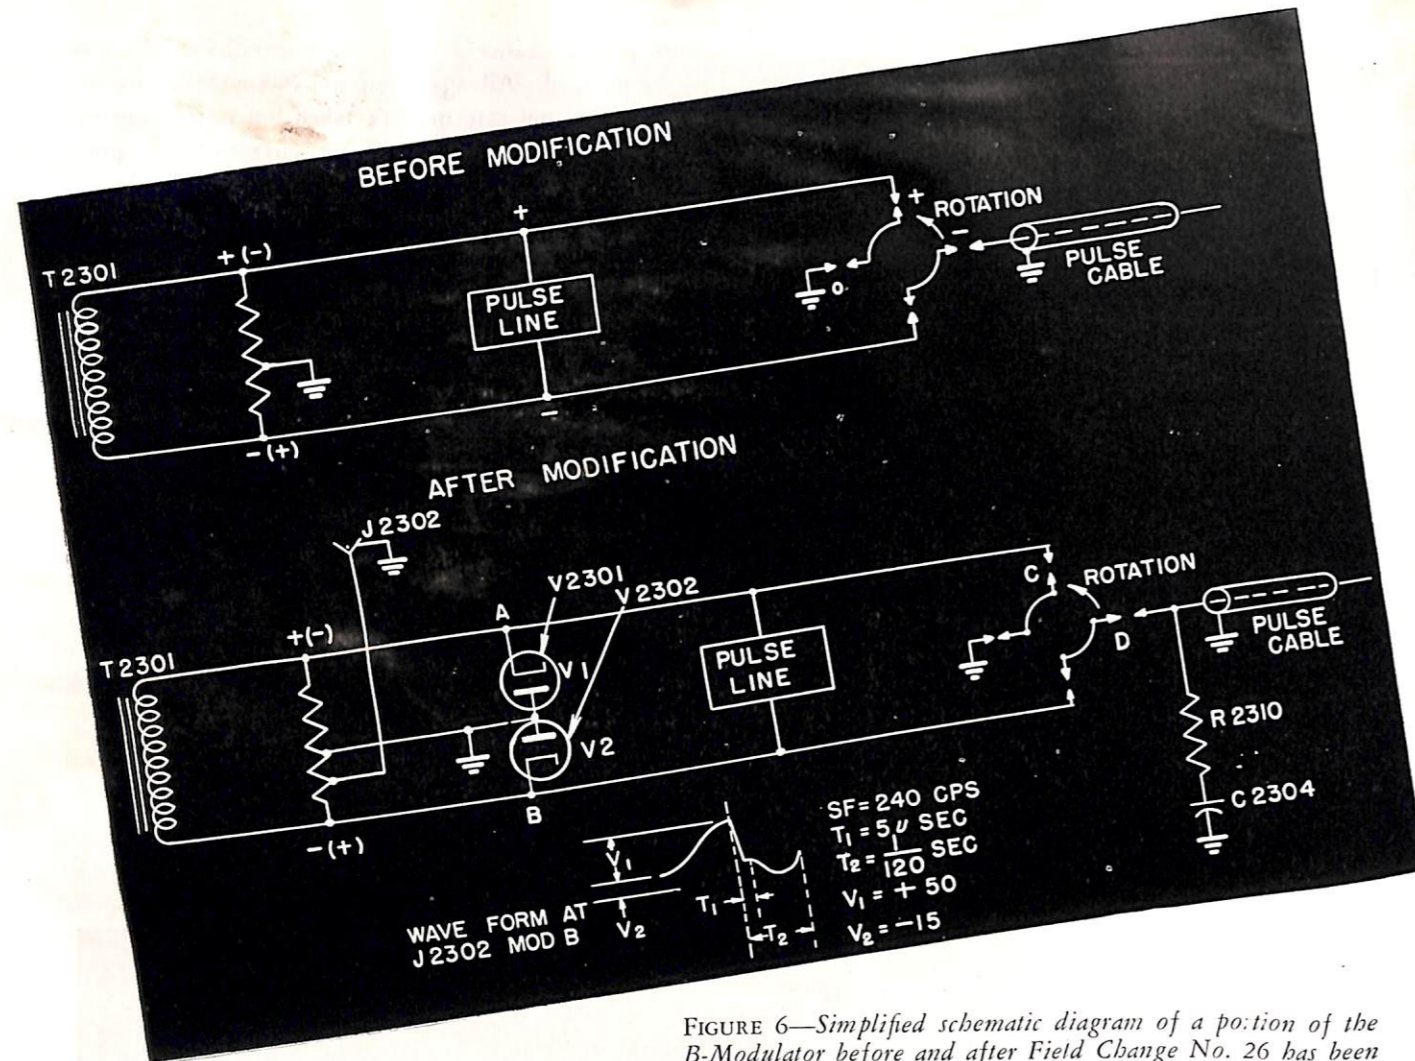
FIGURE 6—Simplified schematic diagram of a portion of the B-Modulator before and after Field Change No. 26 has been installed.

Most of the modulator trouble is caused by failure of the rotary gap to fire. The gap is actually a rectifying device with 4 gaps in series, and is, in effect, a synchronous rectifier. The voltages across all gaps are about the same, and are equal to approximately $1/4$ of the charging voltage. When misfiring occurs, the resonant charging line goes to double voltage which, when shorted by the gap, applies a pulse of twice the normal voltage. This erratic operation is very objectionable and eventually ruins the magnetron.

The despiker consists of R-2310 and C-2304 in series, as shown in figure 6. This is placed so as to take

energy out of the front of the pulse, thereby reducing its rate of rise. This is necessary since the magnetron is not a constant-impedance device but presents practically an open circuit to the front of the wave and, due to the time delay in firing of the magnetron, the voltage may exceed the normal operating voltage before the magnetron fires. This causes a spike on the front of the wave which, if large, will reduce the tube life. Slowing down the rate of rise reduces the height to which this spike can increase before the tube operates. Replacing the 120-mil pins with 80-mil pins increases the voltage gradient in the gap space and improves firing.

Field Change No. 26 adds a double-diode spark-gap stabilizer (V-2301 and V-2302), a despiker network (R-2310 and C-3404), and changes 3 of the 4 stationary pins of 120-mil diameter to new pins of 80-mil diameter. The addition of the double diodes causes the full charging voltage to be placed across 2 gaps in series instead of 4 as shown in figure 6. When point A is positive and point B is negative, diode 2 conducts, effectively grounding point B through a 1-megohm resistor and allowing point A to rise to full charging voltage E_c . This voltage is grounded through 2 rotary pins C, which places a negative pulse of value $E_c/2$ through pins D across the magnetron to ground. On

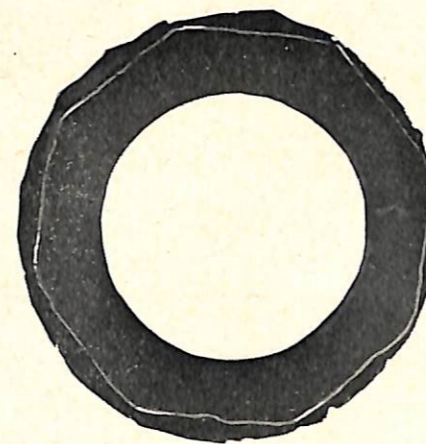
FIGURE 2—Photograph of a packing gland nut that has been removed by means of a cold chisel. Note the damaged edges.
