BUSHIPS

A MONTHLY MAGAZINE FOR
ELECTRONICS TECHNICIANS

NOVEMBER · VOLUME 5 · NUMBER 5

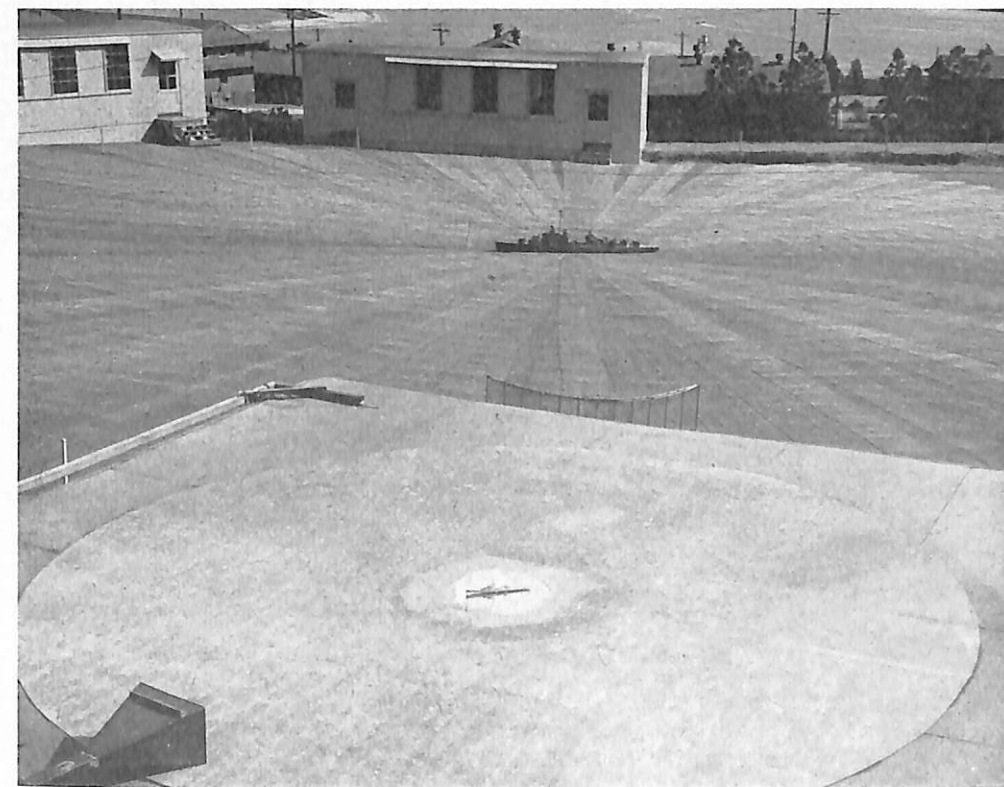
SCALE MODELS on SIMULATED OCEANS are used by the U.S. Navy Electronics Laboratory's model range for research into antenna characteristics. In the background a 1/24-scale brass destroyer stands on metal webbing and in the foreground a 1/480-scale vessel floats in a pool of mercury. Studies of such models have enabled the laboratory's scientists to originate and develop many devices of permanent value to the Navy communications system.

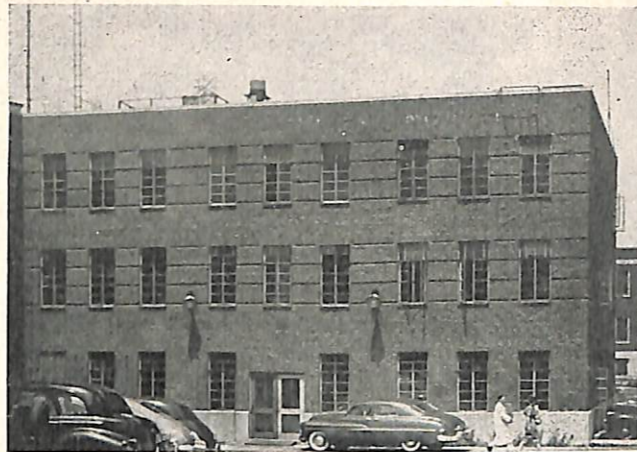
IMPROPER SITE SELECTION. This receiving activity is located on the second floor of this building directly over a commissary containing the usual assortment of radio interference sources including coffee grinders, electric adding machines, etc. A parking area is located around the building directly under the receiving antennas. High levels of ignition interference are radiated to the receiving antennas by the unshielded ignition systems of vehicles using this area. Numerous other activities containing prolific sources of radio interferences such as radar and link trainers are located in proximity to this receiving activity. It is considered impractical, in view of persons in this photo laden with bags of groceries, to exclude vehicles from a 1000-foot radius of this building.

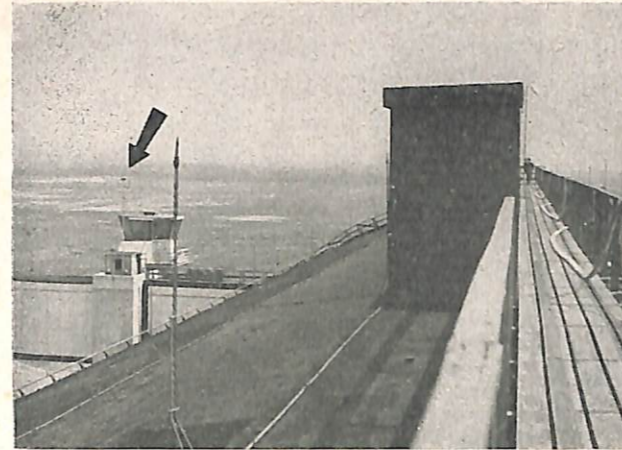
IMPROPER RECEIVER SITE is shown in this photo of a control tower located on one end of an airship hangar. The v-h-f antennas, indicated by an arrow, are located below the roof level of the hangar, with resultant poor communications between the control tower and any airships that may be operating in the areas shadowed by the hangar.

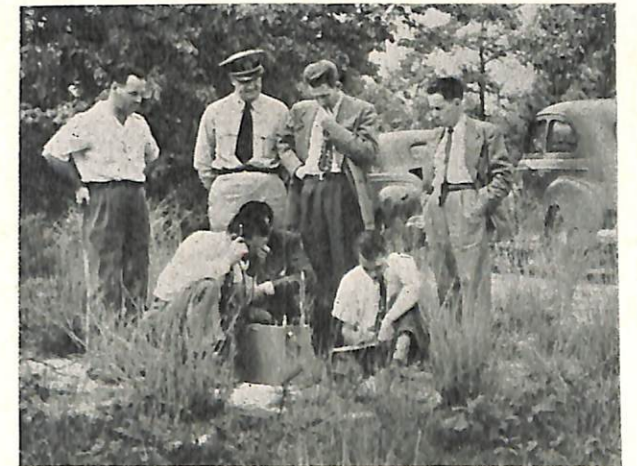
SITE SELECTION SURVEYS are an important phase of the Bureau of Ships comprehensive program for the elimination of radio interference at future Naval receiving activities. This photo shows a Bureau of Ships radio interference field engineering survey party checking the suitability of proposed receiving station sites. These sites are thoroughly analyzed from the standpoint of existing radio interference, signal strengths and the ground conductivity of the area.
