BUSHIPS

AUGUST 1951

# ELECTRON

A  
MONTHLY  
MAGAZINE  
FOR  
ELECTRONICS  
TECHNICIANS

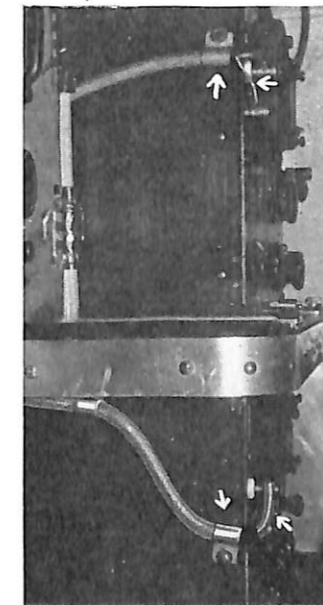
FIGURE 6—Examples of good antenna lead-in cable termination.

such interference is to replace cables of the antenna distribution system, in the radio compartment, with adequately shielded cables, such as type RG-10/U, which are properly terminated. A good example of such cable termination is shown in Figure 6.

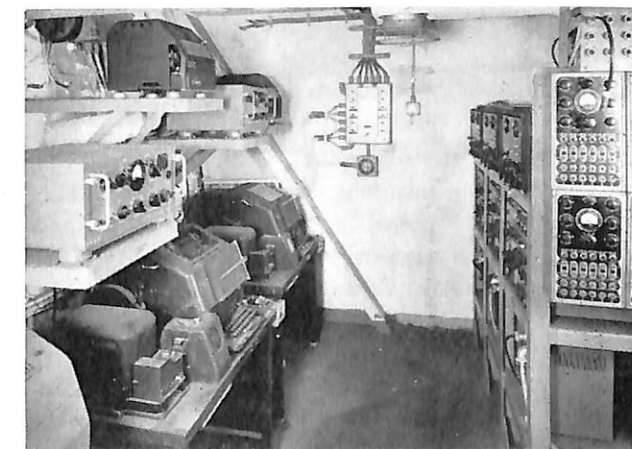
FIGURE 3—Radio Central (Radio 1) on the CV-34.

tions are shown in photographs such as Figures 3 and 4.
