**COMMUNICATION EQUIPMENT MAINTENANCE BULLETIN**

## SECTION II. 'AN' AND ARMY EQUIPMENT

## TYPE AM-215A/U A-F AMPLIFIER

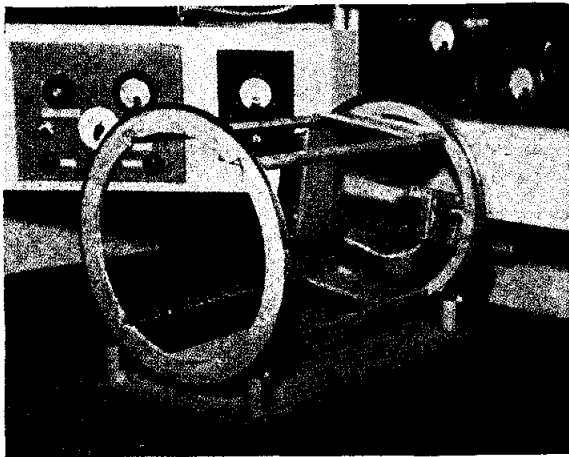
Figure 1.—AN/ARC-1 rotary test rack.

The rotating rack for AN/ARC-1 servicing is shown in the accompanying photographs (Figures 1 and 2). This type of rack has seen wide use and is a great help whenever any sizable number of equipments are being repaired. Many activities have manufactured these units but have varied slightly from the original design. The details shown in Figure 3 are those used by NAS Pearl Harbor except for a few slight changes which reduce the amount of machine work and simplify construction.

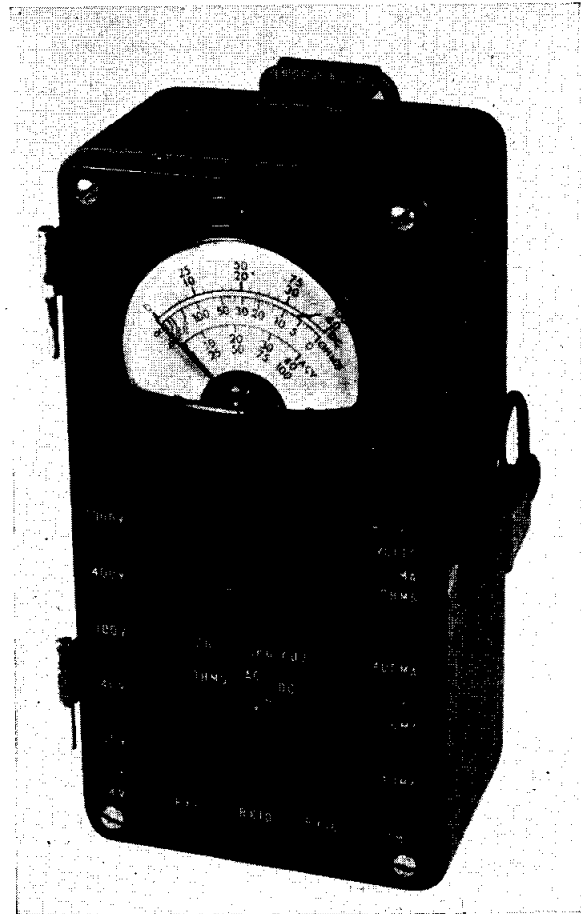
FIGURE 1.—Multimeter TS-297/U.

On the first inspection of the meter, it will be observed that the smallest milliamper scale is from 0 to 4 ma. Since the maximum current to be measured on the AN/ARC-1 performance check is only 1 milliamper, the TS-297/U would appear to be useless. However, by examining the internal circuits of the TS-297/U, some very important facts are brought out.

Figure 1 shows the TS-297/U with the protective cover removed. Directly under the meter is an OHMS-ZERO ADJUST knob, and below this knob is a selector switch for selecting OHMS, AC or DC. The meter does not have a Range Selector Switch so the test leads must be

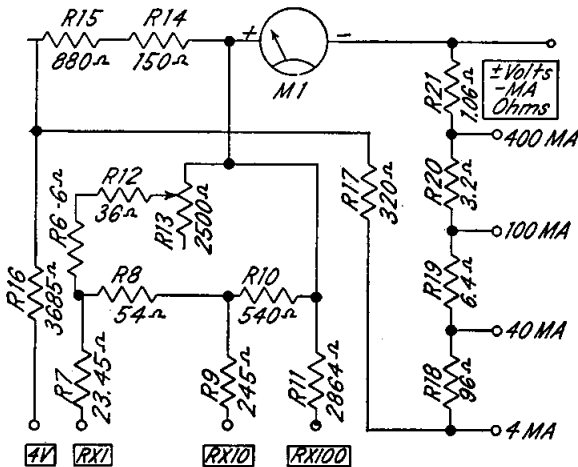
FIGURE 2.—Internal circuitry of Multimeter TS-297/U with selector switch on DC.

A composite circuit diagram, Figure 2, shows all of the circuits when the selector switch is in the DC position. A series of shunt resistors are connected across the meter so that the meter will not exceed the current rating of its movement, 250 microamperes with 62.5 millivolt drop.

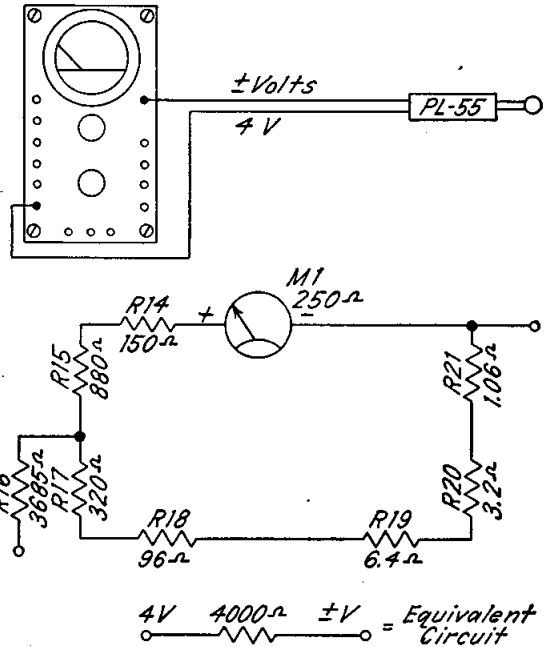
FIGURE 3.—Internal circuitry of Multimeter TS-297/U using 4-volt jack.

With the selector switch in the DC position, the red lead of the test cable inserted into the 4V jack and the black lead inserted into the  $\pm$  VOLTS jack, the meter will have a full scale deflection when 4 volts is impressed across it and the circuit will draw 1 milliampere of current. Figure 3 shows the connections to be made on the front panel of the meter and the internal circuit when the above cable connections have been made. Since the circuit will

draw 1 ma, it alone may be used in place of the TS-80/U. With less than 0.6 ma flowing in the circuit, the sensitivity of the TS-297/U drops so that the readings are below 25 on the 0-100 scale. Therefore the 4V jack connection should be limited to readings above 0.6 ma.
