COMMUNICATION EQUIPMENT MAINTENANCE BULLETIN

SECTION 8. RECEIVING EQUIPMENT

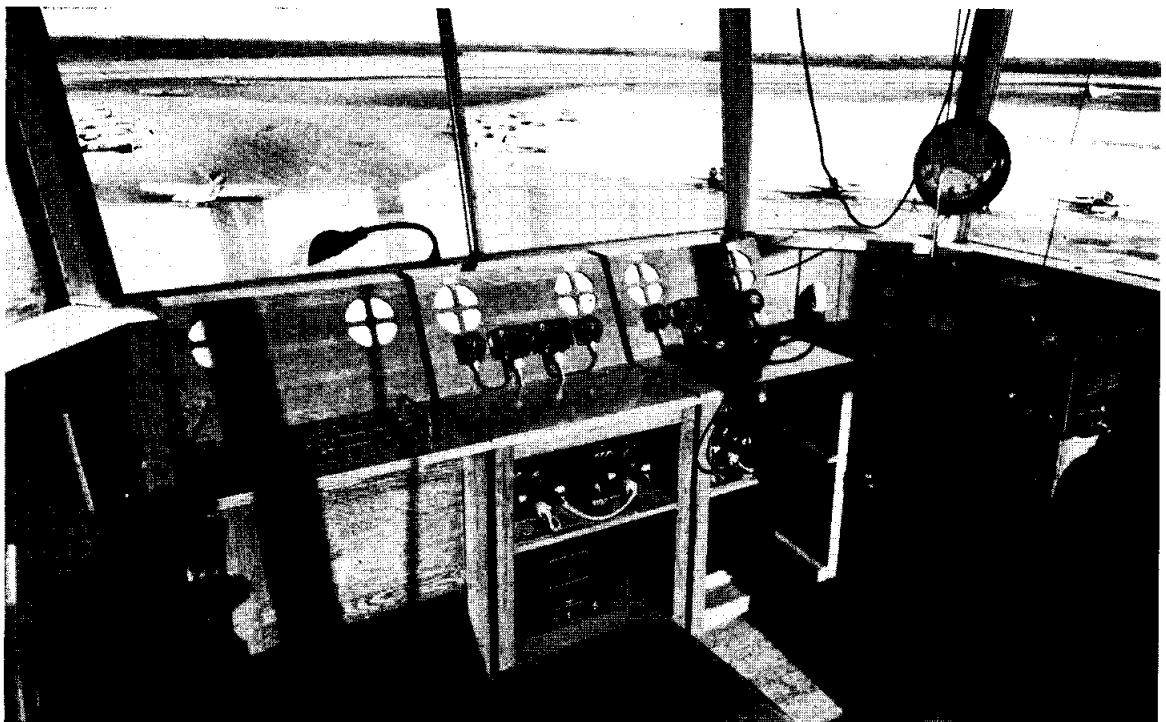
FIGURE 2.—Air control tower containing two movable consoles.

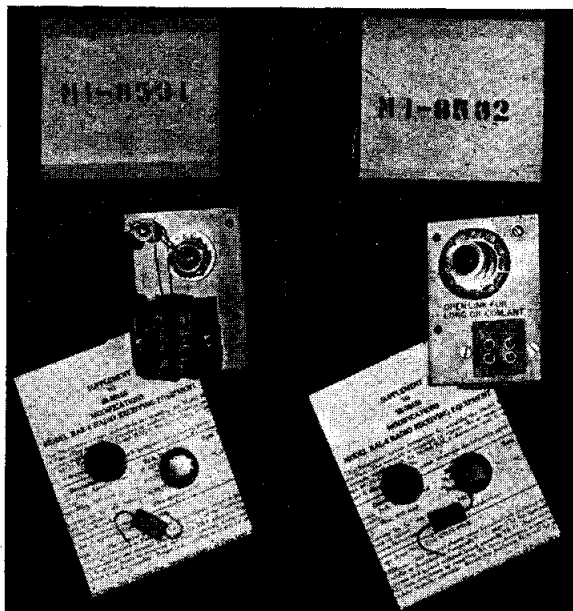
FIGURE 1.—Contents of kit.

The choke and capacitor units should be removed from the replaced binding-post assemblies and stowed in the receiver spare parts boxes. The remainder of the assemblies may be discarded.

Vessels are requested to contact an Electronics Officer at the next opportunity for the installation of this kit.

A record of completion of this installation should be made on the ship's "Radio Equipment Log", NAVSHIPS 900,039. Completion of this installation should be reported on the NBS-383 form. 2/1/46

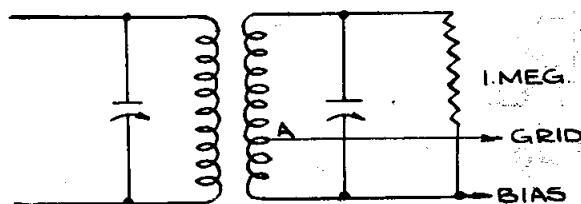
FIGURE 1.—Original connections.

(2) The secondaries of the first and second stage intermediate-frequency transformers have a tap to which the grid was connected in the original installation as shown at "A" in Figure 1. The grid connection was removed from this tap and attached to the extreme end of the coil which

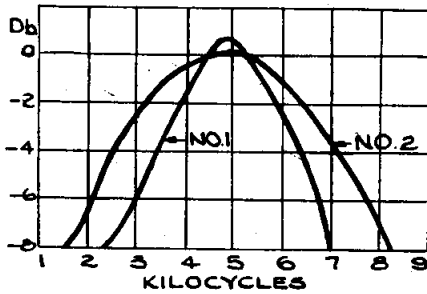
FIGURE 4.—Selectivity before and after the modification.

(4) Selectivity before and after modification is shown in Figure 4.

(3) A 1/2-watt resistor of 60,000 ohms was connected in parallel with the primary circuit of each i-f stage, as shown in Figures 2 and 3.

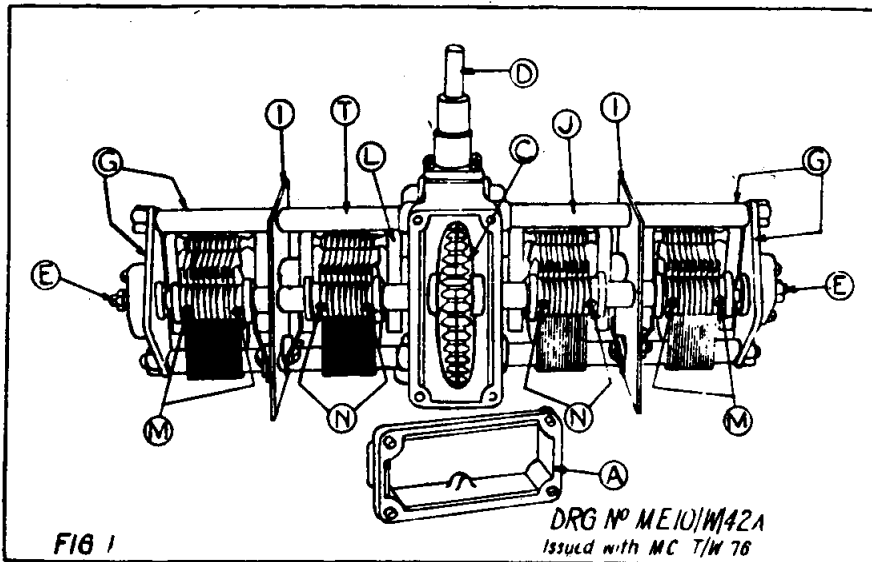
FIGURE 1.—Main tuning condenser assembly.

In certain RAS equipments the drive on the main tuning condenser has seized when working under conditions of high humidity. In order to effect a positive cure for this defect it is necessary to completely strip the assembly, remove a small amount from the bearing surface of the main shaft and finally to impregnate the bakelite covering of the shaft with wax to prevent further ingress of moisture. This modification should be carried out as required, or when an equipment is returned for complete overhaul. The necessary steps are as follows:

(6) Remove four screws retaining gear case top cover Figure 1 (A) and four screws retaining gear case cover Figure 2 (B).

(11) Loosen Allen set screws securing outer rotors Figure 1 (M) to spindle and remove rotors taking care not to distort vanes.

(16) Loosen Allen set screws securing inner rotors Figure 1 (N) to spindle and remove rotors, taking care not to distort vanes.

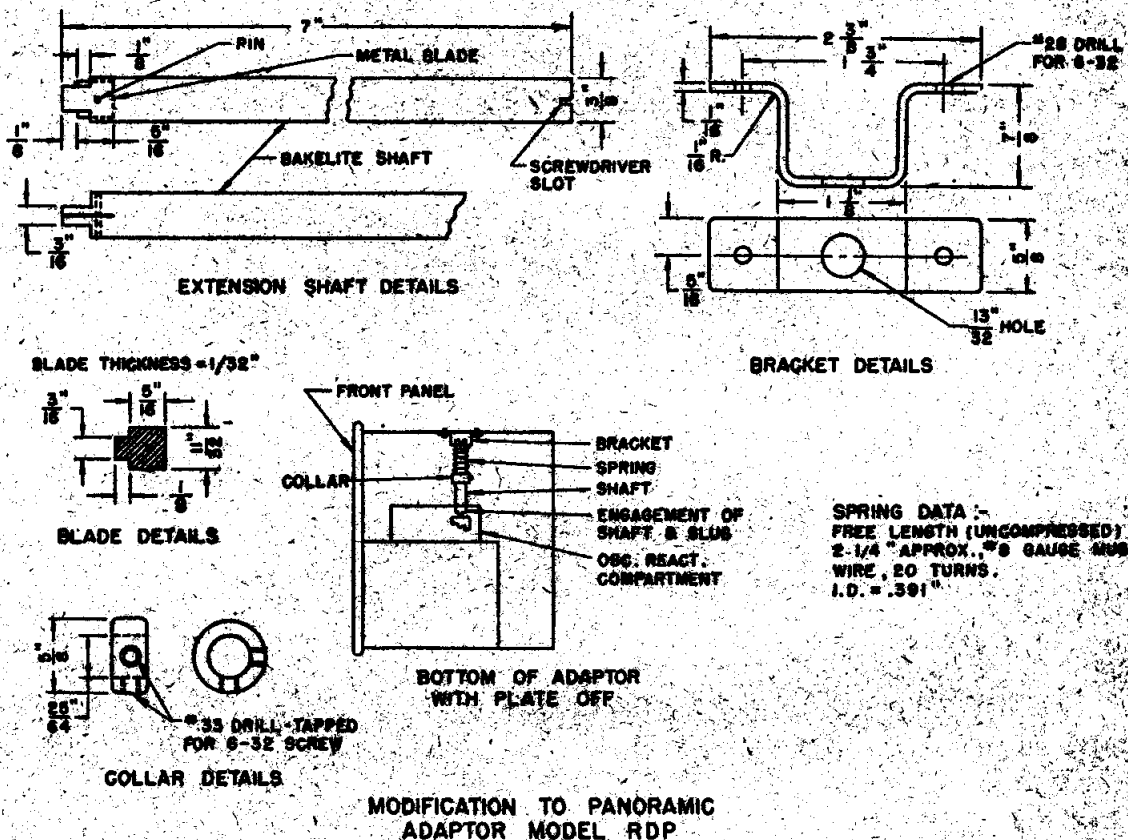
FIGURE 1.—Field change No. 1 to the model RDP panoramic adaptor.

Purpose.—To alleviate alignment difficulties and safeguard personnel.

chassis, and the other end of the shaft is supported by its insertion into the tuning slug assembly. The bracket is mounted by means of 6-32 screws and bolts, for which holes are drilled through the side of the chassis with a #28 drill. A third hole, $1\frac{1}{32}$ -inch in diameter, permits access to the screwdriver slot in the extension shaft. Spring loading is provided

Procedure.—Details of this modification are shown in Figure 1. Minor alterations may be made to meet the particular needs of the activity making the modification.

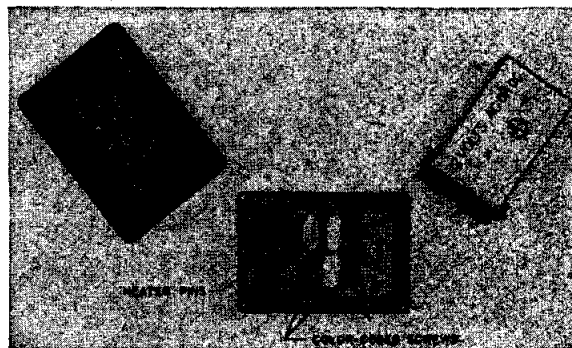
Figure 1.—The Crystal oven and the two identifying screws.

Figure 1 shows the oven and the two identifying screws.

Crystal ovens of the old type should be returned to the Electronics Officer for replacement with the new improved ovens. Electronics Officers should ascertain that new improved ovens are provided for all model RDZ, MAR and TDZ equipments before installation. The spare parts should also be checked for inclusion of the new oven. 6/1/46
