Section 10
AIRCRAFT NAVIGATION EQUIPMENT
Y Series

COMMUNICATION EQUIPMENT MAINTENANCE BULLETIN

SECTION 10. AIRCRAFT NAVIGATION EQUIPMENT

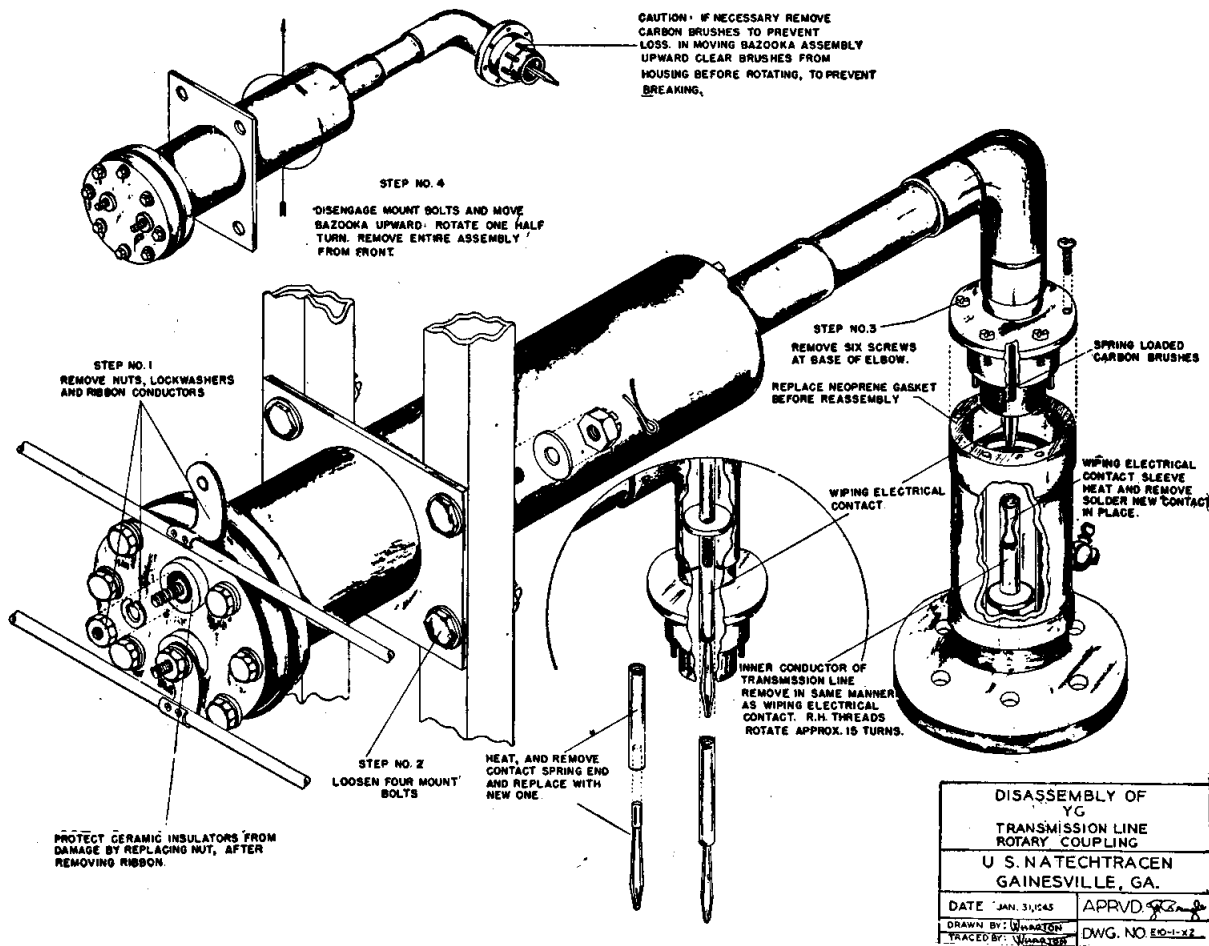
FIGURE 1.—Disassembly of YG transmission line.

A step-by-step method of disassembling the YG transmission line rotary coupling has been well presented by a drawing prepared by the Naval Air Technical Training Center, Gainesville, Georgia, and is reproduced here as Figure 1.
