**AN/FRC-37 Filament Power Supply — Wiring Error
Hint**

AN/FRD-10A(V) Manual DF Position Receivers—Alternate Procedure for Minimum Discernible Input Signal Check

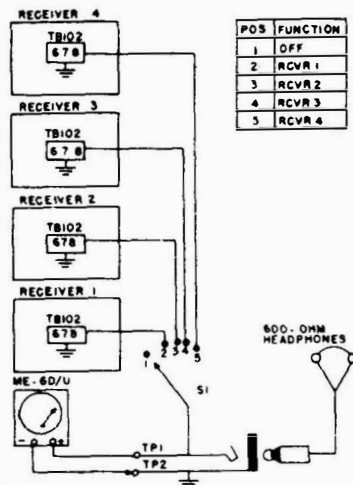
Figure 1. Minimum discernible signal input test panel for the AN/FRD-10A(V) manual DF position receivers.

This alternate test panel, shown here in figure 1, modifies the test configuration by using a pair of 600-ohm headphones instead of the 600-ohm, one watt resistor and by the addition of a five-position switch. The switch allows both the 600-ohm load and the multimeter to be switched to any one of the four receivers, as desired, leaving only the signal generator output (receiver output) to be physically moved from receiver to receiver. The headphones make it possible for the receiver output to be audibly monitored while the check is made. (16S)

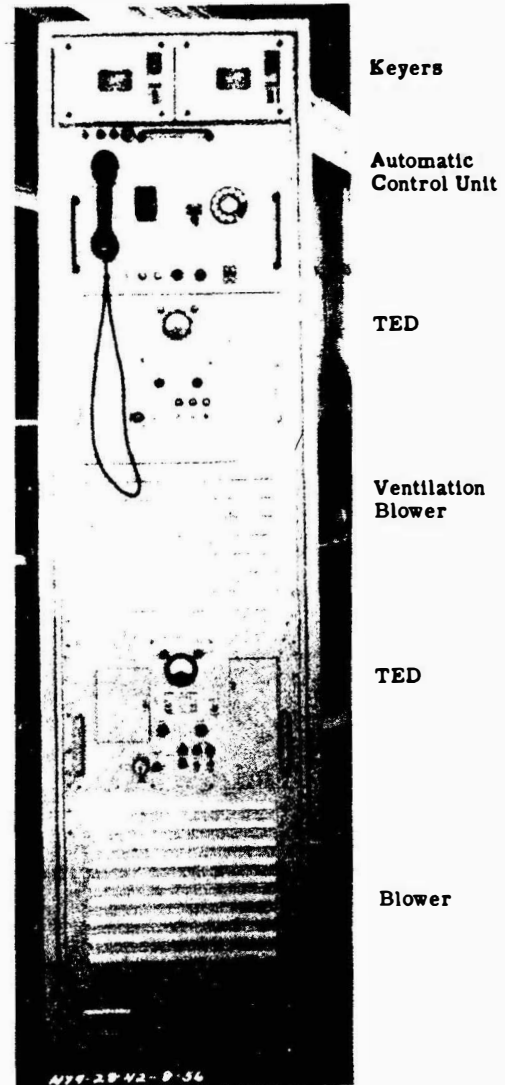
Figure 1

In addition to the two transmitters and two keyers, the automatic--control unit and ventilating equipment are mounted in a CY-597/G cabinet, figure 1. The transmitting-site component is entirely self-contained and needs only to be connected to a suitable source of 115-volt, 60-cycle, single-phase, ac power, a telephone pair to the control-tower unit, the antenna, and ground. The tower remote-control unit contains an AM-413/G amplifier, microphone, dial mechanism, and indicator lights. These units are now being assembled by the Philadelphia Naval Shipyard and availability dates will be published when firm.

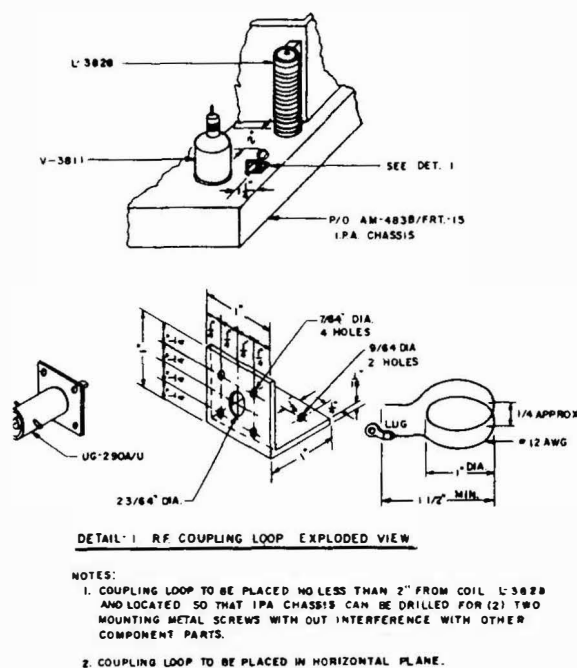
Figure 1

Several naval shore-type transmitters, presently in use with an unbalanced coaxial output, do not incorporate facilities for frequency measurements of the actual output energy. The Naval Ship Repair Facility, Guam, has devised a circuit for the AN/FRT-25 which has the Bureau of Ships approval. A small induction loop, Figure 1, is placed near the IPA-plate tank coil - the first point where the output frequency is assured regardless of multiplication factors employed in the transmitter. RF sampling at any of the previous stages would result in measurement of a subharmonic of the output frequency and lesser frequency spread when the transmitter is operated in F1 or F4 modes of emission. This method of RF Sampling may be applicable to other shore type transmitters, provided consideration is given to the power involved which would necessitate a construction change of the induction loop, such as number of turns and spacing from IPA-plate tank coil.

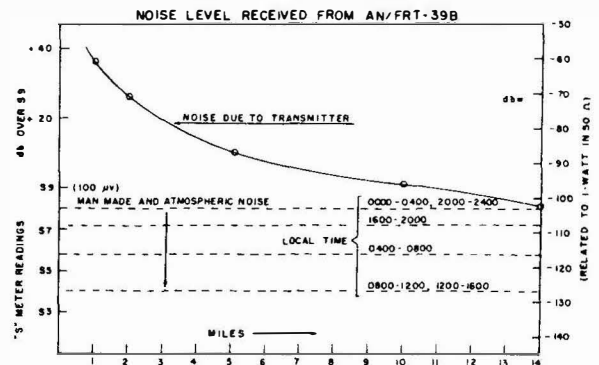
Figure 1. $f = 3$ mc.

Figures 1, 2, 3, and 4 show the received noise versus distance in miles from the transmitting antenna for a typical Naval Air Station located in the Southeastern United States. Typical expected man-made and atmospheric noise curves, corrected to 3 kc bandwidth, are shown for different times of the day. These graphs assume conical monopole antennas for both transmitting and receiving. Only the ground wave case is considered and good earth conductivity is assumed.

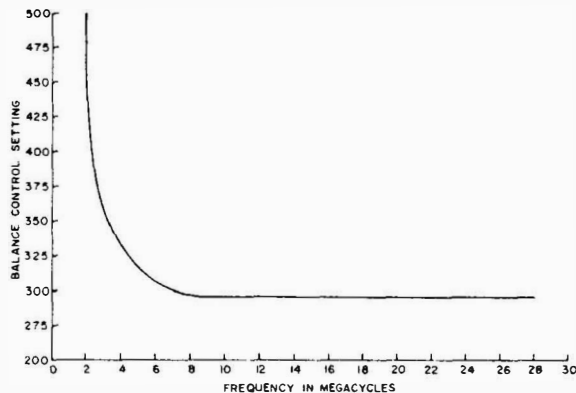
Figure 1. Typical Tuning Curve

In tuning those transmitters that do not contain the VSWR circuitry, it is suggested that the curve illustrated in figure 1 of this article be used to preposition the output balance control. This curve is an idealized curve derived as an average curve taken from readings on several transmitters and will enhance the operation of the transmitter over the total frequency range.

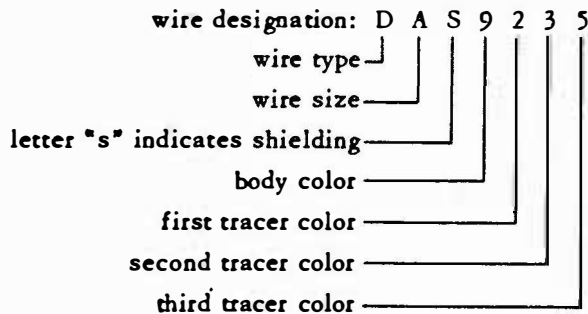
Figure 1. Wire Code Legend

It has been pointed out that there are difficulties in identifying internal leads in the AN/GRC-27A because of omission of a wire code legend in NAVSHIPS 92774. This legend is published herewith (figure 1.) for use by all activities concerned with servicing the AN/GRC-27A:
