**AN/UCC-1(V)-Telegraph Terminal Diversity Pairs**

**AN/UCC-1(V) Series Telegraph Terminal Utilization-Information Concerning**

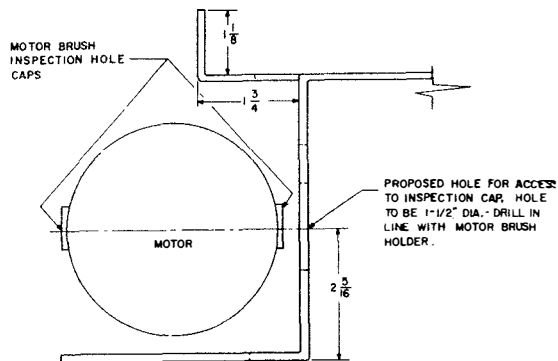
**Figure 1.**

A 1-1/2-inch hole drilled in the base (LRB-32) of the Auxiliary Typing Reperforator unit (TT-316/UG) will expedite the inspection of one of the brushes of the PD-18/U series governed motor by eliminating the need to remove the motor from the base. (See Page 1-11 of NAVSHIPS 93788, Volume 1, and figure 1 of this article, showing location of hole to be drilled.)

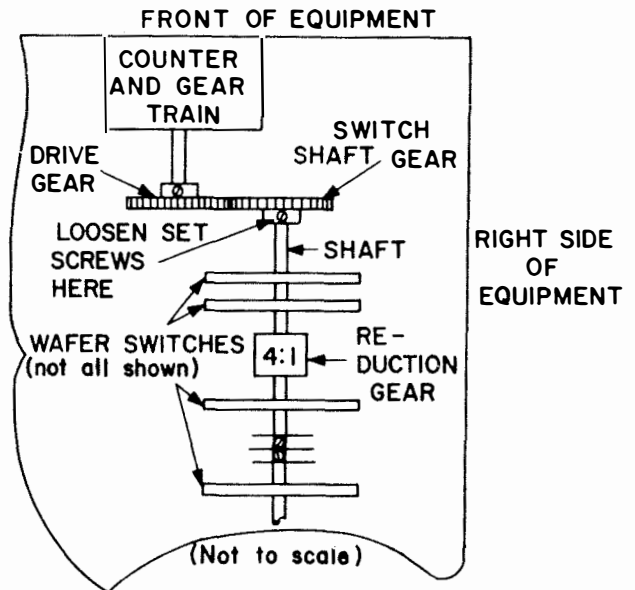
Figure 2. Delay Switch Assembly, S-206

When misalignment of Delay Switch, S-206 is caused by slippage of the gear on the shaft of S-206 and/or slippage of the Switch Drive Gear, MOTU-13 has devised a simple alignment procedure as follows:

2. If the above conditions do not exist, refer to Figure 2 and proceed as follows:

a. Loosen set screws on switch shaft gear.

c. Verify that counter still reads  $98375 \pm 4$  and tighten set screw on switch shaft gear.

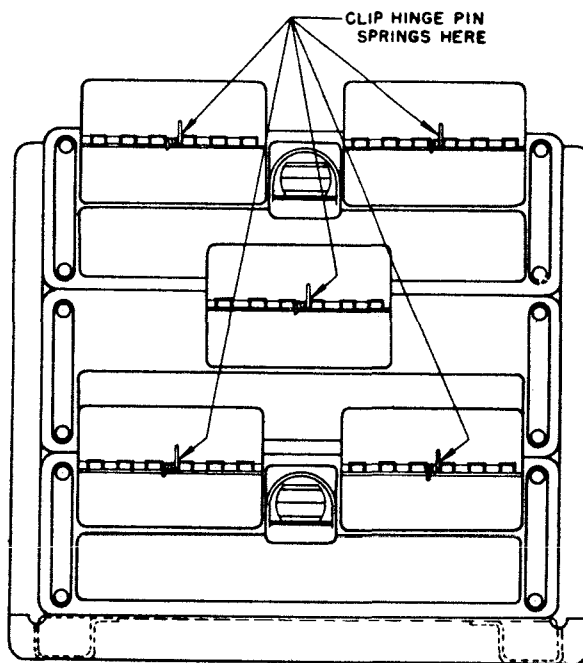
FIGURE 2. Modification of control knob covers.

Norfolk Naval Shipyard has pointed out that open control-knob covers on the AN/URA-8A, -8B equipments are held in an upright position by the hinge-pin spring. These upright covers may cause damage by hanging in the wiring and resistor networks of the drawer above if the drawers are carelessly opened and closed during alignment and repair periods. This damage may be eliminated by clipping the hinge-pin spring in accordance with the accompanying figure. The covers will then drop into a closed position after control adjustments have been made. (See fig. 2.)

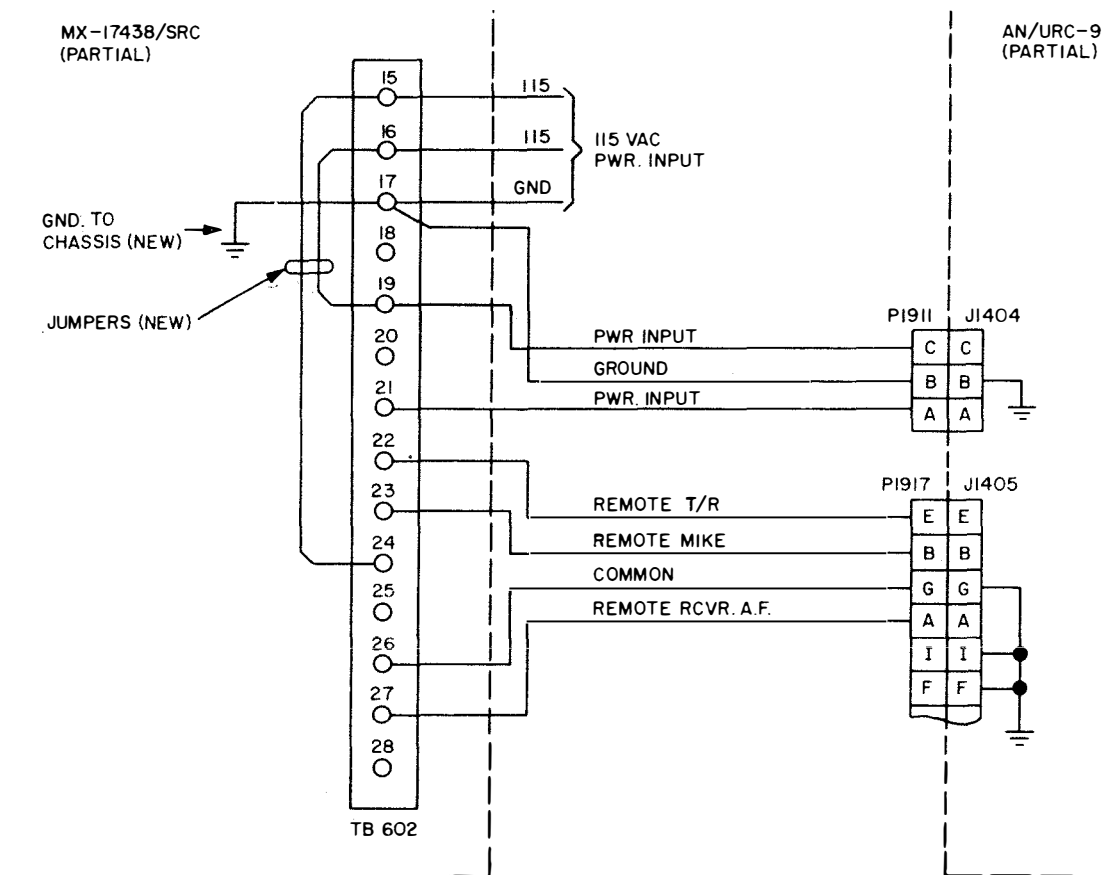
Figure 1. Connections Between MX-1743B/SRC and AN/URC-9

It has been noted by the Engineering Interface Management Office (EIMO), NAVSHIPS Code 06C, that different methods are being used to interconnect the MX-1743B/SRC and the AN/URC-9. The method shown in figure 1 provides the required connections and eliminates the need for modifying the internal wiring of the MX-1743B/SRC. (710)

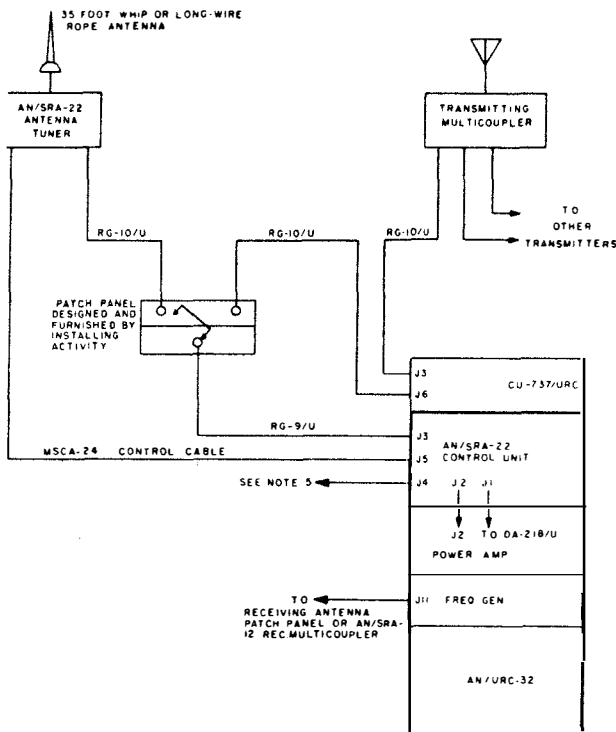
Figure 1. Typical System Interconnection Diagram

Since the CU-737/URC was not originally intended to perform this system function, the equipment modifications as noted on Figure 1 notes must be accomplished. When the AN/SRA-22, CU-737/URC system is used, it is preferable to provide a separate receiving antenna to the AN/URC-32 receiver antenna input. (518)

Figure 1 provides the typical system interconnection for this purpose. The control unit for the AN/SRA-22 shall be installed in the AN/URC-32 rack in the space provided and the CU-737/URC shall be located close to the AN/URC-32 for convenience in tuning. Figure 2 indicates the preferred method of mounting, if space permits.

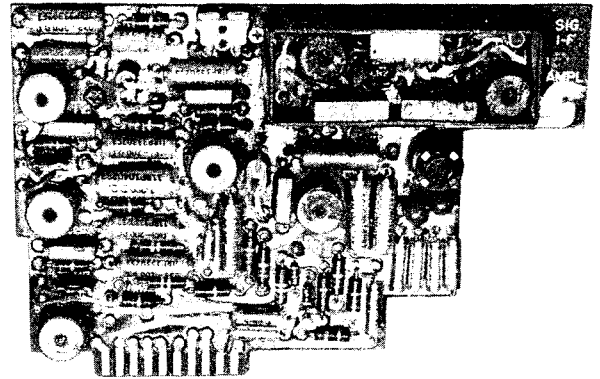
Figure 1

Figures 1, 2, 3, and 4 show the destruction of the printed circuit boards (Signal IF Board in the Stabilized Master Oscillator Module), caused by the thermostatic switch (AIS1) sticking. If Field Change 1 had been accomplished, the damage probably would not have occurred. (See note below)

Field changes to these equipments have been published and announced repeatedly in successive issues of the EIB. It is strongly recommended that holders of equipments accomplish equipment field changes as soon as they are available.

NOTE: Holders of Models A or B SMOS should turn same in and draw C SMOS.
