AN/URT-2, -3, -4 OVERHEATING

AN/URT-2, -3 AND -4 INSPECTION OF BRUSHES

AN/URT-2, -3 AND -4 AN/SRT-14, -15 AND -16 CORROSION OF CABLE CONNECTORS AND RECEPTACLES

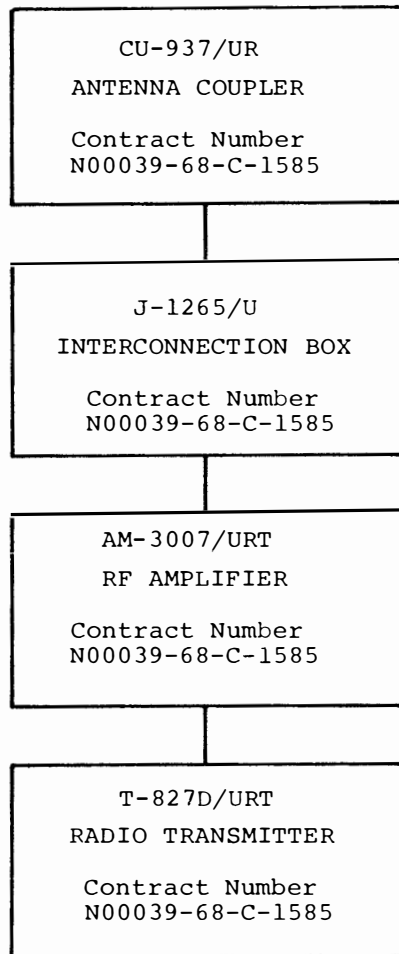
AN/URT-24 CONFIGURATION

In many instances AN/WRC-1B transmitters are installed aboard ship and the local operating position labels identify these equipments as "AN/URT-24." This causes confusion in data reporting, in the determination of field change applicability and in using the correct APL for ordering replacement parts.

THE SIGNIFICANT DATA ARE THE CONTRACT NUMBERS ON THE NAMEPLATES.

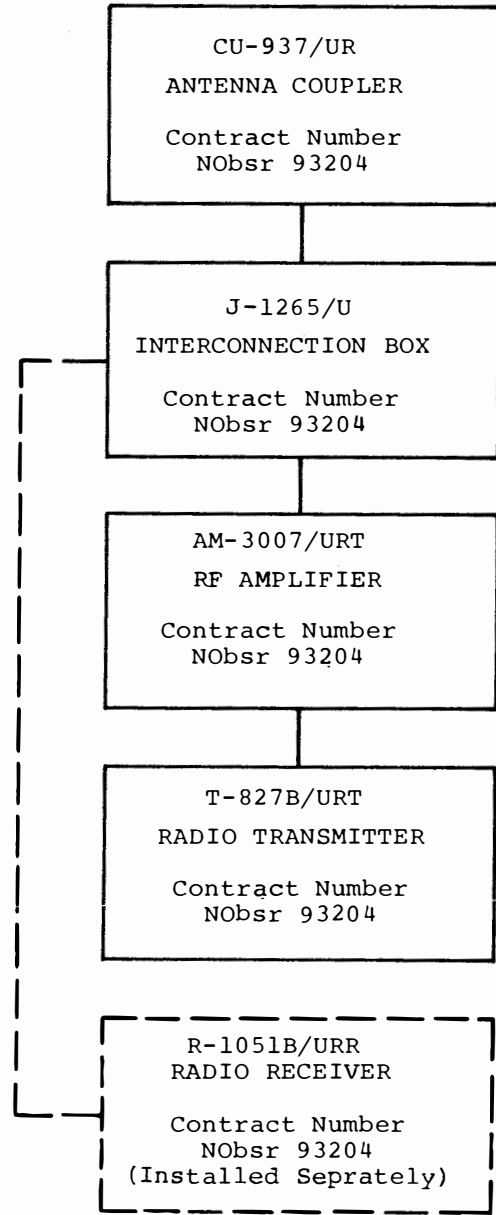
AN/WRC-1B CONFIGURATION

(Local Operating Positions labeled "AN/URT-24")
