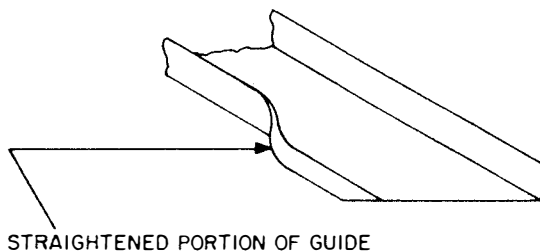
STRAIGHTENED PORTION OF GUIDE  
Figure 1. Circuit Card Guide.

This article provides information to facilitate removal of the printed circuit cards that are located in the back slots of the A1 and A2 circuit card drawers. The circuit card guides for these slots have a portion of the side channel flattened (see figure 1) to allow removal/installation of the circuit cards with a slight rotational motion as shown in figure 2-A rather than a straight perpendicular motion as shown in figure 2-B.

1. Fully extend the A1 or A2 drawer and lock it in position.
2. Remove the top and bottom circuit card locking bars, located along the front edges of the circuit cards involved, by removing the three screws holding each bar in place.
3. Removal of several adjacent circuit cards may be necessary to provide clearance for removal of the desired cards.
4. Using the circuit card puller, pull the card straight forward to break it loose from the plug; then using the rotational motion shown in figure 2-A, carefully remove the desired card.

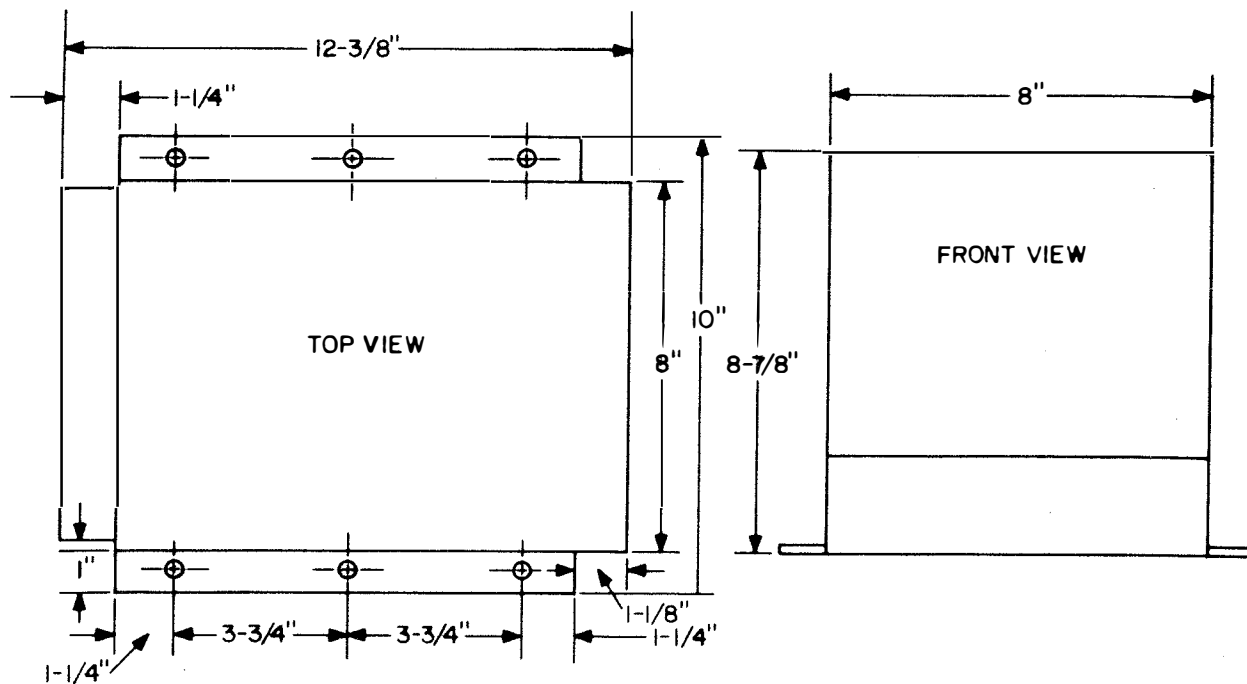
Figure 1. PP-3495B/UG Power Supply.

3. Although the two power supplies are electrically compatible, a physical difference exists. Power supply PP-3495B (Figure 1) is physically larger in its overall dimension and has a different mounting configuration than power supply PP-3495C (Figure 2).

4. Due to the physical differences of the two power supplies and differences in shipboard installations, PP-3495B may not necessarily fit in the space allocated to PP-3495C.

5. Shipboard users should consider their individual application when ordering one of the foregoing power supplies. If the application is constrained by size, it is extremely important that the ordering requisition include a "2B" advice code. Using a "2B" advice code will preclude normal SCAT substitution.

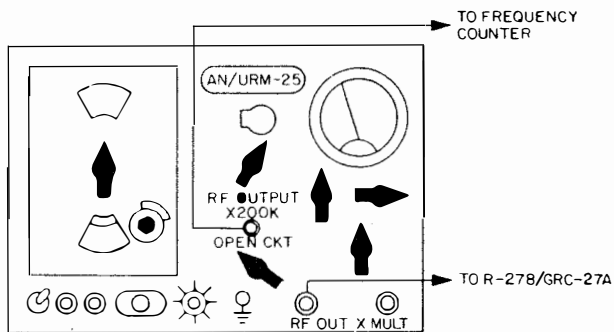
Figure 1. AN/URM-25D Test Set-Up

Field Change 12 to the AN/GRC-27 and AN/GRC-27A Radio Sets, which will soon be published, will make the radio sets compatible with broadband ancillary equipment. To work properly with the ancillary equipment, the 3rd IF Amplifier bandwidth must be 65 kc, centered at 2.05 mc. Unless the swamping resistor is used, this requirement will not be fulfilled.

A frequency counter must also be connected to the RF output X200K output jack as shown in Figure 1 to assure that the AN/URM-25D Signal Generator is providing exactly 2.05 mc. (689)

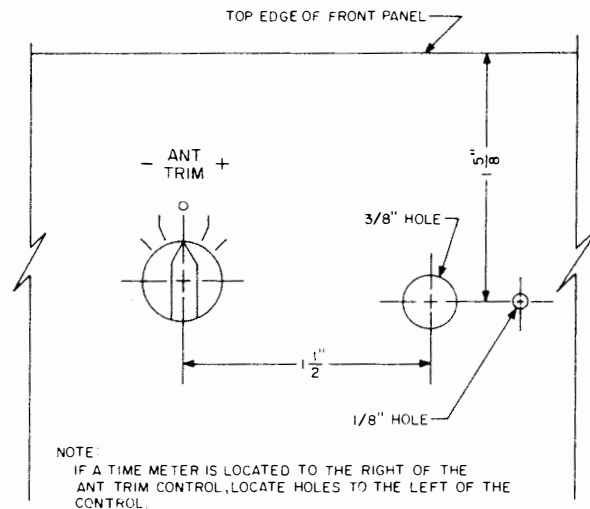
Figure 2. Front Panel Location

12. On the front panel of the receiver, to the right of the ANT TRIM control locate and center punch the point indicated in figure 2. Drill a 3/8 inch hole at this point.

14. Using the control, locate and drill a 1/8 inch hole for the control's position lock tab. Insert the control from front to locate hole. See figure 2.

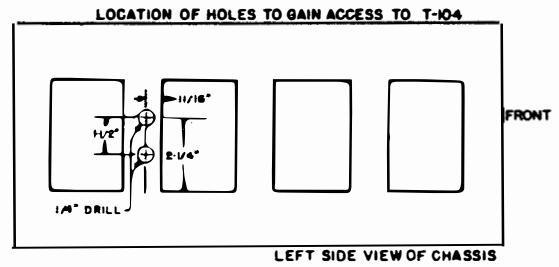
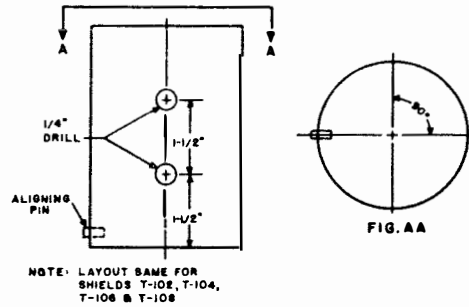
Figure 1

NOTE: LAYOUT SAME FOR SHIELDS T-102, T-104, T-106 & T-108

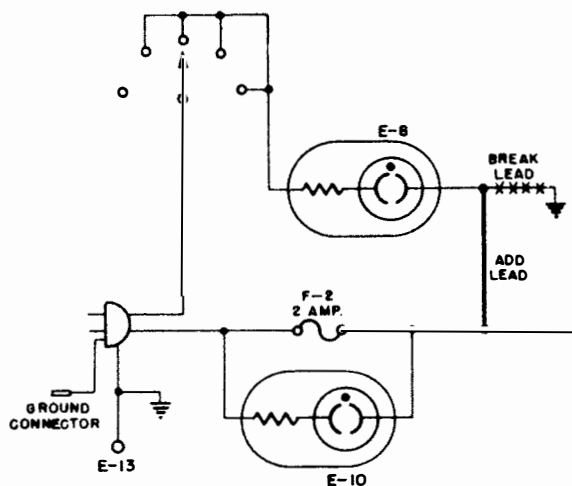
CORRECTIONS TO SCHEMATIC DIAGRAM FIG. 13 OF NAVSHIPS 91401

NOTE: THIS DIAGRAM IS INTENDED AS AN AID IN REWIRING E-8, IT IS NOT A COMPLETE DRAWING OF THE RD-92/UX.

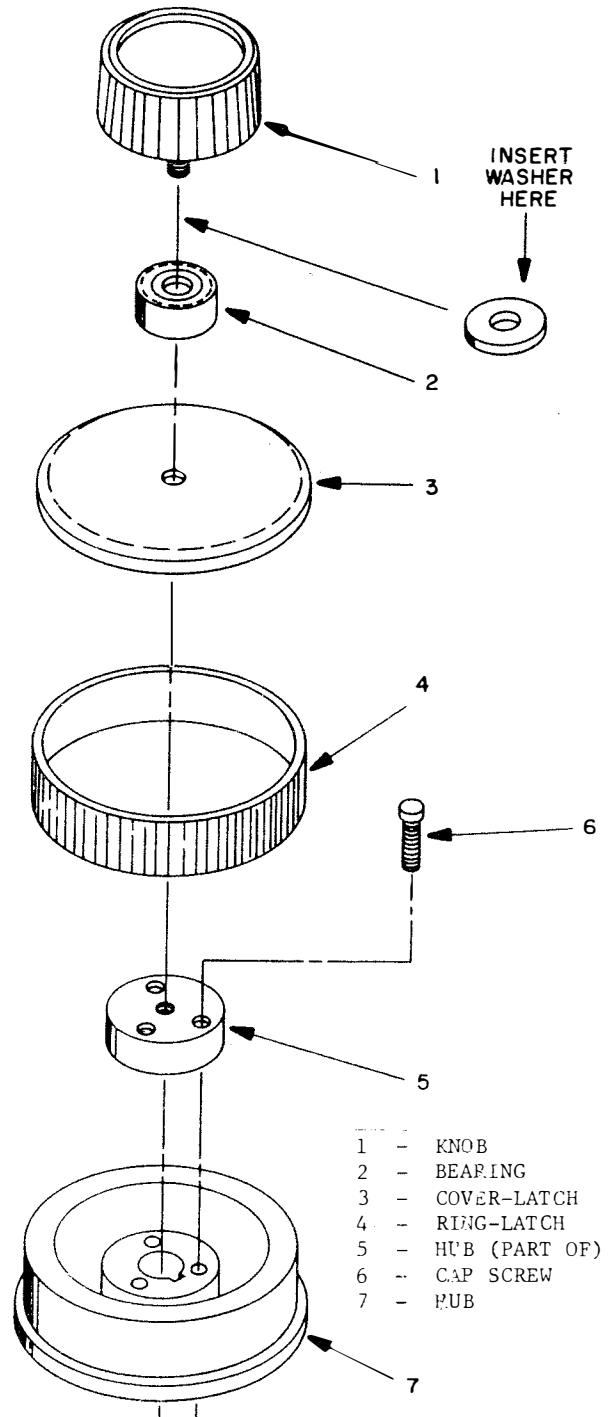
Figure 1. IBM Reel Hub Assembly.

The purpose of this article is to inform technicians of a method to prevent the stub on the IBM reel hub assembly from being pulled out of the knob when the knob is tightened excessively.

This problem may be eliminated by inserting a flat, round metal standard (3/8 inch inside diameter) washer, FSN 5310-080-6004, between knob and bearing as shown in figure 1. (EIB 859)

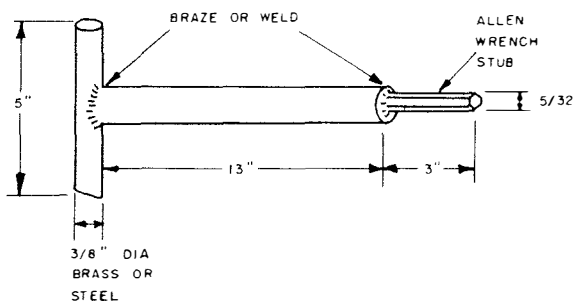
Figure 1 Interpreter Removal Tool

Removal of the interpreter sub-assembly from the CRPI is difficult and time consuming using standard tools.

COMINEPAC has designed a special tool (see figure 1) that can be locally manufactured at AN/UYK-5(V) activities. Use of the tool will reduce maintenance time caused by inaccessibility of the interpreter retaining screws. (768)

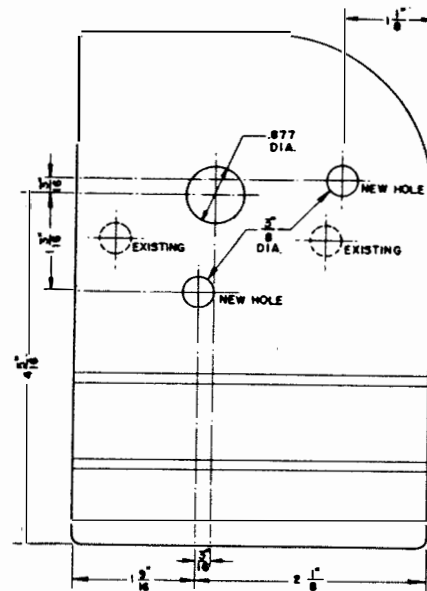
Figure 1

A modification to the RDZ equipment (radio-receiver) permits alinement of the rf section while the receiver chassis is locked in the tilted position. At present, rf trimmer capacitors C-103E and C-103F are not accessible when the chassis is tilted because the bearing plate (left hand, viewed from in front of the receiver) obstructs the access holes in the rf section enclosure. Two new holes, indicated in figure, will permit adjustment of these trimmers without shifting the chassis position during alinement of the rf section. Time can be saved since the repeated alinement and control adjustments sometimes required for optimum results will be easier to perform. Position of the new holes in the bearing plate should be carefully marked to insure alinement with access holes in the rf enclosure, prior to drilling. Manufacturing tolerances and wear in the tilt-locking mechanism may require slight deviations from hole locations shown in the drawing. Careful drilling is essential to prevent metal chips from entering the rf section. Remove all chips after drilling is finished. This modification may be performed, if desired, by the maintenance activity. No official field change will be issued.

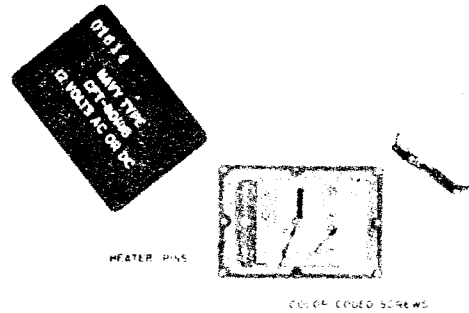
Several failures of the crystal oven, E-121, Navy type CFT-40148, used in RDZ, MAR and TDZ radio equipments have occurred in test and in the field. Activities report that the fine wires connecting the crystal socket to the pin in the oven base break causing an open circuit.

FIGURE 1.--The Crystal oven and the two identifying screws.

The manufacturer has corrected this defect in all crystal ovens shipped after December 7, 1945. A larger wire is used for the connections.

Crystal ovens of the old type should be returned to the Electronics Officer for replacement with the new improved ovens. Electronics Officers should ascertain that new improved ovens are provided for all RDZ, MAR and TDZ equipments before installation. The spare parts should also be checked for inclusion of the new oven.
