RL-216/UG Tape Winder--Possible Shock Hazard

SERVICE NOTES

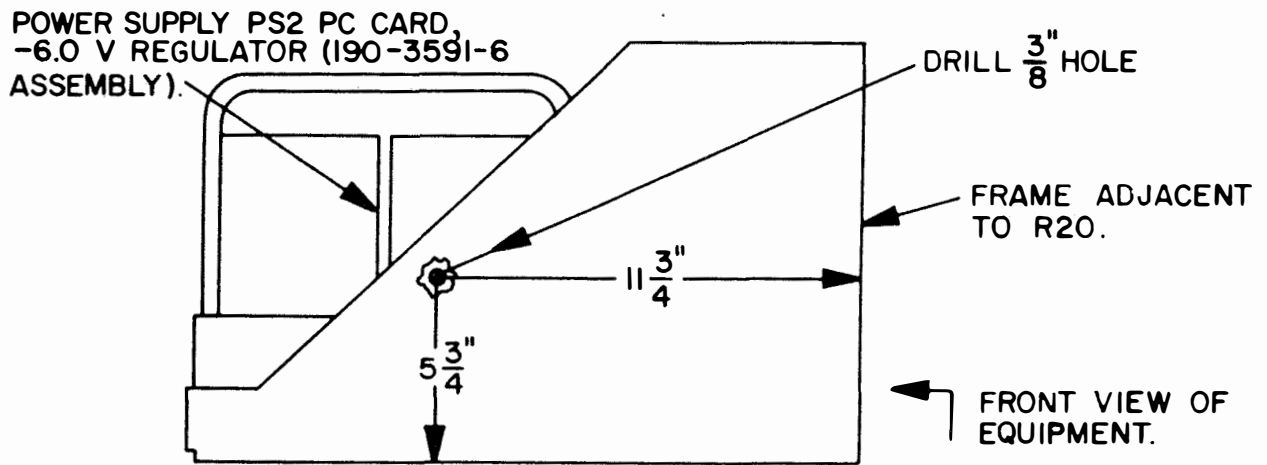
LEFT SIDE VIEW OF CONTROL LOGIC ASSEMBLY

Voltage adjustments to the Printer Interpreter Power Supply, items 16 and 42, Figure 4-49, NAVSHIPS 0967-324-0060, requires the use of an offset screwdriver which creates a hazard of short circuiting and damage to personnel and equipment. To eliminate the hazard and to facilitate making future adjustments to the -5.3 and -6.0 volt DC power supplies, 3/8-inch holes must be drilled through the equipment frames adjacent to R-53 (-5.3 V regulator) and R-20 (-6 V regulator) to permit adjustment with normal tools.

The foregoing alteration should be performed during the next maintenance period on the RO-314/G punch equipment. Use standard hand tools and assure power to the equipment is turned off and that adequate protective covering is placed over surrounding circuit boards and chassis. It is suggested that assemblies 12-890143-001 and 190-3591-6 be removed prior to drilling to prevent possible damage to these printed circuit cards. (See figure 1 for details.)

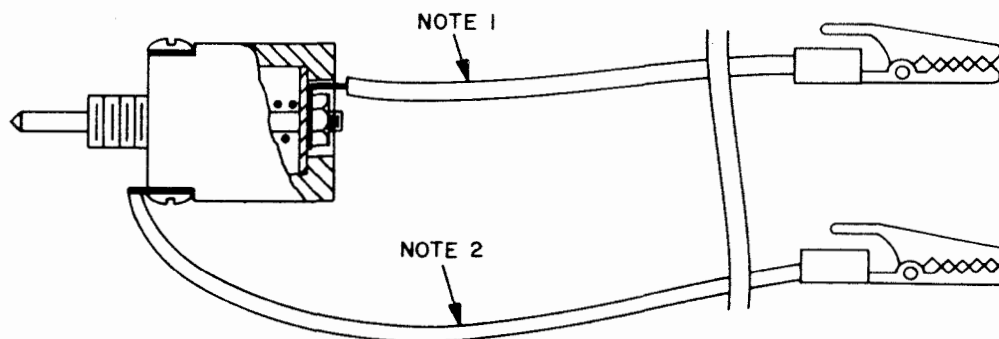
Figure 1. Battery Test Harness Assembly.

Planned Maintenance System Feedback Reports indicate problems in performing step 1.d of Maintenance Requirement Card number C-82 Q-1 due to incorrect lead polarity of external battery test harness. These test harnesses are now being manufactured for use with negative ground equipment such as Radio Transmitting Buoy T-616/SRT. The T-347()/SRT, however, has a positive ground. Users are cautioned to observe the polarity of leads when assembling the test harness. Correct assembly of the battery test harness for use with the T-347/SRT and T-616/SRT is shown in figure 1. The test cable harness assembly for Radio Transmitting Buoy T-347()/SRT was assigned a new Federal Stock Number 9G5995-295-2855; this FSN appeared in EIB 647. Users are advised to reverse the assembly of leads, if required, to agree with instructions on the Maintenance Requirement Card. (788)

1. For use with T-347()/SRT this lead should be black.
For use with T-616/SRT this lead should be red.
2. For use with T-347()/SRT this lead should be red.
For use with T-616/SRT this lead should be black.

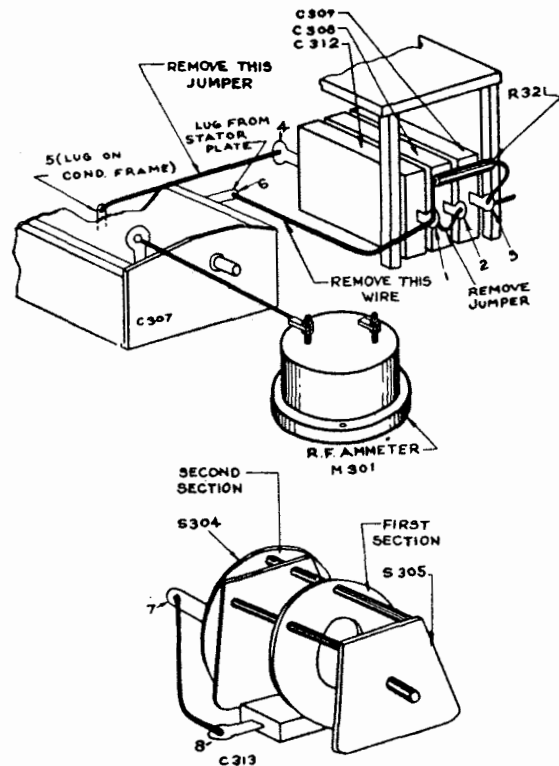
FIGURE 3.--Original connections.

In some of the type CG-43005 transmitter-receiver units of the TBX-2 portable radio equipments, capacitors C-313 and C-314 were inadvertently transposed during manufacture. Under certain conditions of operation (if operated below 2200 kc. on ANT. COARSE adjustment on top no. 1), the performance of the unit will be impaired due to this transposition. All units bearing serial numbers from 509 to 800 inclusive should therefore be examined, and if the error is found to exist, it should be corrected in accordance with the following instructions:

Remount the capacitors. Be sure that the shorter wire of C-313 is connected to lefthand lug facing nameplate side (this assures maximum clearance between lugs and shield) and that the red color-coded wires at C-314 are not short-circuited to ground.

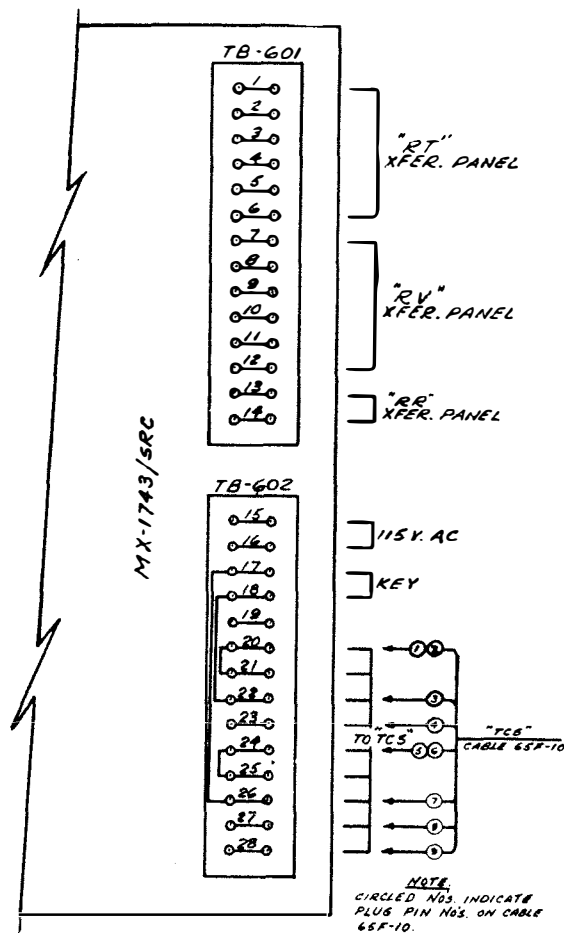
The INSTALLATION INSTRUCTIONS AND LIST OF PARTS, which accompanies the MX-1743/SRC adapter, includes BUSHIPS Drawing No. RMHP-23-D-127 (Rev. A). However, this drawing does not indicate the cross connections from terminals 20 through 28 on TB-602 to the TCS cable and a considerable amount of time may be lost in tracing out the TCS circuits.

Figure 1 indicates the cross connections from TB-602 to the conductors of the TCS cable No. 65F-10.

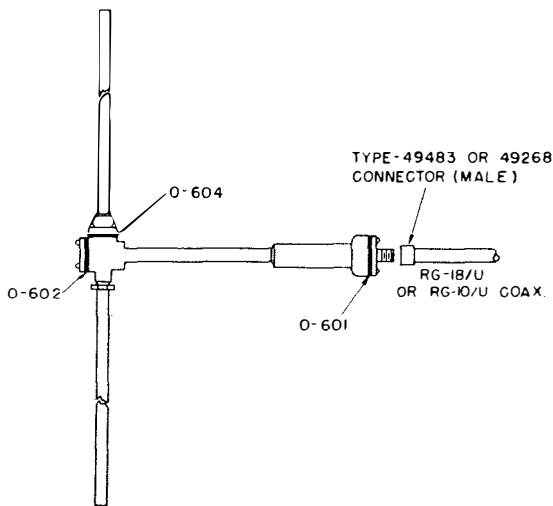
FIGURE 1.--Location of TDQ gaskets to be checked on antenna

Several reports have been received by the Bureau recently concerning failure of the Type 66095 antenna as

To illustrate the importance of close inspection and proper maintenance, a number of cases have occurred where requests were made that the antenna be relocated. Investigation disclosed that the antenna had a ground or short.

than is done in routine maintenance procedure. It is recommended that the arrays be disassembled and inspected when low-strength radiation and reception are experienced. Failures of this type cannot be determined by visual inspection alone. After inspection and cleaning, the arrays should be reassembled. New gaskets should be used and care should be taken that the gaskets and insulators are installed properly and that the bolts are drawn up tight. Glyptol should again be applied to the bolts in each instance to insure against loosening due to vibration.

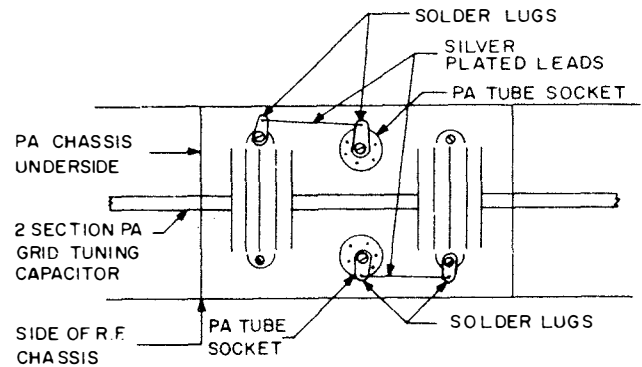
Figure 1. PA Grid Stage (Partial), Wiring Diagram

Specifically, the PA grid stage of some TED transmitters manufactured by Nevada Air Products cannot be properly aligned. All TED transmitters, especially those manufactured by Nevada Air Products, should be checked for the following condition.

Inspect the connections from the PA grid tuning capacitor (two sections) to the grids of the two PA tube (4x150) sockets. These connections should consist of a solder lug attached by a screw to each grid capacitor section, a solder lug attached by a screw to the grid connection of each PA tube socket, and a length of silver plated lead soldered from each grid solder lug to its respective capacitor section solder lug, as illustrated in figure 1.

In the defective TED's, no silverplated lead wire is installed. The connection between the capacitor section and the respective PA (4x150) tube socket grid connection was made by turning the solder lugs at right angles from the position shown in figure 1 so that the ends of the solder lugs overlapped. The lugs were then soldered together. In this fashion, the lugs were made to serve as leads.

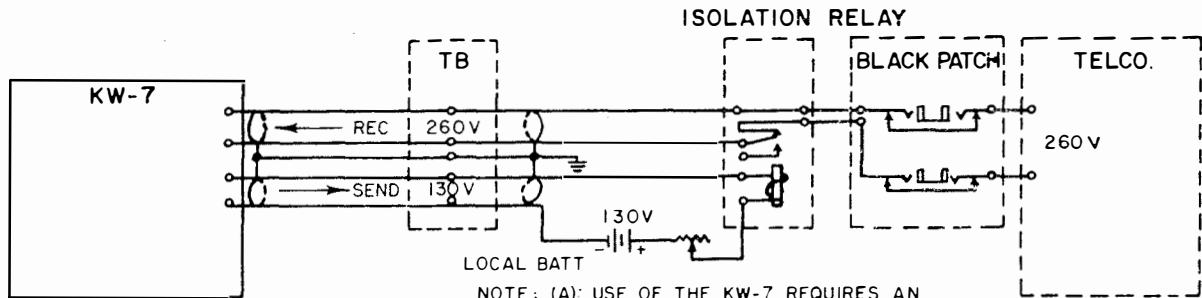
The simplest acceptable device is the Star/Delta network shown in figures 2 and 3. It has the following general properties:

Many field reports of contact failure in the transmit line relay of subject equipments have been forwarded. Engineering studies of the problem have revealed the following condition:

The relay internal arc suppression network is designed for operation in loops not exceeding 130 volts. Immediate damage to the contacts, by inadequate arc suppression, occurs when a 260 volt line is installed and keyed.

In those instances where the telephone company is unable to supply loop voltages of 130 VDC or less, the installation of an isolation device is recommended. Suggested materials and procedures for effecting such isolation is contained in the following paragraphs.

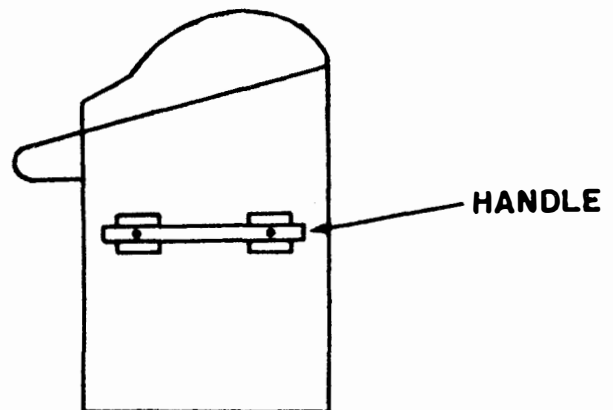
Figure 2. Mounting Location of Handles

The distance of 13-3/4 inches between the two studs is required in order that handles will fit existing holes in teletypewriter cabinet. The felt pads are glued permanently to the steel plates to protect cabinet finish. Figure 2 illustrates how handles are mounted on side of cabinet.

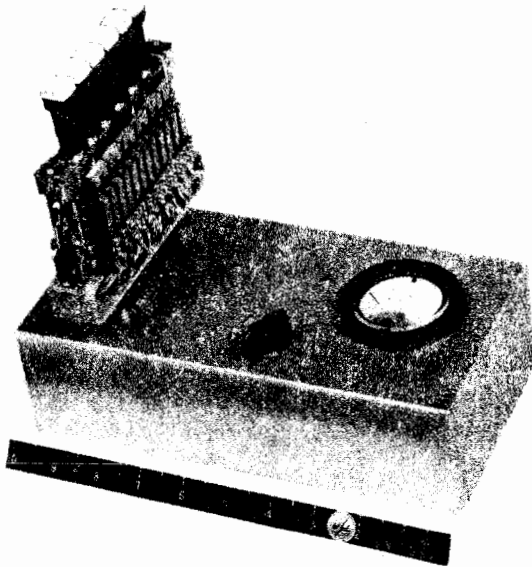
Figure 1. Switch-Stack Assembly Test Set, Top View

The Test Set shown in figures 1 and 2 is a laboratory model. The arrangement plan, figure 3 describes a configuration of a compact, inexpensive Test Set that can be assembled by FBM submarine tender personnel, using the material listed in Table 1. Figure 4 is a wiring diagram of the Test Set and assembly under test.
