**SERVICE NOTES**  
**RADAR**

**DEPARTMENT OF THE NAVY**  
**BUREAU OF SHIPS**

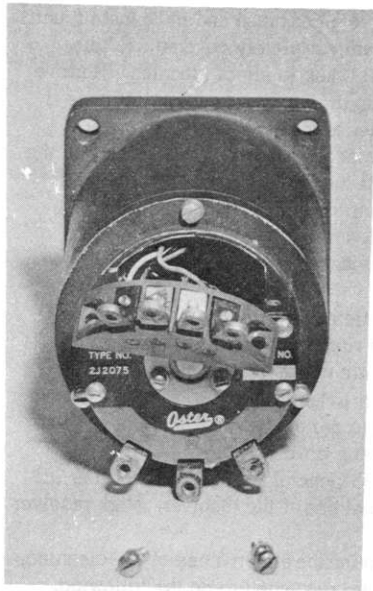
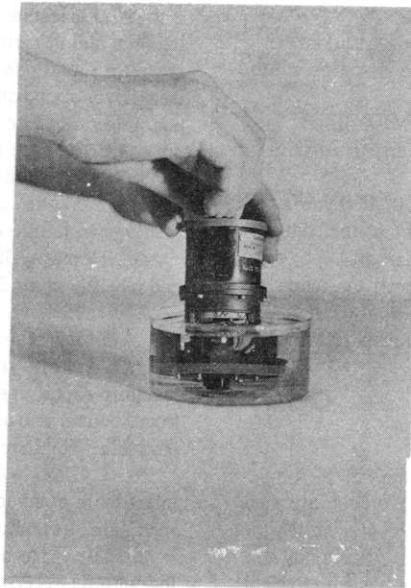
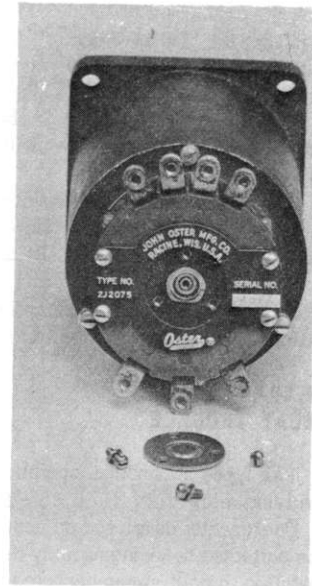
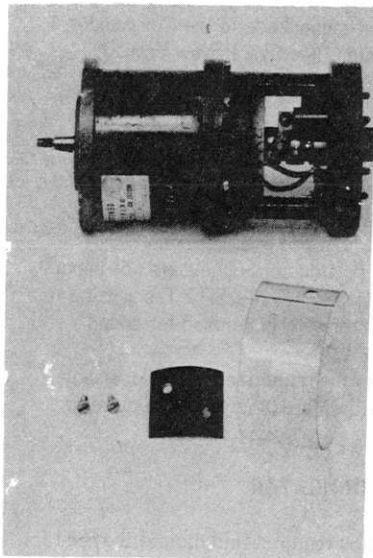
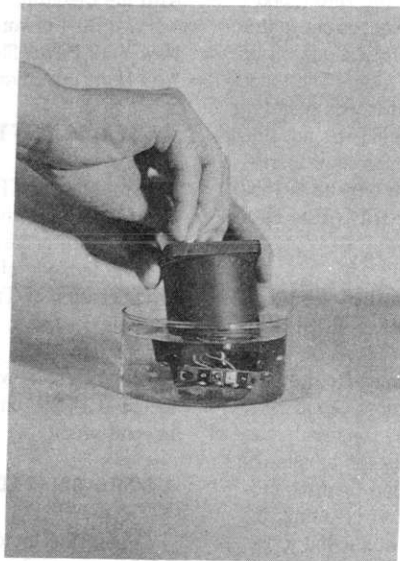
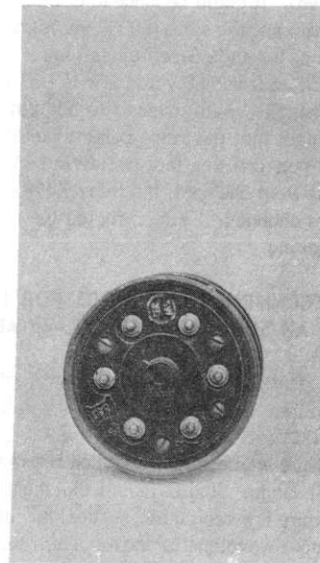
Methods for Cleaning Resolvers.

The Component Reliability Program included a study of failures in the resolvers used with Indicators Group AN/SPA-8, -8A -9, VK-4a and VK-5. The principal cause of failure was the dust produced by wear between brushes and slip rings. Studies reveal that the following cleaning procedure has been quite successful, and after cleaning, the output waveform for the resolvers tested was found to be free of noise. The report indicated that with the normal life of 1000 hours consumed prior to the first cleaning, 1200 to 1400 additional hours could be run without serious evidence of noise development. No report was made regarding a second cleaning, although it is worthy of trial.

2. Immerse slip ring and brush end in Sovasol 5 until brushes and slip rings are completely covered. Rotate armature rapidly several times to effect cleaning. Remove from Sovasol and allow to drain. Blow out with air hose if possible. Replace stator terminal holder.

3. Remove three screws holding plate located in the center of nameplate and lubricate bearing with No. 2135 General Purpose Lubricating Oil. Replace plate. Mark resolver with date of cleaning.

2. Immerse slip ring-brush end in Sovasol 5 until brushes and slip rings are completely covered. Rotate armature rapidly several times to effect cleaning. Remove from Sovasol and allow to drain. Blow out with air hose if possible. Replace plastic cover.

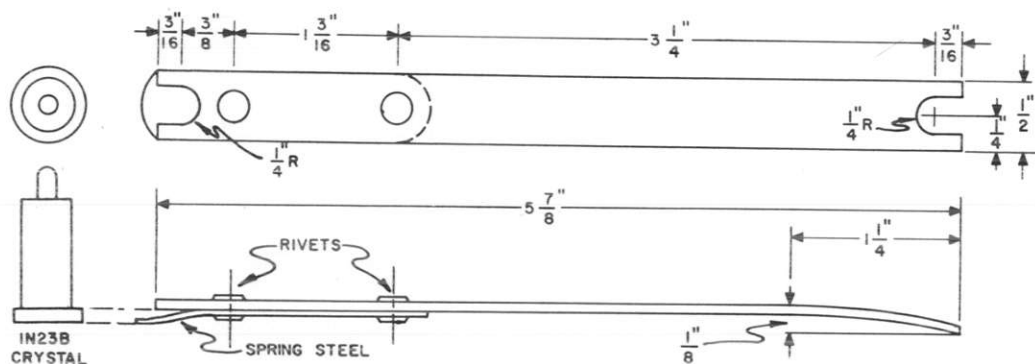
Figure 1 CRYSTAL INSERT/EXTRACT TOOL (AN/SPS-4)

The mixer assembly (RE-201) for the AN/SPS-4 is a precision item. Periodic removal of the crystal (1N23B or equivalent) in this assembly is necessary. During this removal the crystal holder may become damaged if the crystal is removed or inserted at an angle with common tools. A special tool has been designed which will permit horizontal insertion of the crystal and which will prevent damage to the holder.

Figure 1 shows the complete tool which can be used to insure positive spring contact and to check these contacts without removing the complete sub-assembly. It will reduce the likelihood of damage and will greatly simplify the job of crystal removal and replacement.

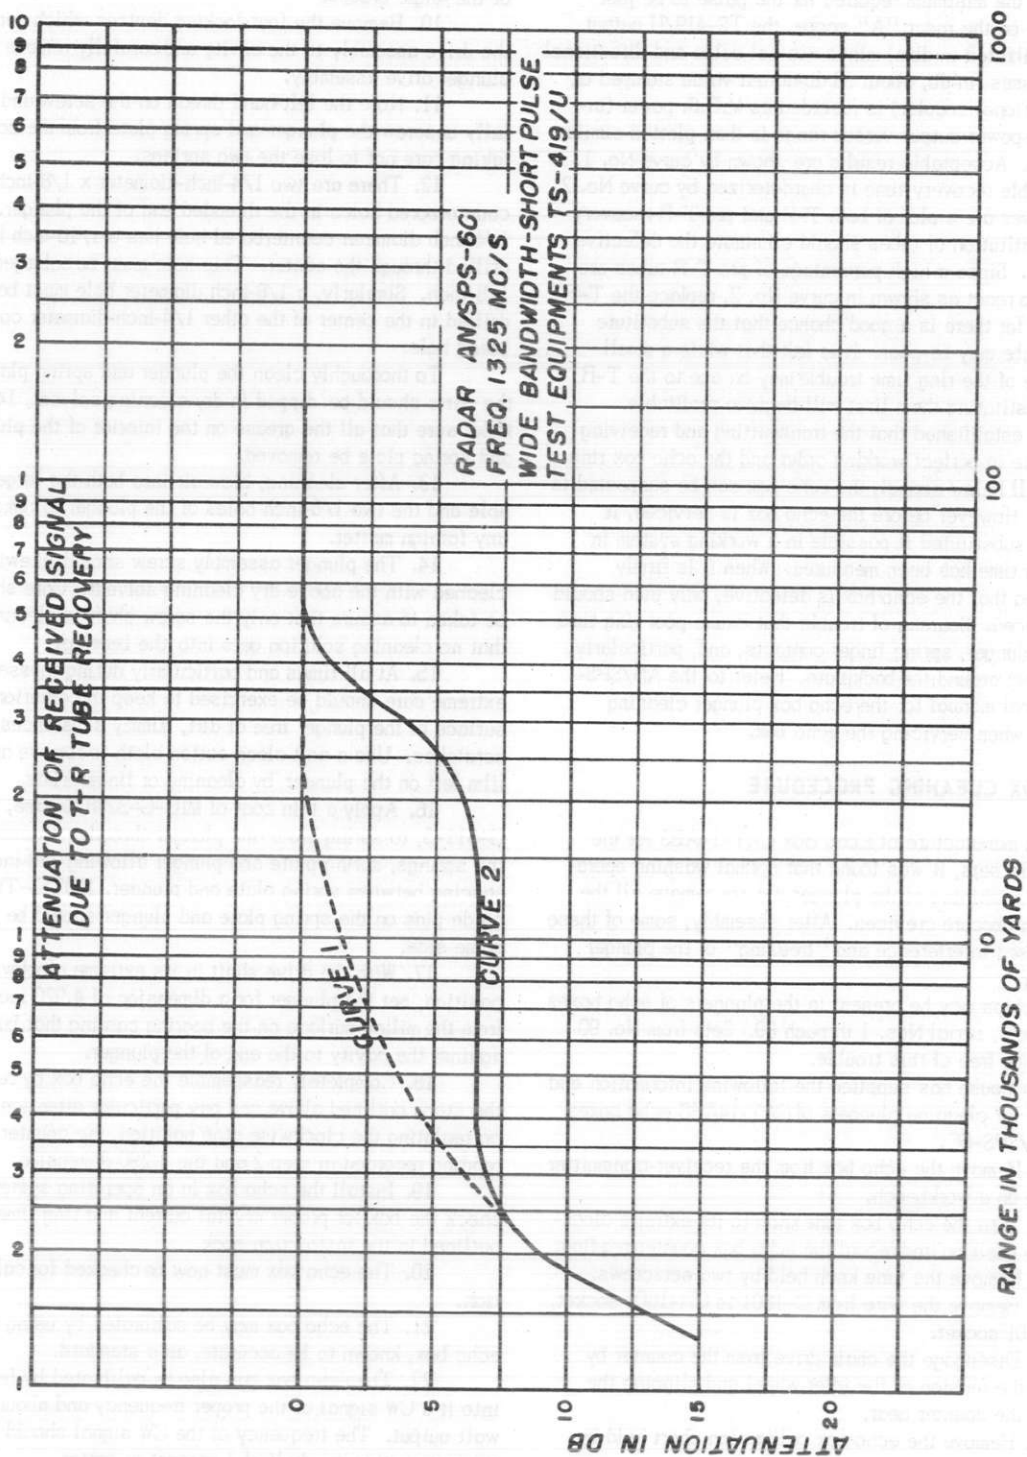
FIGURE 1.

Particularly hard troubles to diagnose are weak, bad or defective T-R or pre-T-R tubes. By defective is meant tubes with inherently long recovery time, high leakage or other similar characteristic defects. A suggested way of measuring the recovery time of T-R and pre-T-R tubes involves a method of measuring minimum discernible signals as follows: The system is first tuned for optimum performance, preferably on distant targets. The pulse output of a Signal Generator TS-419/U is applied to the echo box

connector of the directional coupler. With its output power reduced to the minimum required for the pulse to be just observable on the radar "A" scope, the TS-419/U output power (calibrated in-dbm) minus coaxial cable and directional coupler losses (in db, about 38 db-actual value stamped on each directional coupler) is recorded as M.D.S. power (in-dbm). The power output versus range is then plotted similar to figure 1. Acceptable results are shown by curve No. 1. Unacceptable recovery time is characterized by curve No. 2. These curves are a plot of both T-R and pre-T-R recovery time. Substitution of tubes should eliminate the defective component. Since a high percentage of pre-T-R tubes are believed to react as shown in curve No. 2, replace the T-R tube first, for there is a good chance that the substitute pre-T-R tube may be poor. It is felt that while a small percentage of the ring time trouble may be due to the T-R tubes, substituting them first will be more profitable.

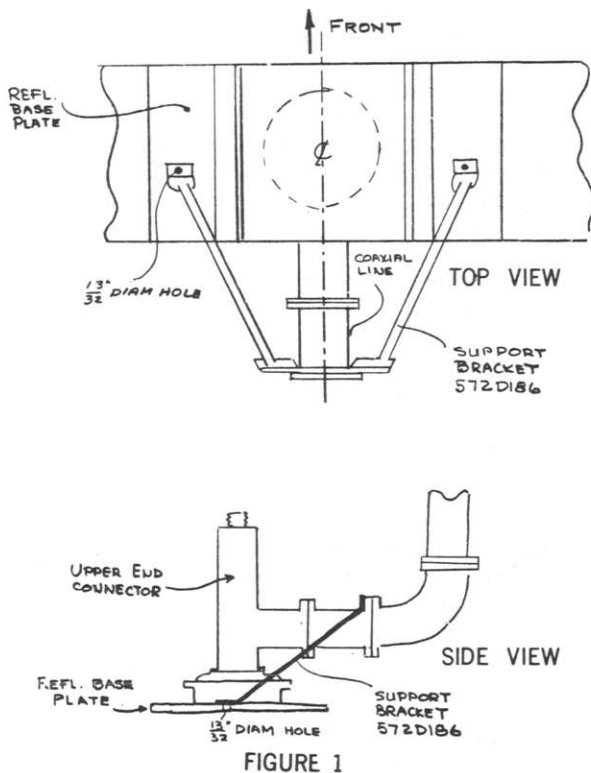
FIGURE 1

The support bracket for AN/SPS-17, -28 antenna coaxial feed line has, in some cases, been installed incorrectly, or left out completely.

Figure 1 shows the correct location and mounting arrangement.
