INCORRECT METHOD OF RANGING

METHOD TO REDUCE FAILURES OF THE RF SIGNAL MONITOR FOR SG-1 SERIES

LOSS OF ECHOES IN SG-6 RADAR ANTENNA GEARS

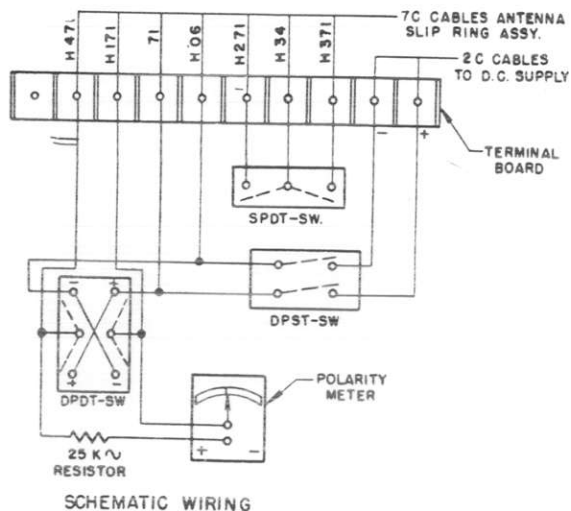
Figure 1

The wiring and outline drawing shows necessary details for fabricating the test set, figure 1. The "Surface-Zenith" switch in the test set provides a means of reversing polarity of the input voltage to the drive motor; the meter provides a visual means of checking the polarity.

The suggested device, by changing polarity on the input voltage, also permits a reversal of the rotation of the Geneva Wheel within the selector valve assembly. This test equipment also changes position of cams and switches to allow a change from Surface Search to Zenith Watch and to permit proper alignment of the waveguide in either position. Use of the suggested test set at yards and repair facilities may be locally authorized.

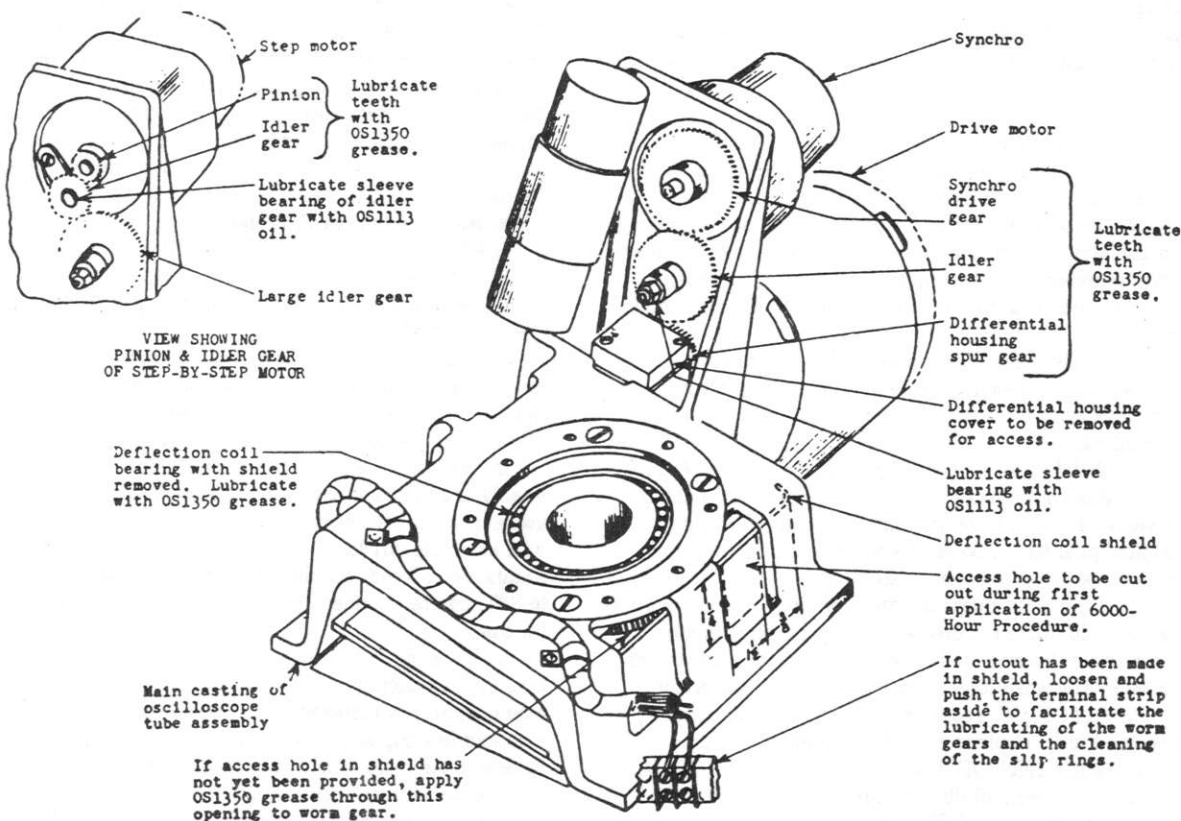
FIGURE 2.—Location of 1,500-hour lubrication points and access hole in shield.

a. The worm gear can be observed by looking into the openings in the front part of the indicator tube assembly main casting just above the terminal strip as indicated in figure 2. At the first time that the "6,000-hour procedure" is applied, this opening will be enlarged by cutting away a part of the deflection coil shield assembly. If an opening has been cut in shield, dismount the terminal block without disconnecting the wires and push the terminal block to one side.

c. Apply a few drops of OS1113 oil to the sleeve bearing of the idler gear located next to the differential housing gear as indicated in figure 2. If true bearing motor

is a step-by-step motor, apply oil to idler gear sleeve bearing on step motor as indicated on figure 2.

- a. The deflection coil shield should be modified to provide an access hole, if one has not already been provided, as indicated in figure 2.
- b. Clean the spring contact surfaces with a clean cloth and carbon tetrachloride or equivalent. Do not use abrasives.
- c. If a gram gage is not available, a check of the angle of the brush springs should be made so that the tension will be approximately correct. Before the deflection coil shield is installed, the ends of the brush springs should be 11/16 of an inch from the insulating strip on which they are mounted.

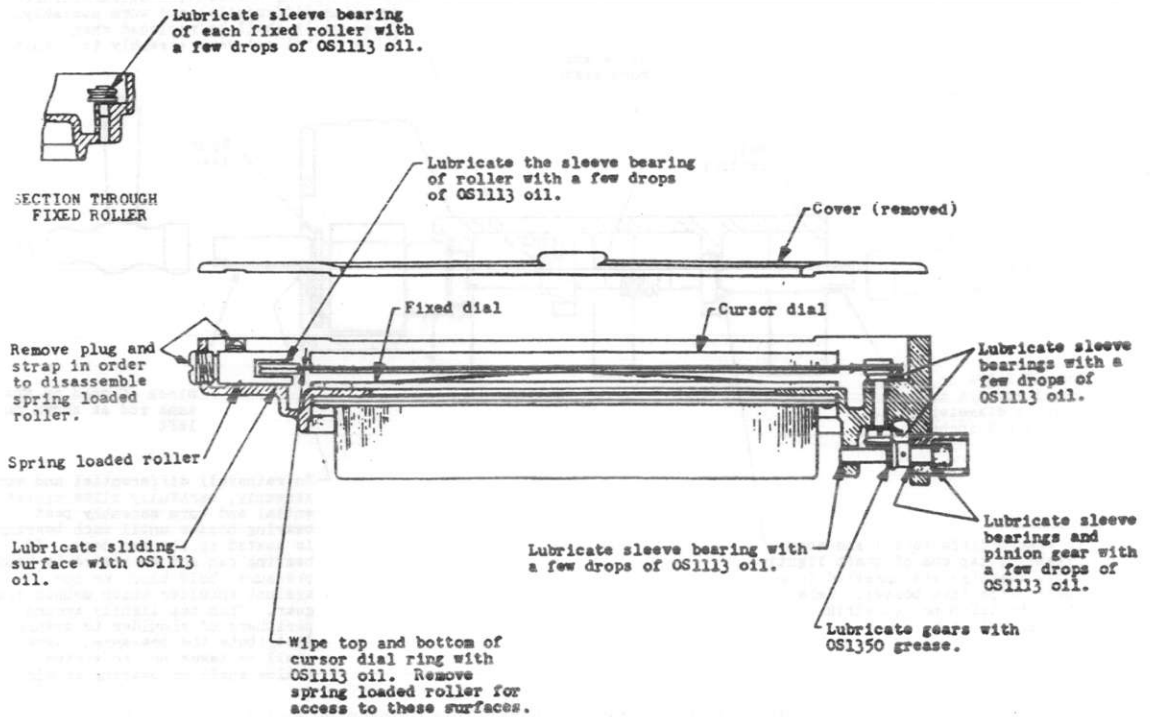
FIGURE 3.—Lubrication of bearing cursor assembly.

a. Remove the cover plate from the top of the bearing cursor assembly. See figure 3 for lubrication points.

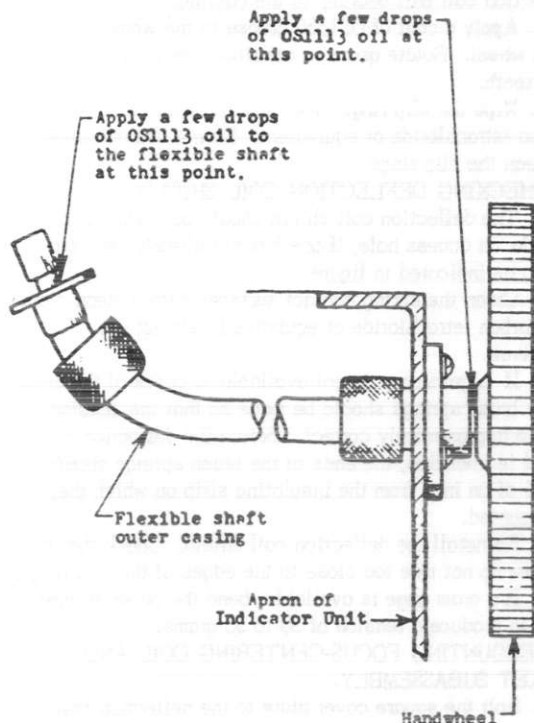
FIGURE 4.—Lubrication of flexible shaft assembly.

Lubricate the flexible shaft assembly as indicated in figure 4.

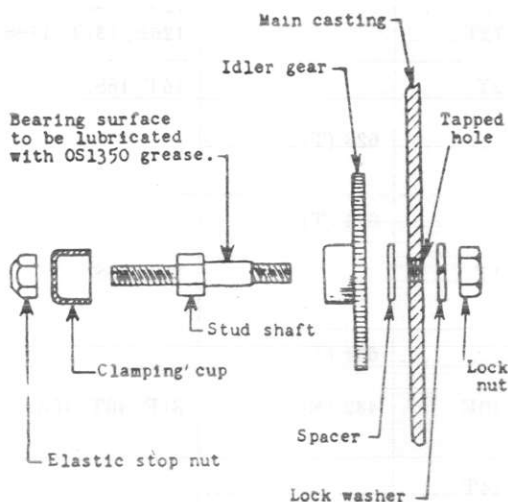
FIGURE 7.—Exploded view of large idler gear assembly

g. Remove the idler shaft and idler gear. An exploded view of the idler gear assembly is shown in figure 7. First remove the locknut and lock-washer. Then screw the elastic stop nut back and push the clamping cup back in order to expose the hexagonal portion of the stud shaft. Finally screw the stud shaft out of the main casting.

- a. Clean the components of the idler gear assembly with a cloth and Stoddard solvent.
- b. Apply OS1350 grease to the hub bearing of the idler gear and reassemble to main casting as indicated on figure 7.
- c. After assembly to casting, apply OS1350 grease to teeth of idler gear. Rotate gears to distribute the grease over teeth of the idler gear and the differential spur gear.

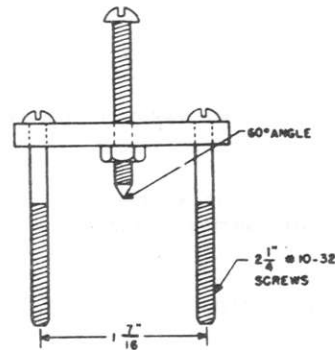
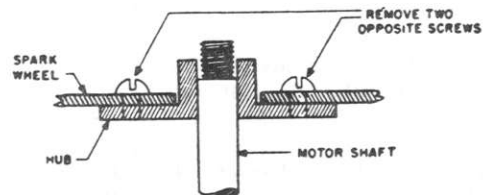
To loosen the motor shaft nut it is necessary that the spark wheel assembly be prevented from turning. To prevent this natural tendency to turn requires patience and the correct method of blocking the assembly. Do not block on the spark wheel pins because they are very brittle and will snap off when pressure is applied to the nut. Use a double open-end wrench with 5/16" and 13/32" openings.

Ordinary methods of applying pressure often-times fail to accomplish the removal of the wheel after the nut has been removed. To meet this situation a wheel puller has been devised (fig. 1). This consists of a piece of steel or brass approximately 1/4" thick, 1" wide, and 2-1/4" long. Three holes are drilled as shown in figure 1. The center hole is drilled and tapped for a #10-32 brass screw. An alternate method is to use a nut through which the center screw is screwed thus accomplishing the same purpose—applying pressure on the center of the motor shaft. The two outer holes are a loose fit for the #10-32 screws.

To use the wheel puller, first remove two opposite screws that hold the spark wheel to the hub. Then screw the two 2-1/4" screws of the wheel puller into these screw holes. The exact depth the screws are inserted is not critical but the puller plate should be parallel with the wheel so that the wheel will have no tendency to bind when pressure is applied. The final step is to screw in the center screw, putting pressure on the center of the motor shaft until the spark wheel is pulled off the shaft.
