SYNCHRO ALIGNMENT OF ROTATING WAVEGUIDE SECTION

AZIMUTH GEAR TRAIN FAILURE IN SX ANTENNA ASSEMBLY

LOCAL OSCILLATOR TUNING RODS

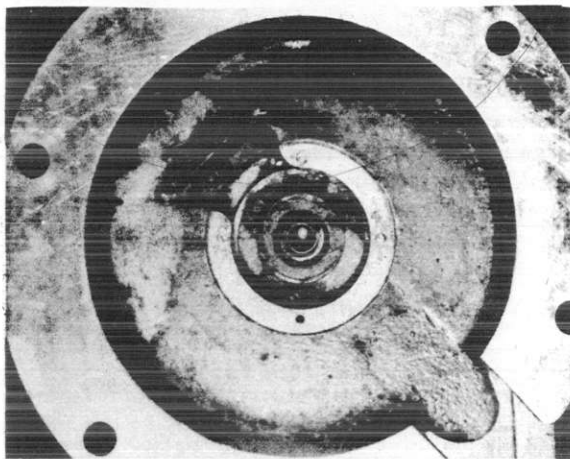
Figure 1 shows an average damaged coupler installed in an adapter. Condition of the average coupler, as received for repairs, is shown to the left and condition to which it may be restored is shown to the right in figure 2. The tools manufactured to effect repairs are shown as tools 1, 2, 3, 4 and 5 in figure 3 and figure 4. All tools are used in the manner of punches.
