TK-188/UG Teletypewriter Tool Kit

LINE CURRENT REQUIREMENTS

TELETYPEWRITER MAINTENANCE

CAREFUL MAINTENANCE REQUIRED FOR HIGHER SPEEDS IN TELETYPEWRITERS

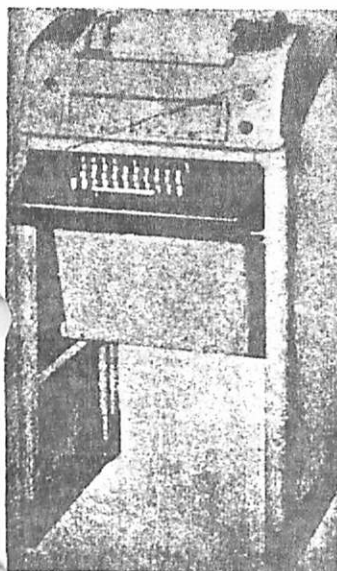
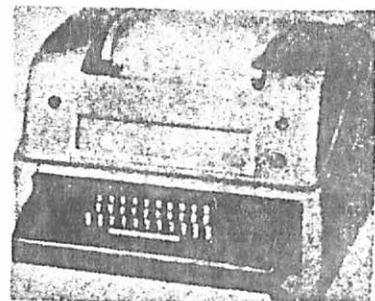
Copy Samples with errors

TROUBLE	REMEDY	COPY SAMPLE #
Copy appears as illustrated.	Automatic Carriage Return and Line Feed Bell Crank not engaged properly with code bar extension. This can happen when front plate is replaced	15
Type box will not shift to figures position.	Figures function pawl broken or inoperative.	16
Copy appears as illustrated.	Unshift on space function not disabled.	17
Irregular spacing and overprinting.	Spacing feed pawl spring broken or missing.	18
Picks up fifth pulse.	Shift slide drive mechanism adjustment. Right decelerating slide spring broken or missing.	19
Printing carriage incorrectly positioned.	Printing carriage position adjustment.	20
Copy appears as illustrated.	Horizontal motion stop slide springs broken or missing. (Top group-Upper slide spring)	21
	(Middle group-Common slide spring)	22
	(Bottom group-Lower slide spring)	23
Keytop will not return to upward position after operation under power and printer will keep repeating selected keytop.	Non-repeat lever adjustment. Code bar reset ball adjusting screw adjustment. Code bar bail adjusting screw adjustment.
