BUSHIPS

ELECTRON

NavShips 900,100

UNDERWATER SOUND

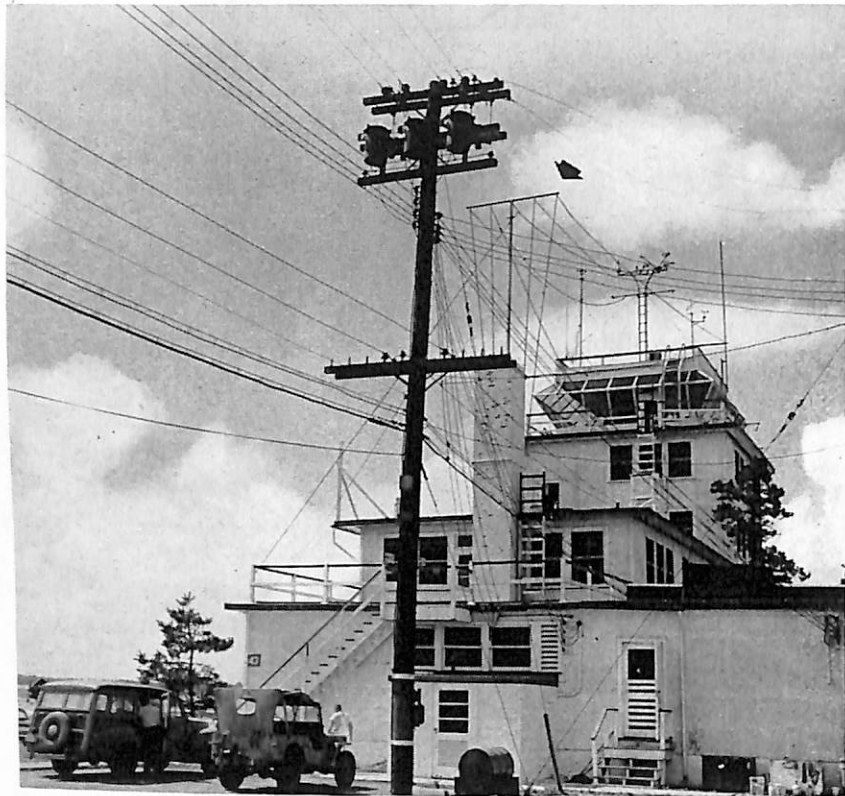
Check for power lines and transformers in proximity to antennas.

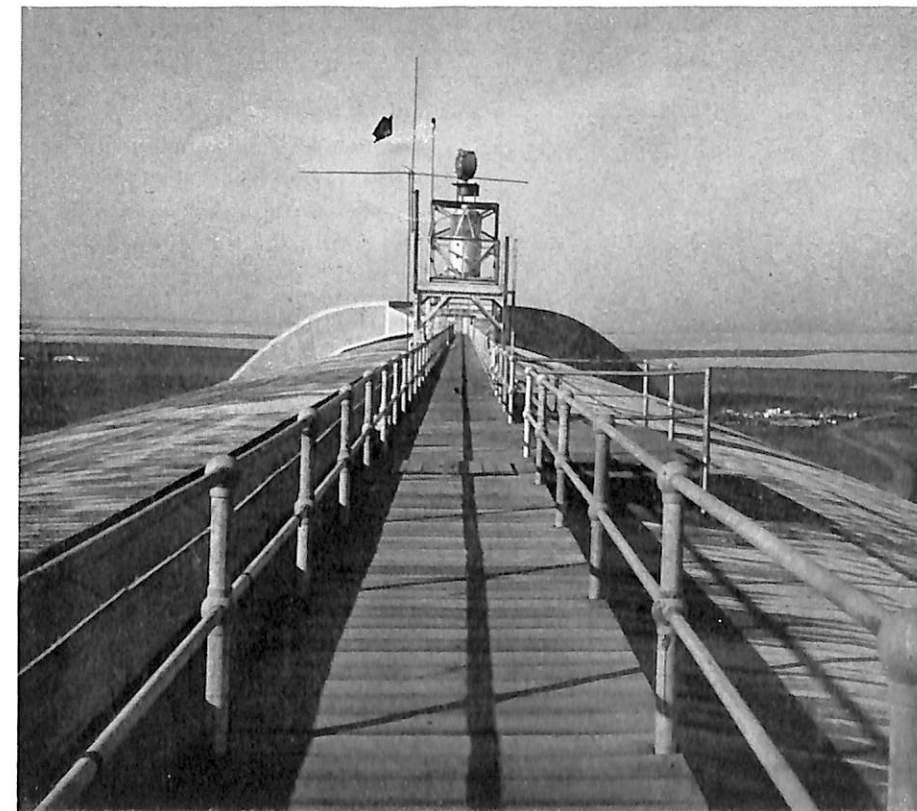
Check for the presence of metal fences in proximity to receiving antennas.

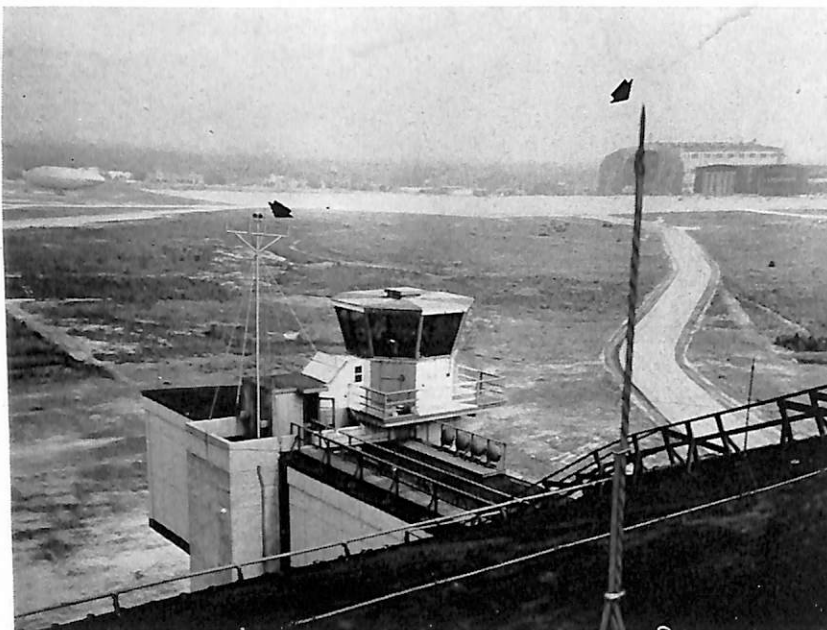
Aircraft hangar lightning rods and cable in the vicinity of receiving antennas.

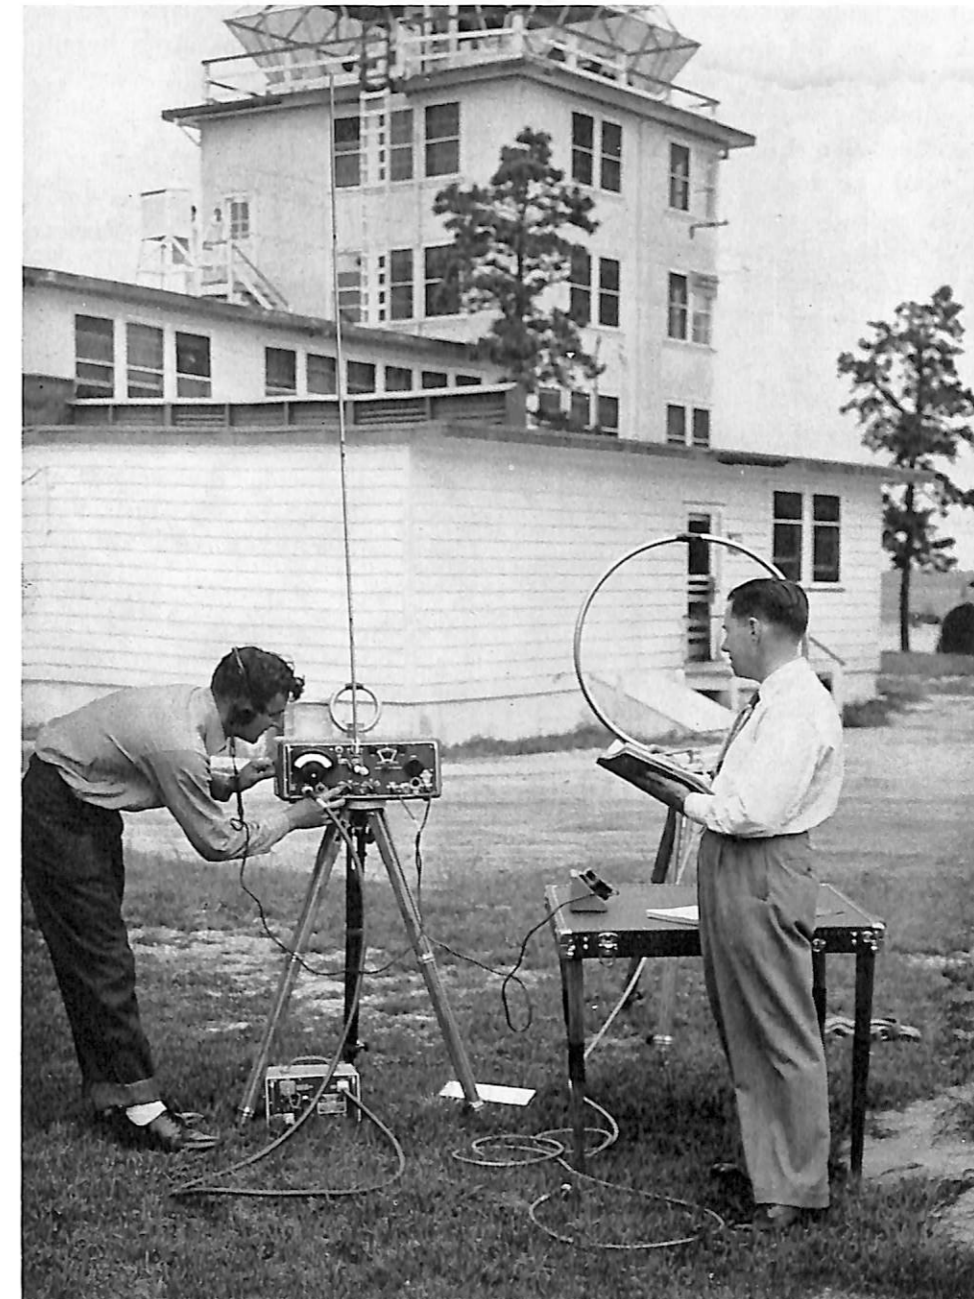
Measuring and locating sources of radiated electronic interference using the AN/URM-6 radio interference and field intensity measuring equipment.

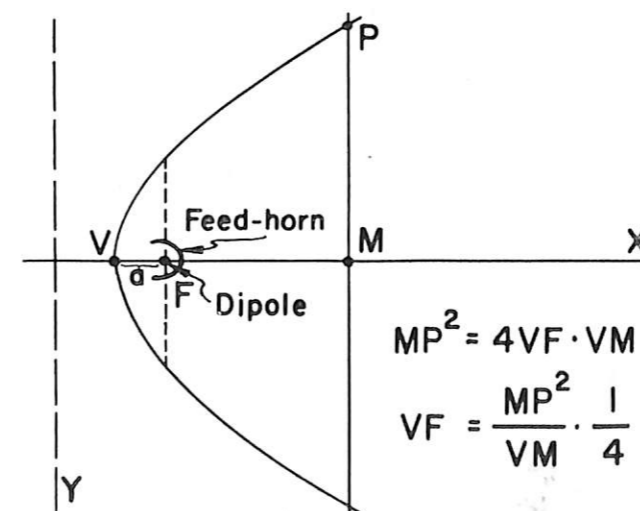
Several times the problem of radiation pattern change, variation, etc. caused by slight changes of Feed-Horn positioning at the focus of a parabolic reflector has occurred on AS-120/TPS-1B antenna; therefore I desire answers to the following questions:

a. Would the distance VF be measured to the center of the dipole or to the edge of the feed-horn?

b. Frequency is in the Lk band. What effect on the radiation pattern does moving the feed-horn and dipole up or down on its y axis cause?

c. If the feed-horn is moved angularly along the y axis (i.e. dipole held fast at focus and the horn rotated up or down on the y axis) would the center of the beam as reflected from the large parabola be raised up and down, if so, how much.
